National Science Foundation Arecibo Observatory Damage Press Call

NSF begins planning for decommissioning of Arecibo Observatory's 305-meter telescope due to safety concerns

RE: RECOMMENDATION FOR COURSE OF ACTION AT ARECIBO OBSERVATORY
TT Project No. U20209

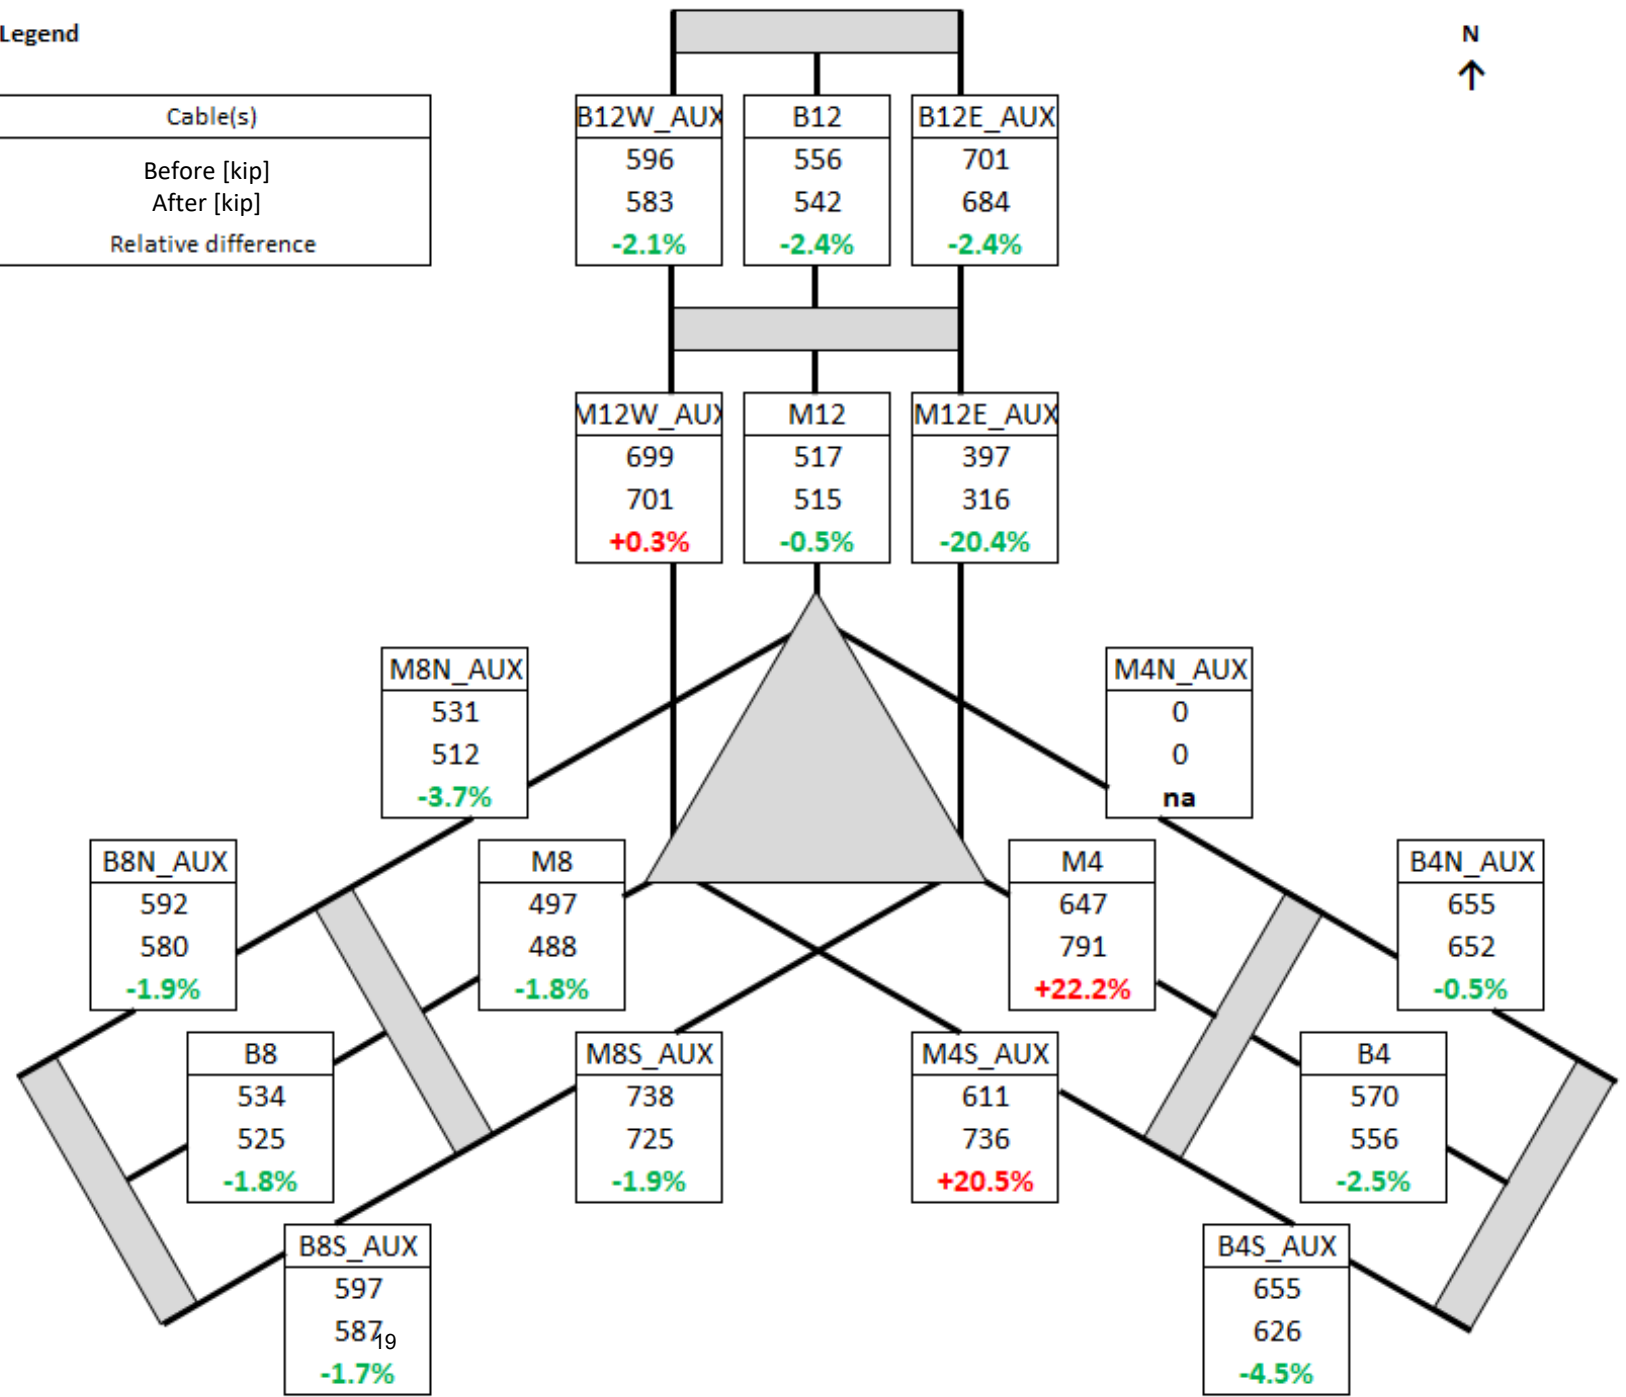
Cable Force Change Due to Second Cable Failure

Another cable failed on November 6. This cable was one of the four 3-inch-diameter original cables also supporting the platform from Tower 4. These original cables had been operating at a factor of safety of 1.67, based upon specified minimum breaking strength for the cable just prior to failure. This corresponded to a load or tension force of 647 kips (1 kip = one thousand pounds) in the original cables. The tension in the remaining three original cables has increased from the 647 kips to 790 kips. This places them at a factor of safety of 1.32 (force in cable/specified minimum breaking strength = 790/1044). This is nearly 75% of the specified

With the loss of two cables, there are now three original cables (of four) and one auxiliary cable (of two) connecting the platform to Tower 4. Should another of these three original cables fail, the two remaining original cables will undergo static force demands at or above the specified minimum breaking strength. A catastrophic failure would be very likely. These cables are not capable of handling the required dynamic demands of a sudden failure of an adjacent cable. The structural redundancy is no longer available and cannot be factored into determining safety.

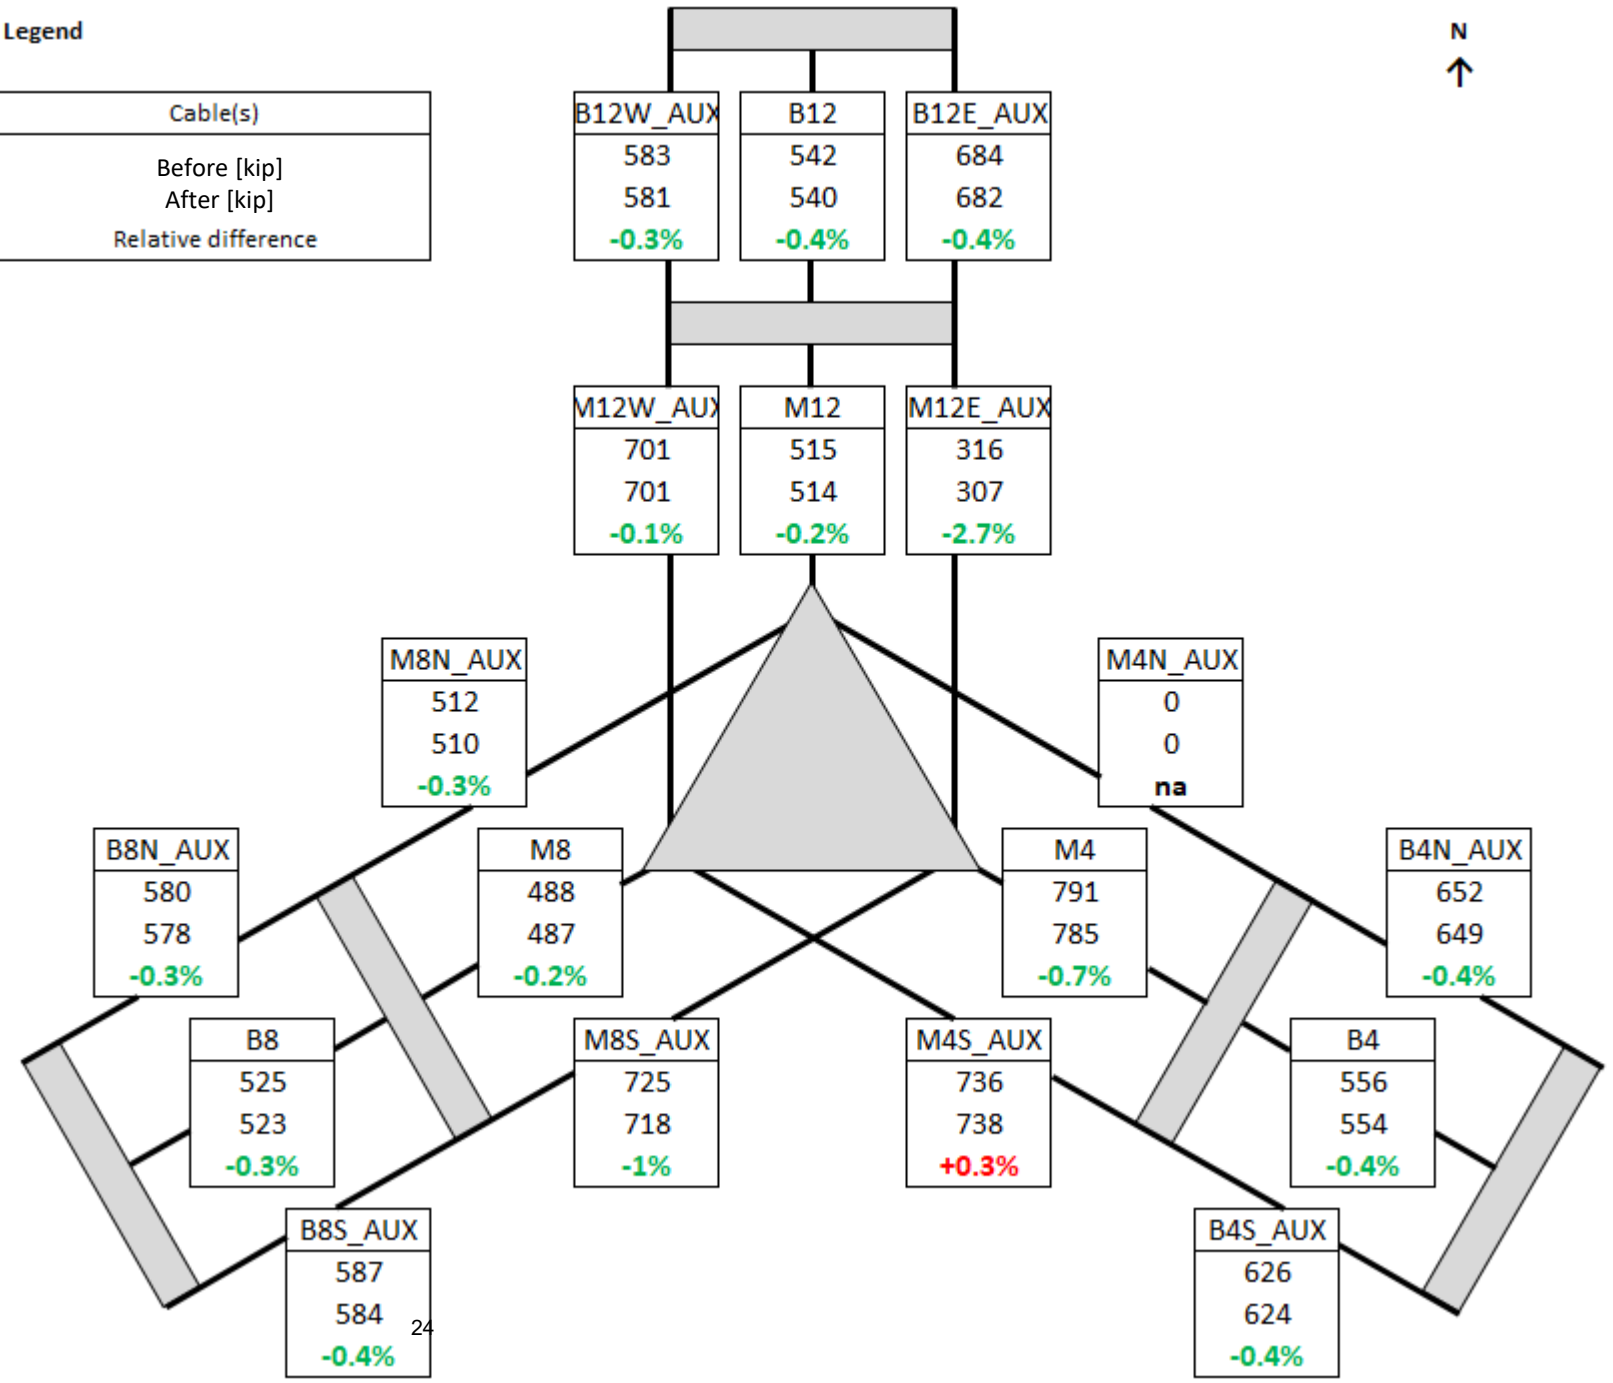
Cable Force Change If Cutting M4-4 (starting from current condition)

B12W_AUX	B12	B12E_AUX
583	542	684
581	540	682
-0.3%	-0.4%	-0.4%

M12W_AUX	M12	M12E_AUX
701	515	316
701	514	307
-0.1%	-0.2%	-2.7%

Task 4 – Cutting of Hanging M4-4 Cable. Using a helicopter, the failed M4-4 cable will be cut from its connection to the platform. This will reduce the load in the M4 cables by about 0.8 percent.

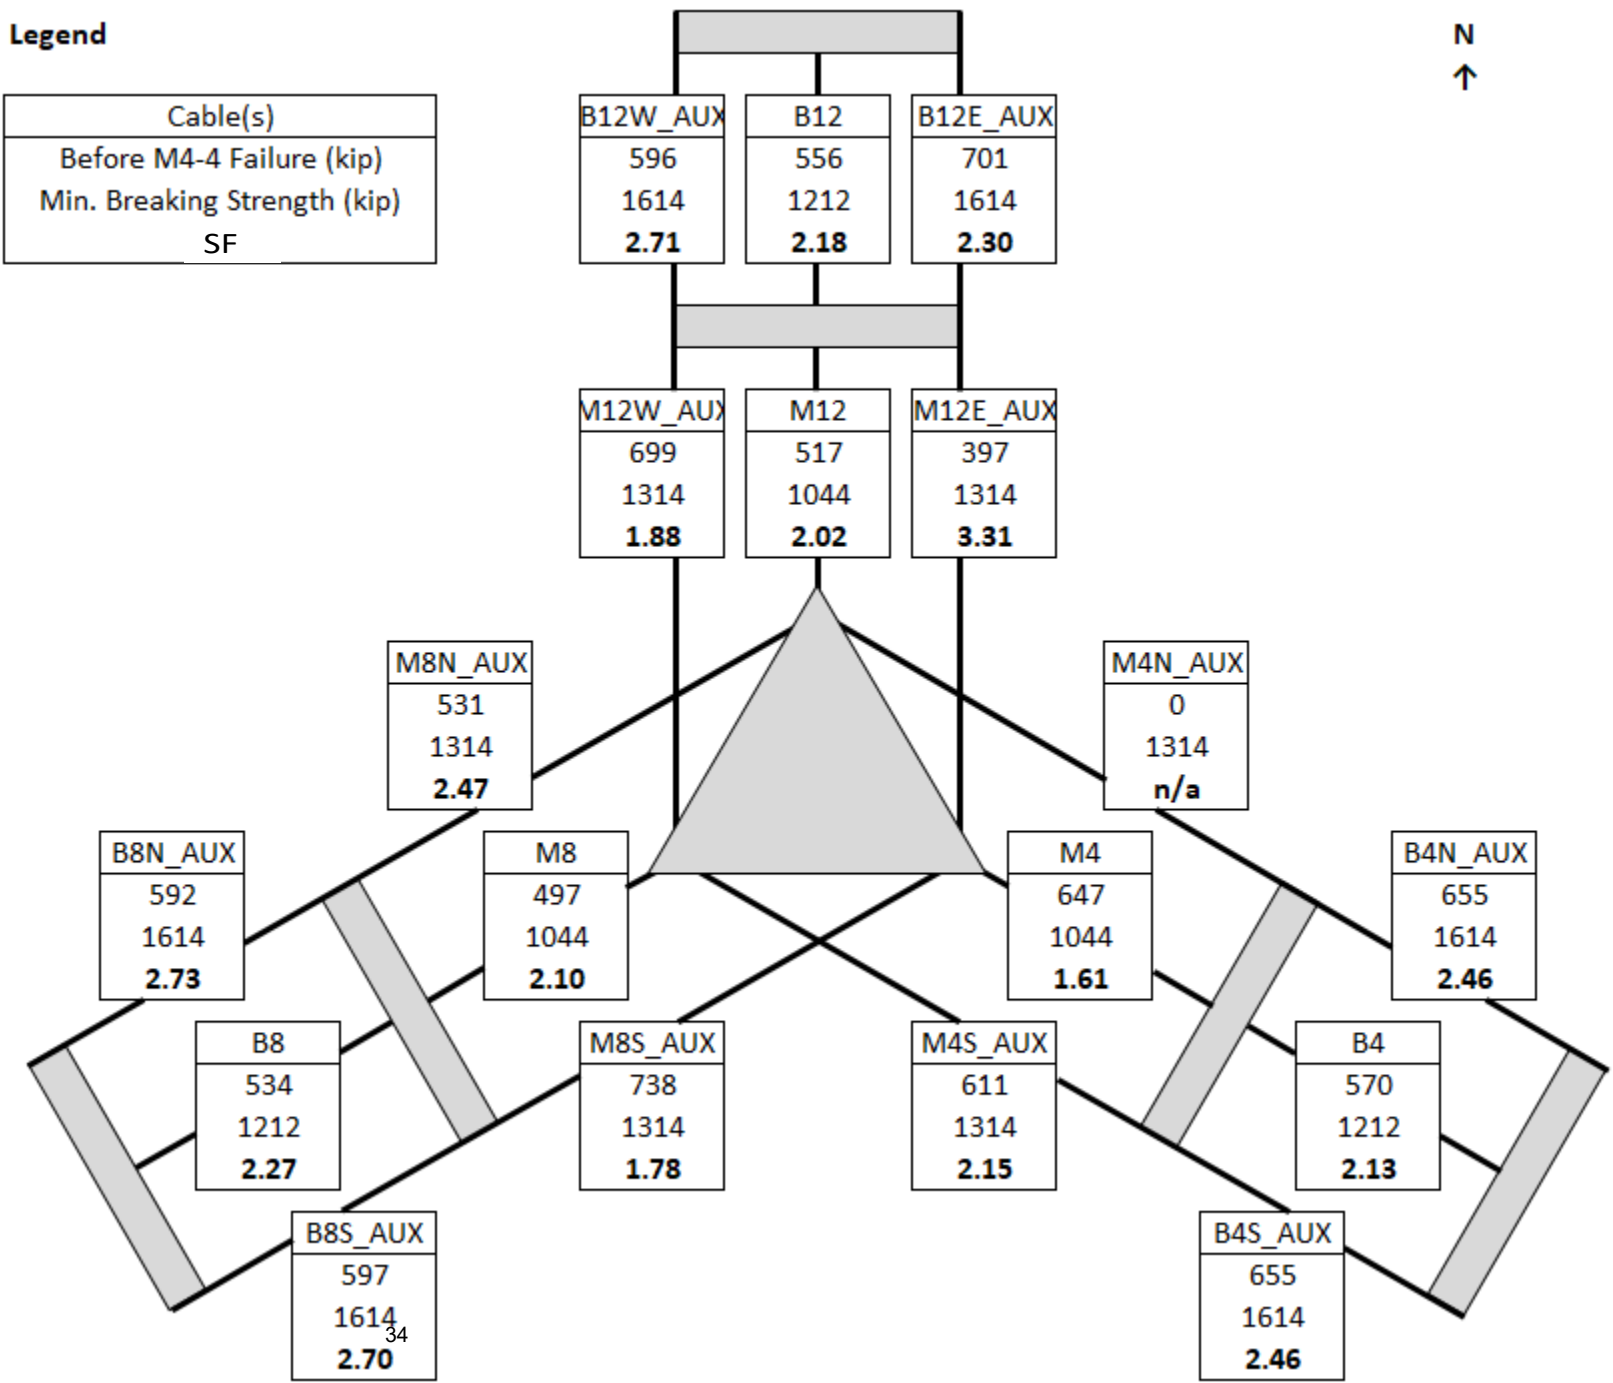
Cable Safety Factors Before Second Cable Failure

minimum breaking strength. The original cable failed near the anchor socket at the tower but did not pull from the socket. The design of the original structure and the upgrade in the 1990s intended a factor of safety of 2.1 or more for the cables.

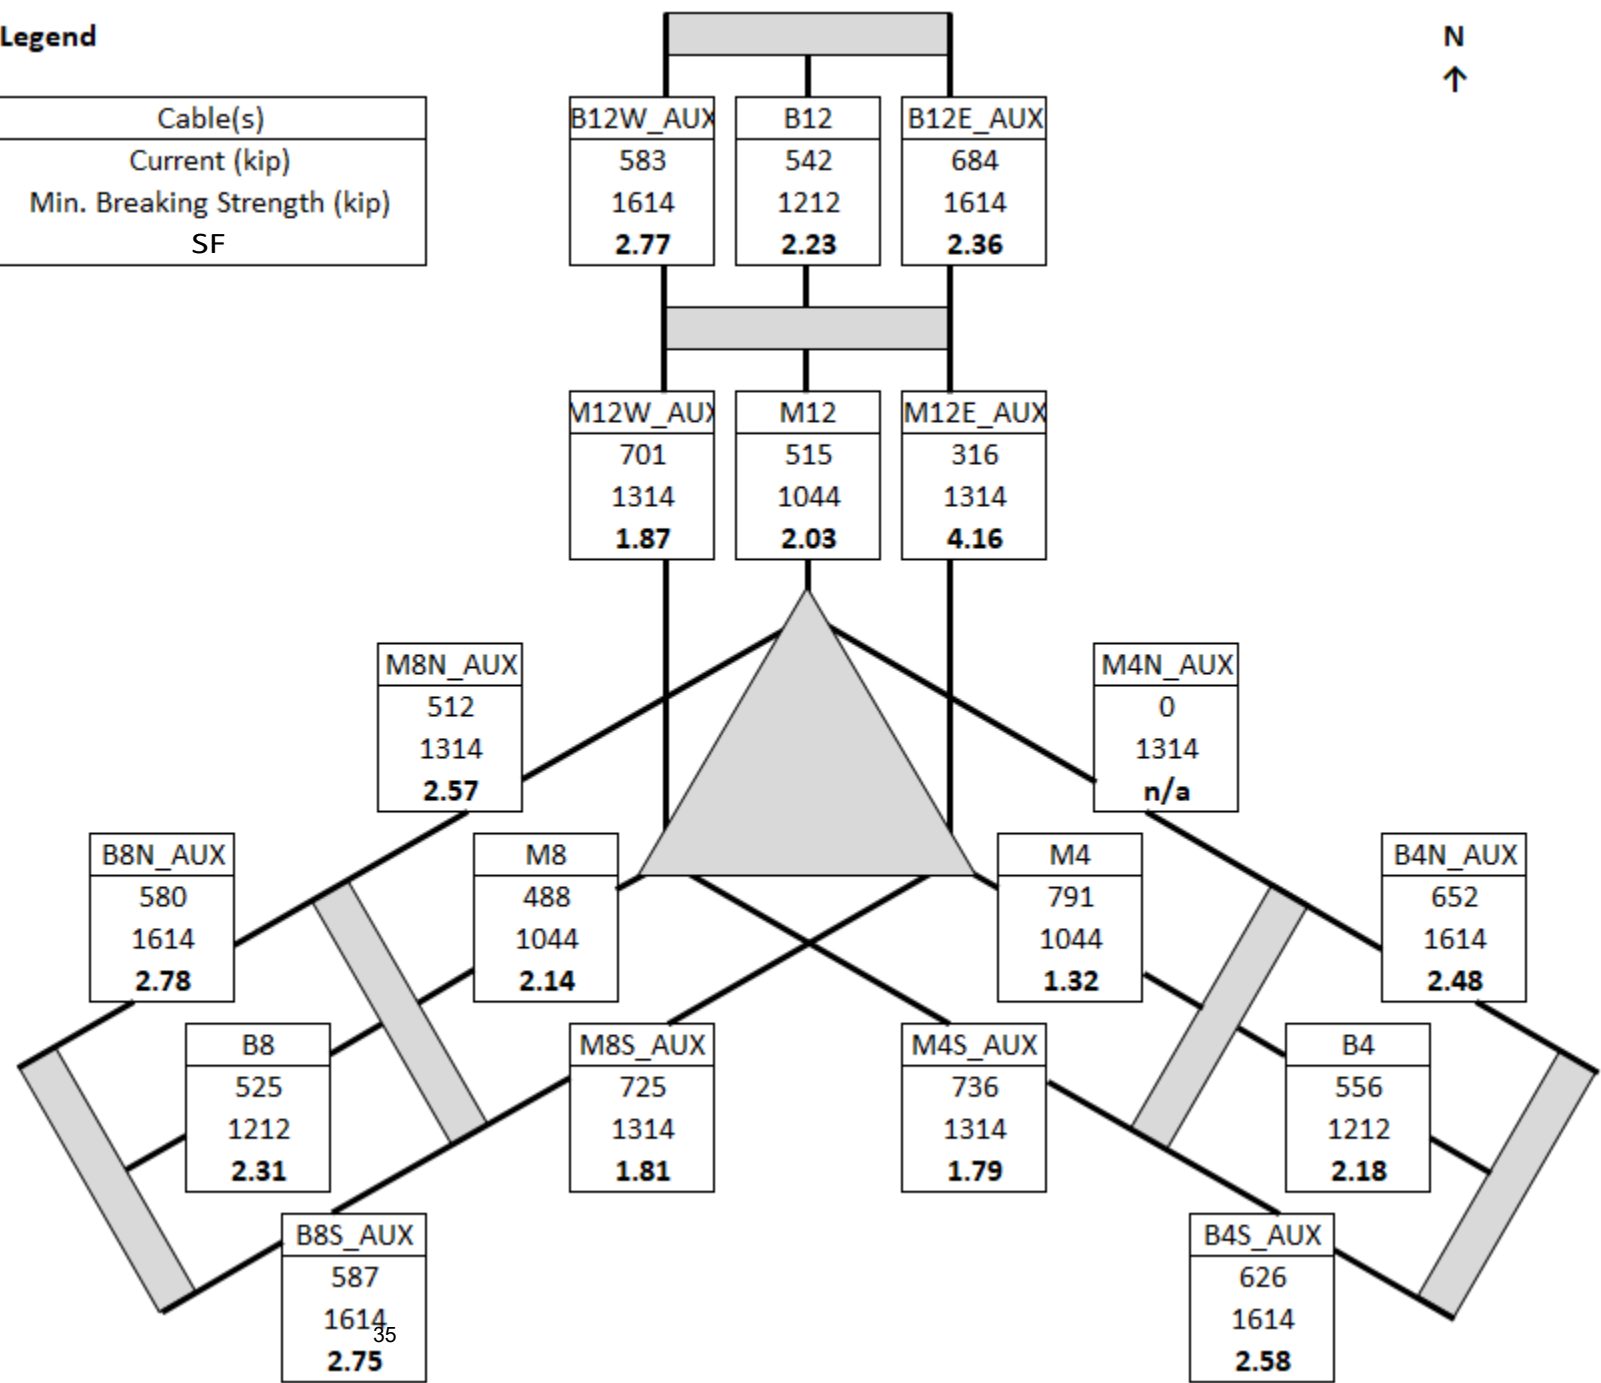
Cable Safety Factors Current Condition

We have noted wire breaks on the three remaining 3-inch-diameter original cables from Tower 4, which occurred during the November event. We continue to monitor the structure and continue to note wire breaks since the failure last week. Furthermore, there is no evidence that the existing original cables can achieve the specified minimum breaking strength and certainly evidence to the contrary, since one failed at 62% of this strength. The failure event may have occurred over a period of eight minutes as evidenced by the increase in stress, measured from instrumentation installed on the south auxiliary cable to Tower 4, just prior to failure. Weather at the time of failure was calm, with no unusual winds or ambient temperatures and no ground shaking. Failure was unexpected.
