NASA/TM-20210017934
NESC-RP-20-01585

Arecibo Observatory Auxiliary M4N Socket Termination Failure Investigation

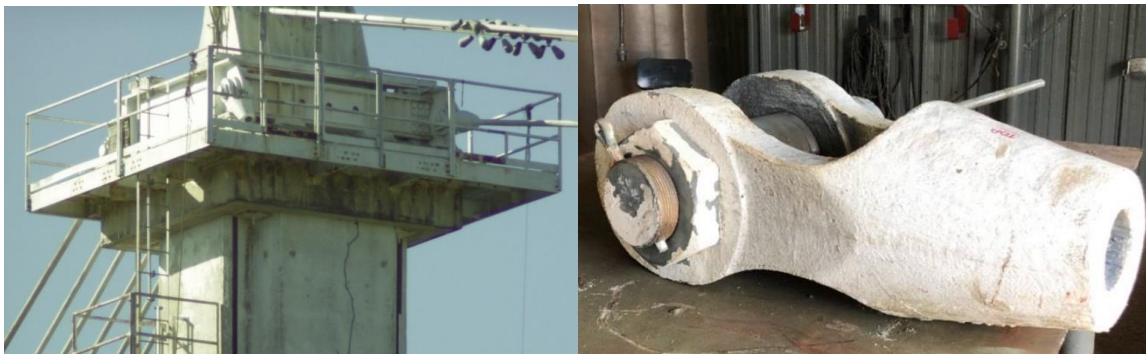
Figure 6.0-1. Tower 4, including Socket

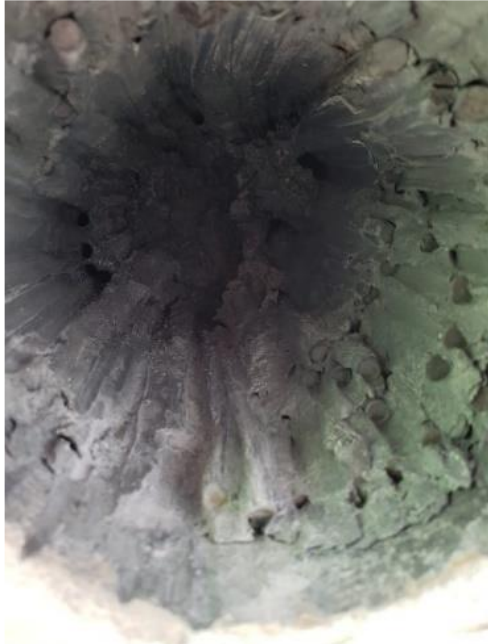
Figure 6.0-2. Wire Strands inside Failed Socket

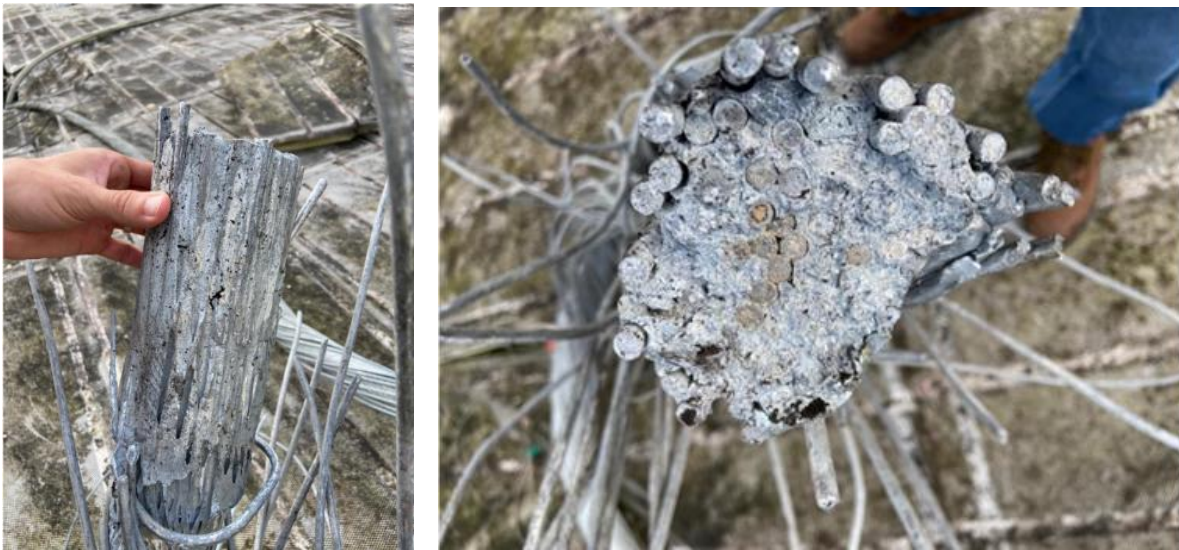
Figure 6.0-3. Pulled-Out Cable Wire, Strands and Zinc (side view)

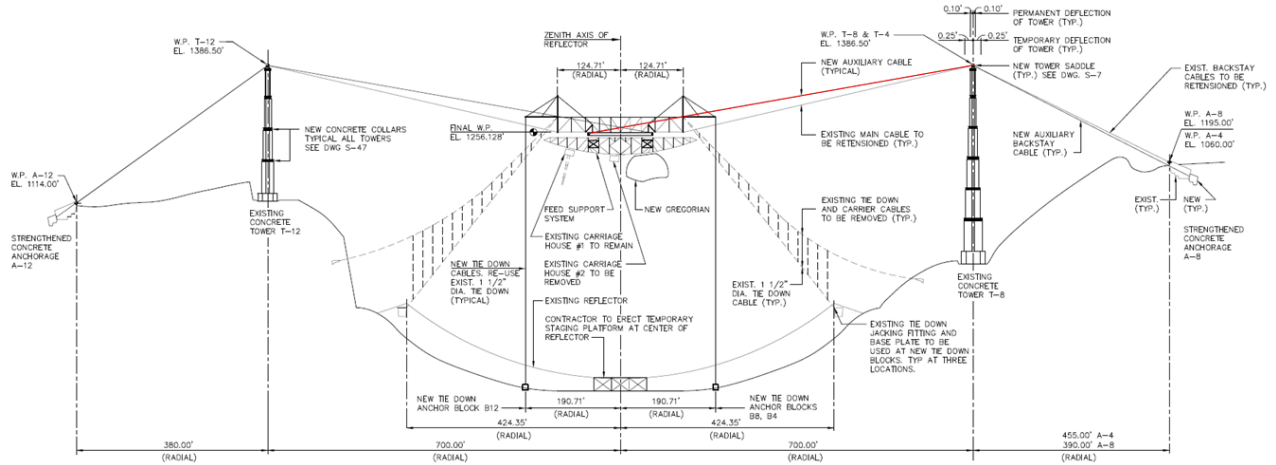
Figure 6.2-2. Elevation Drawing S-2, highlighting Failed Aux M4N Cable in Red

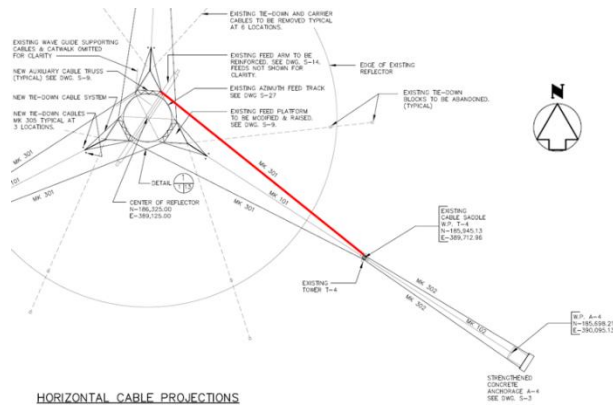
Figure 6.2-3. Horizontal Cable Projections, Drawing S-1, highlighting Failed Aux M4N Cable in Red

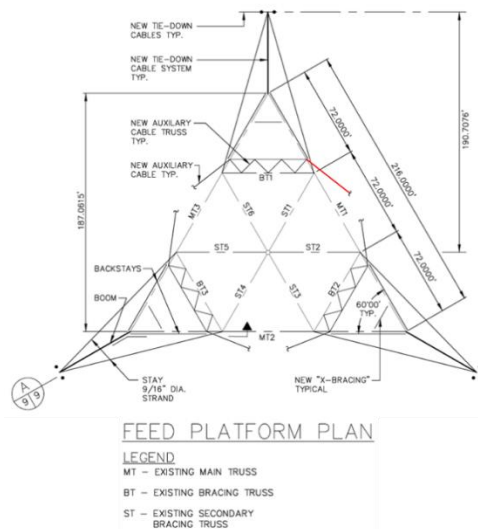
Figure 6.2-4. Feed Platform Plan, Drawing S-9, highlighting Failed Aux M4N Cable in Red

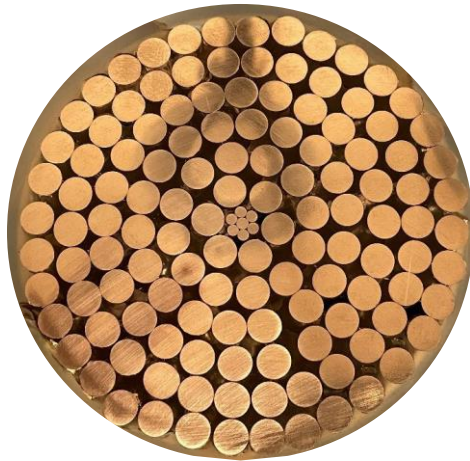
Figure 6.2-5. Cross Section of 1×127 Structural Strand

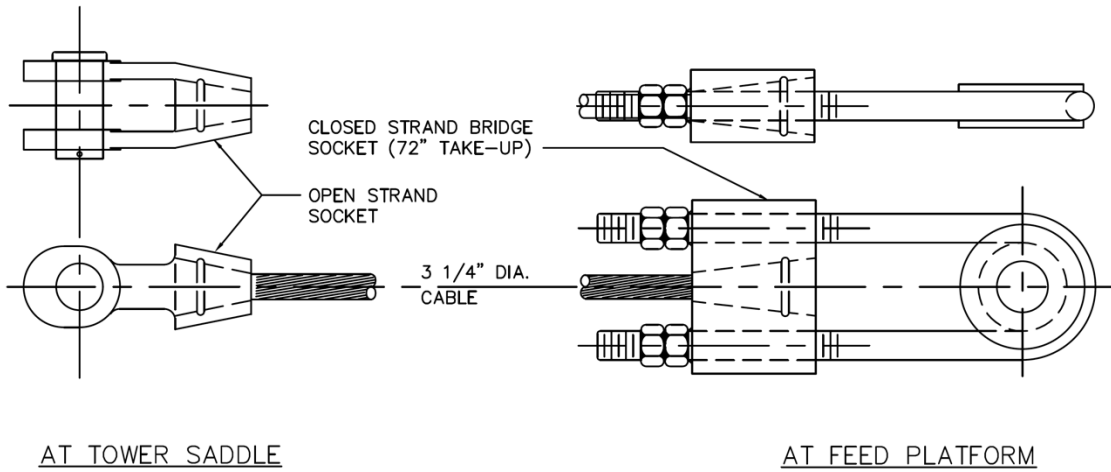
AUXILIARY CABLES: MK 301
N.T.S.

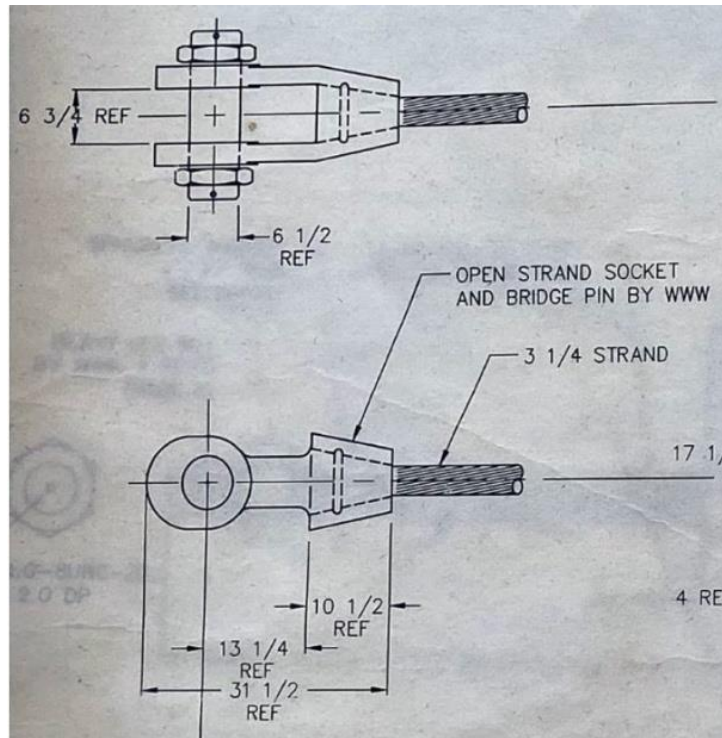
Figure 6.2-7. WWW Shop Drawing for Open Strand Socket

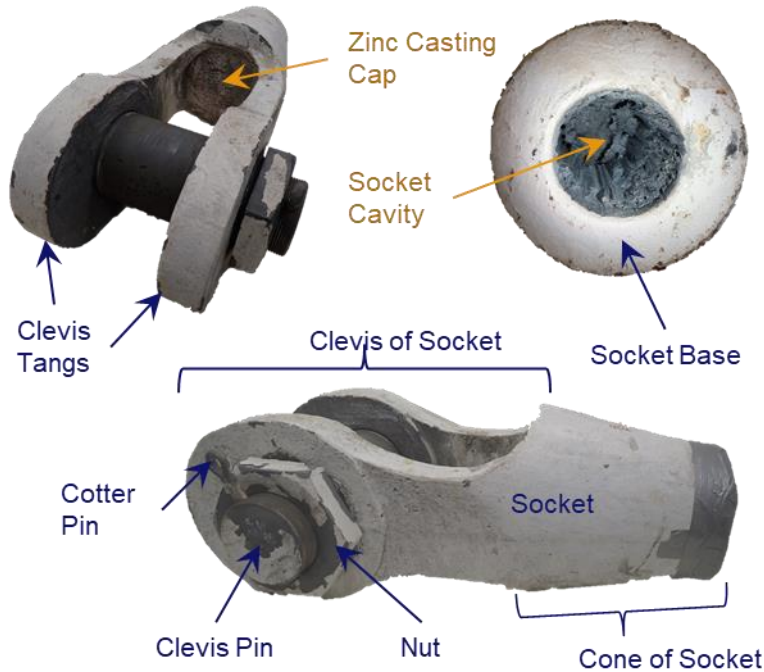
Figure 6.2-8. Nomenclature used to Describe Parts of Failed Socket

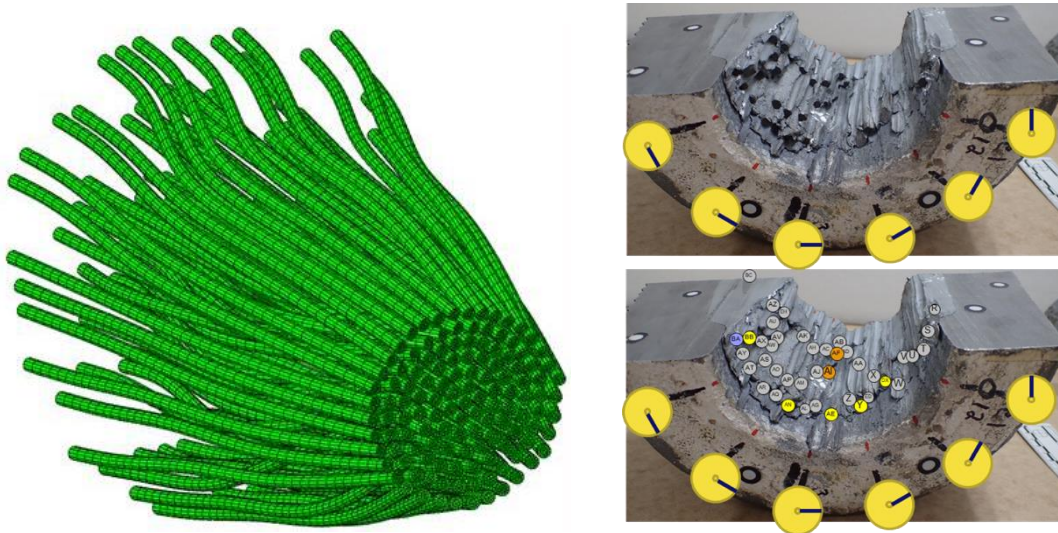
Figure 6.4-1. Aux M4N Wire Reconstruction (left) and Interim Forensic Analysis of Zinc Spelter and Wires showing Wire Fracture Pattern of Wire Segments Left in Socket Termination (right)

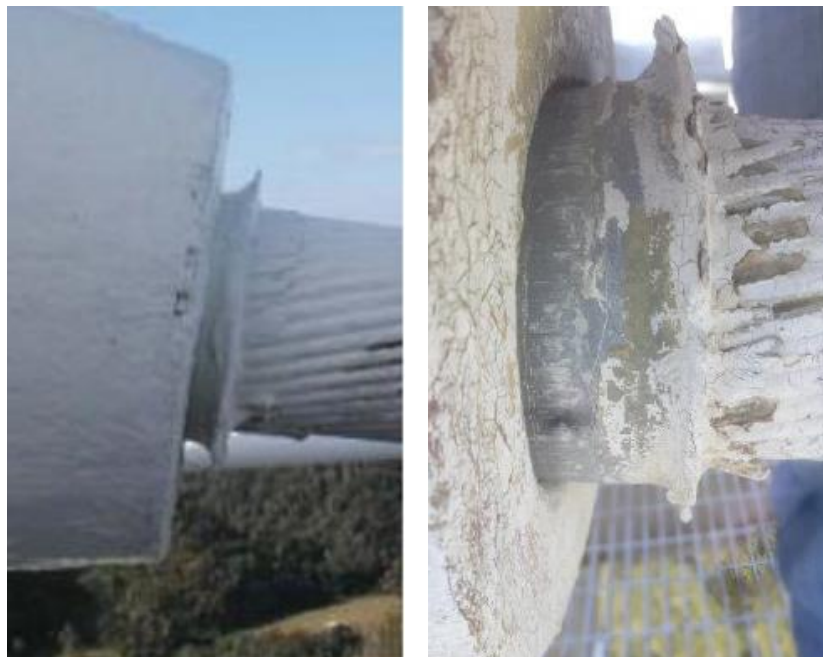
Figure 6.4-2. 2003 Photo of Aux M4N (left) showing ~0.5-inch Zinc Seating Extrusion and 2019 Photo (right) showing ~1 3/8-inches Extrusion [ref. 1]

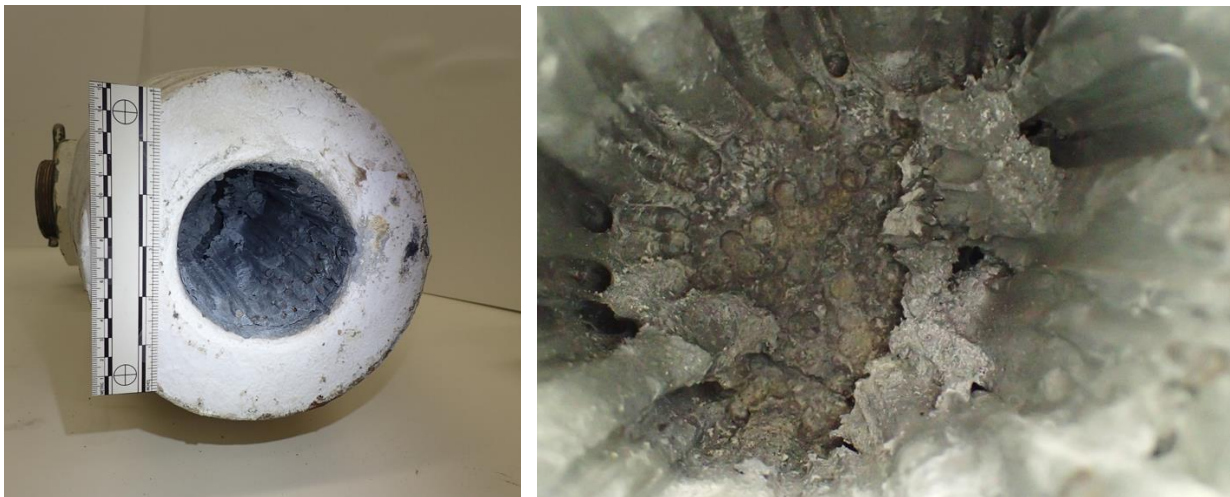
Figure 7.2.1.1-1. As-received Socket Cavity

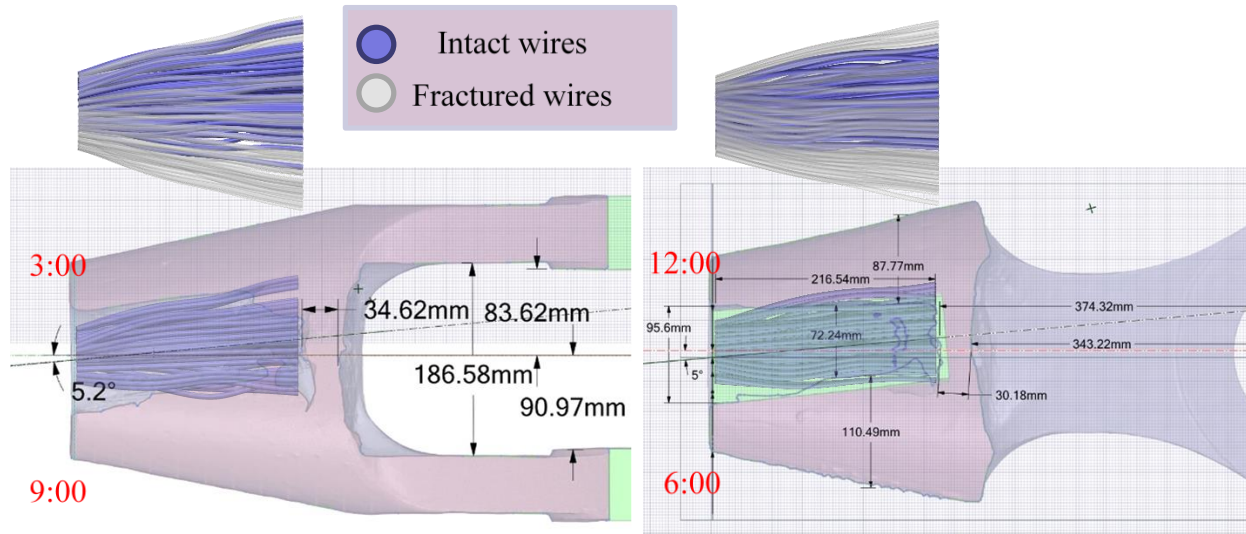
Figure 7.2.1.1-2. Overlays of Intact Wires that Pulled Free of Joint, with Full Broom Above
 Left images are top view of socket; right images are a 9 o'clock view.

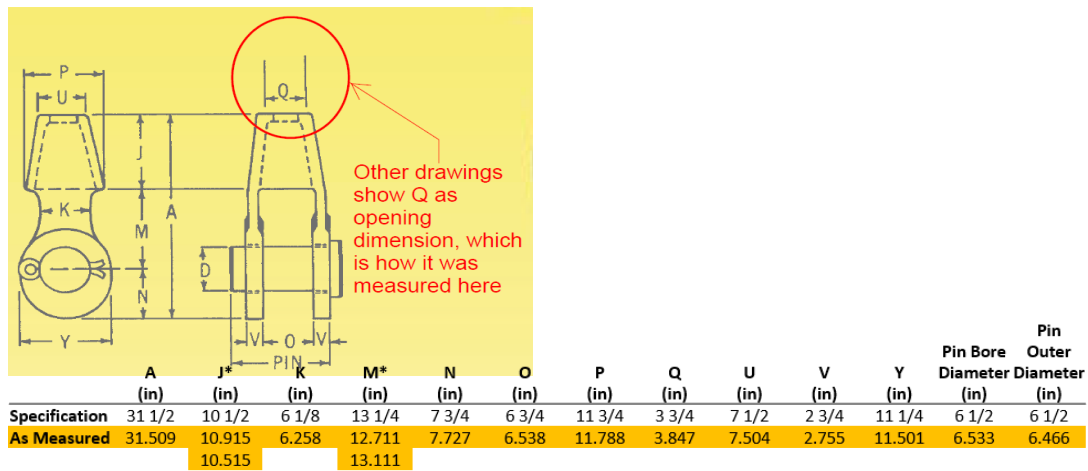
*Draft allowance for mold release produces a taper at J-M interface. Measurements were made at inner edge of cone which gives a larger number (~0.4 in greater than minimum material condition). Numbers come in if draft allowance is ignored which is shown in the lower column.

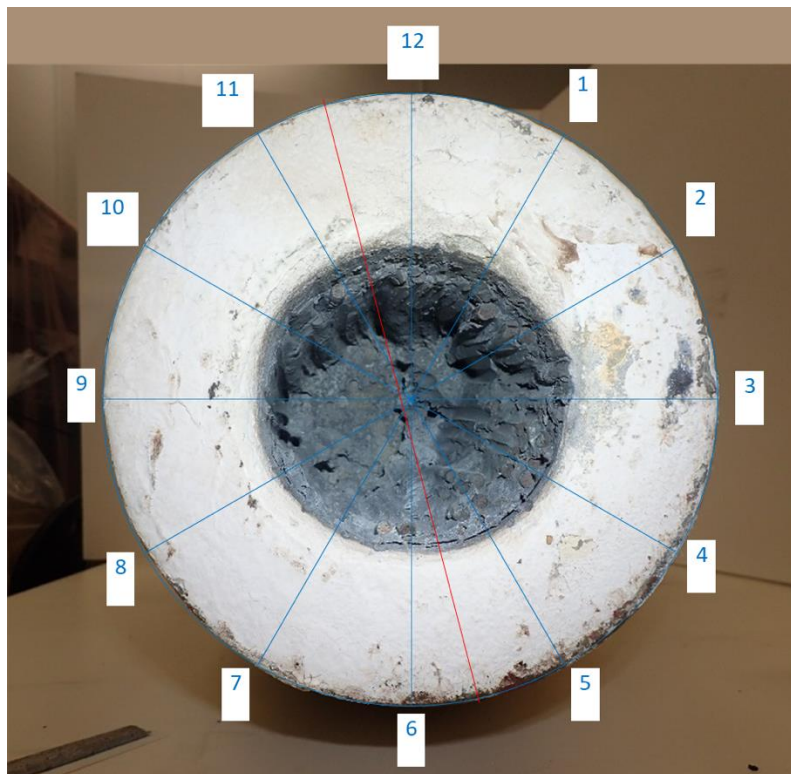
Figure 7.2.1.3-1 (Appendix A Figure 30). Photo of Socket Base with Top of Socket at Top of Image

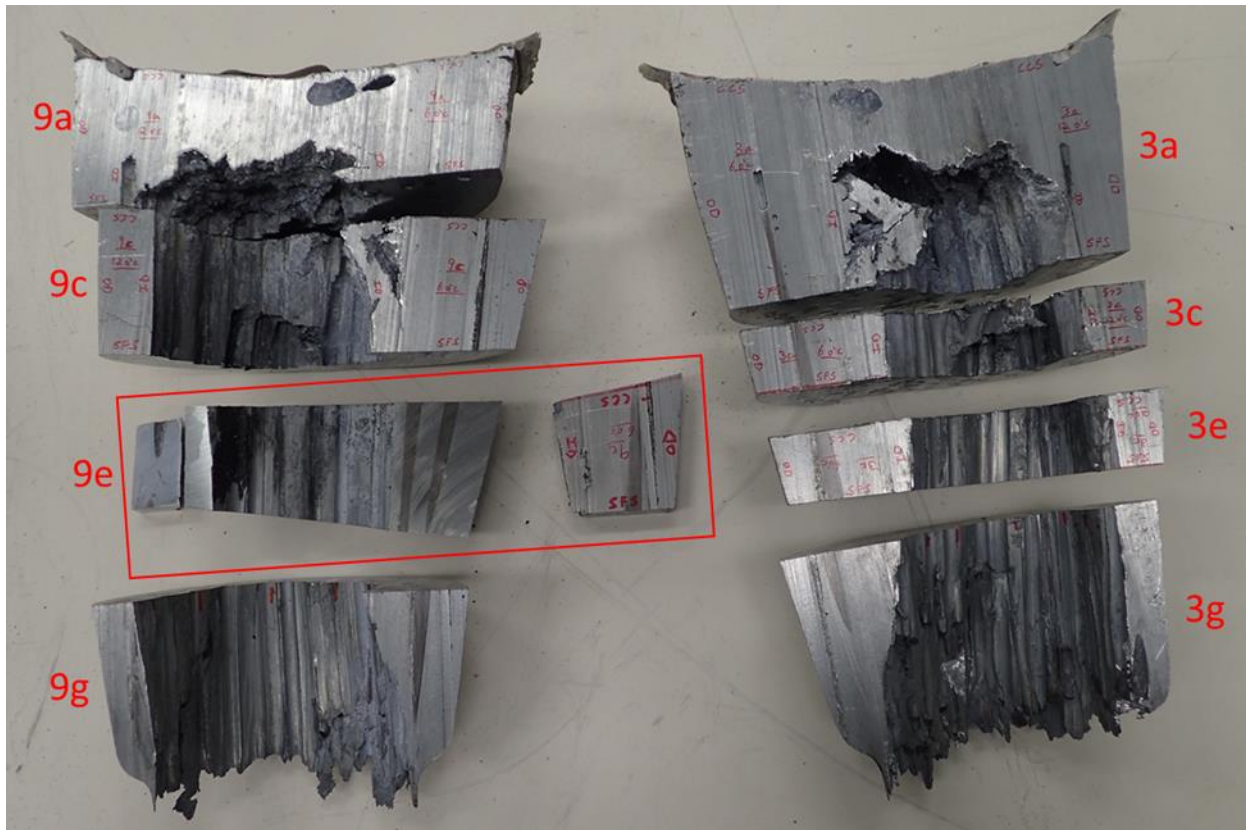
Figure 7.2.1.3-2 (Appendix A Figure 31). Zinc Socket Cavity Transverse Section Labeling

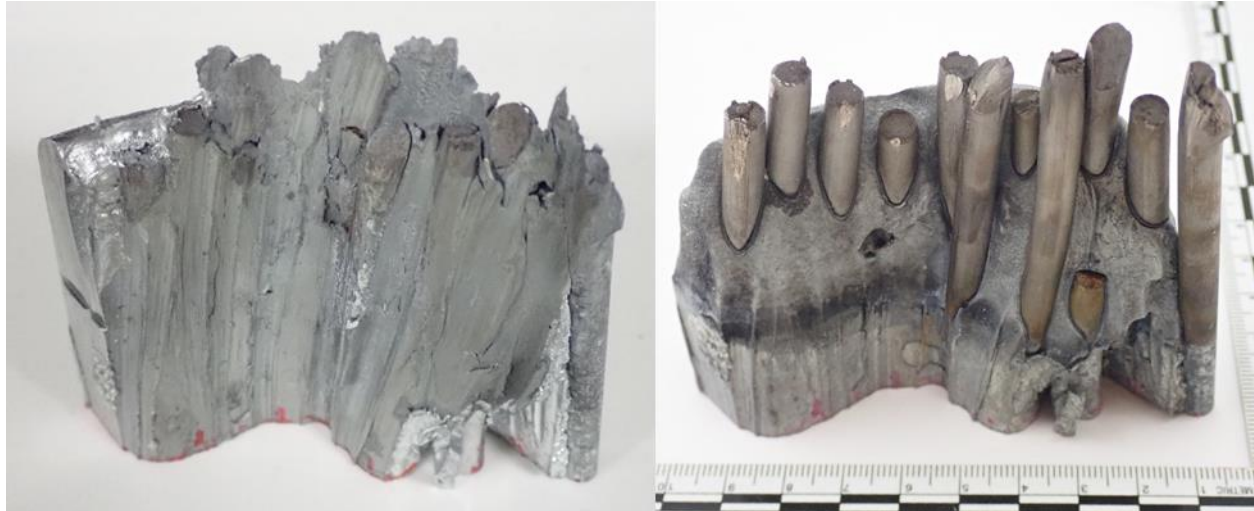
Figure 7.2.1.3-3 (Appendix A Figure 32). Section of Zinc with Encased Wires before (left) and after (right) Removal of Zinc via Dissolution in Acid

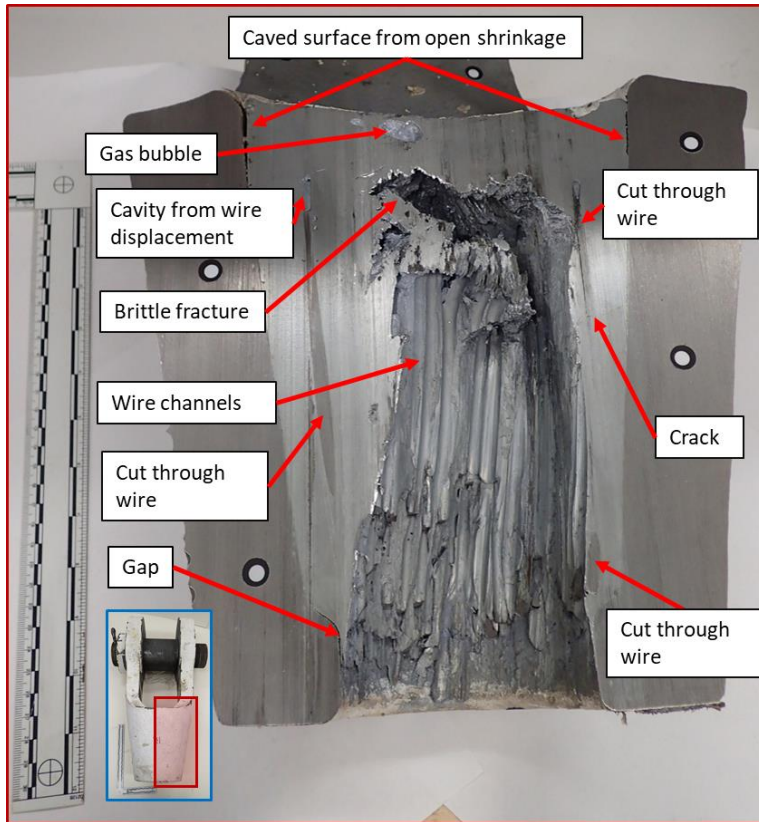
Figure 7.2.2.1-1 (Appendix A Figure 1). 3 o'clock Half of Socket Cavity
 Socket base is aligned with bottom of image.

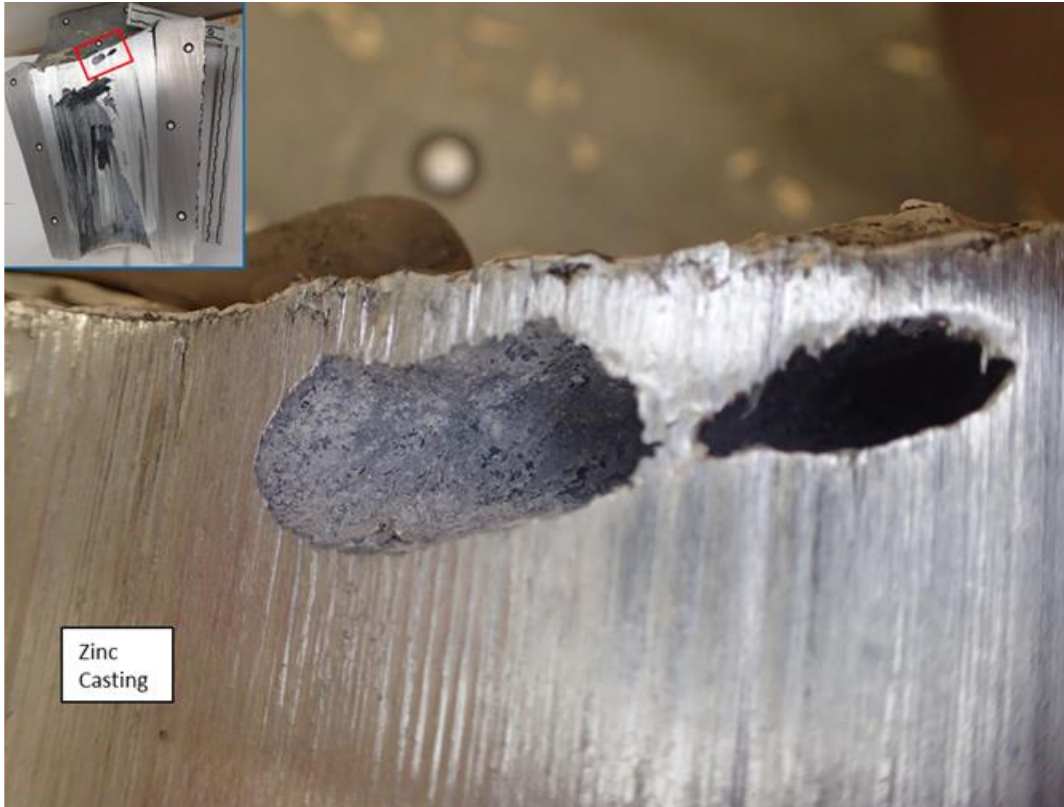
Figure 7.2.2.2-1 (Appendix A Figure 57). Close-up View of a Single Gas Bubble in Zinc Casting with Corrosion Product Buildup on Walls

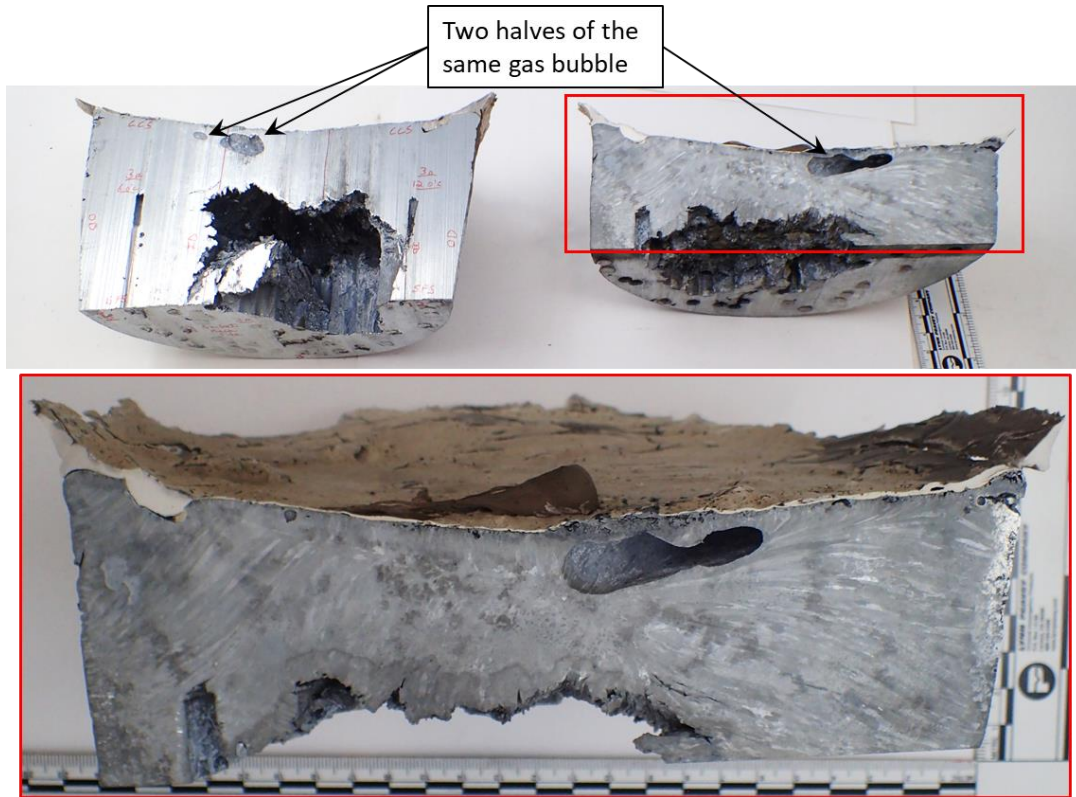
Figure 7.2.2.2-2 (Appendix A Figure 283). Etch of Longitudinal Cut Face and Zinc Grains below Casting Cap

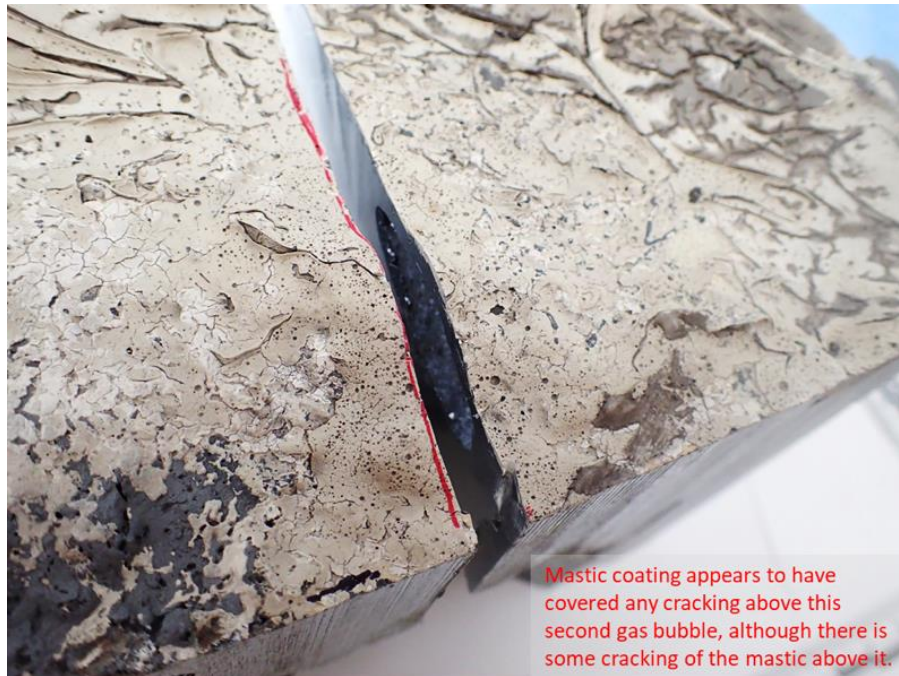
Figure 7.2.2.2-3 (Appendix A Figure 2). Oblique View of Casting Cap Immediately above Second Gas Bubble

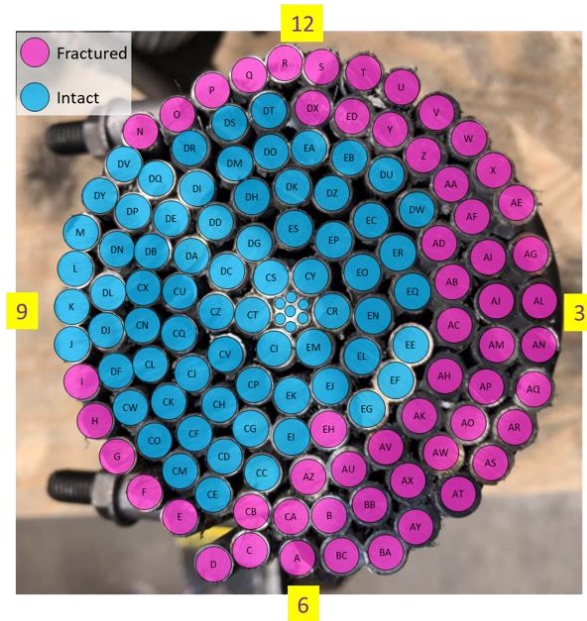
Figure 7.2.3.1-1. Representation of Cable Wire Map at Socket Base (varies with distance from end)

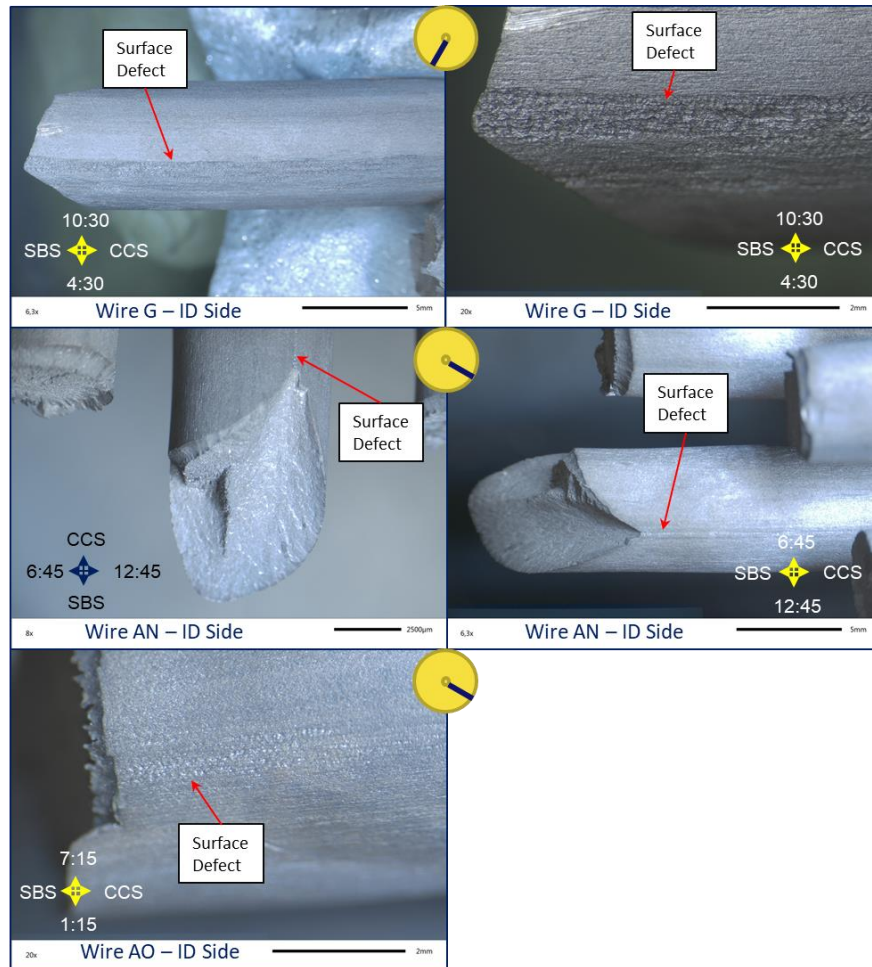
Figure 7.2.3.2-1. Stereomicroscope Images of Similar Surface Defects found on Wires G, AN, and AO

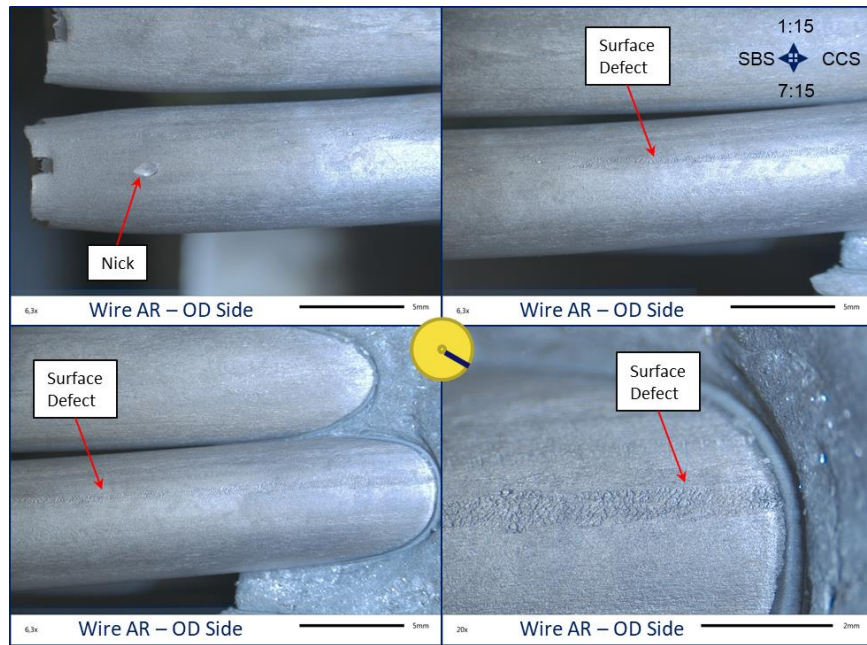
Figure 7.2.3.2-2. Stereomicroscope Images of Surface Defect found on Wire AR (nick visible in top row left image was likely from sectioning)

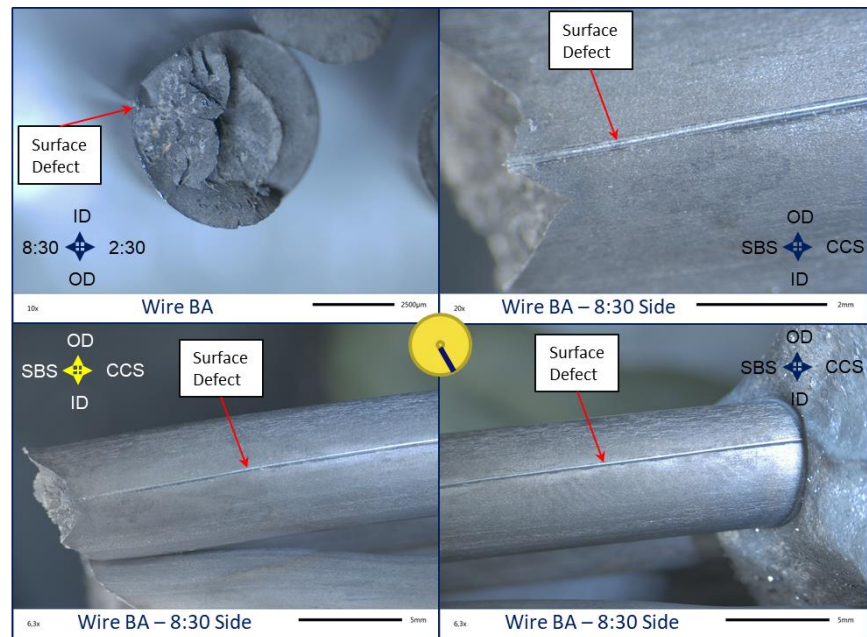
Figure 7.2.3.2-3. Stereomicroscope Images of Surface Defect found on Wire BA

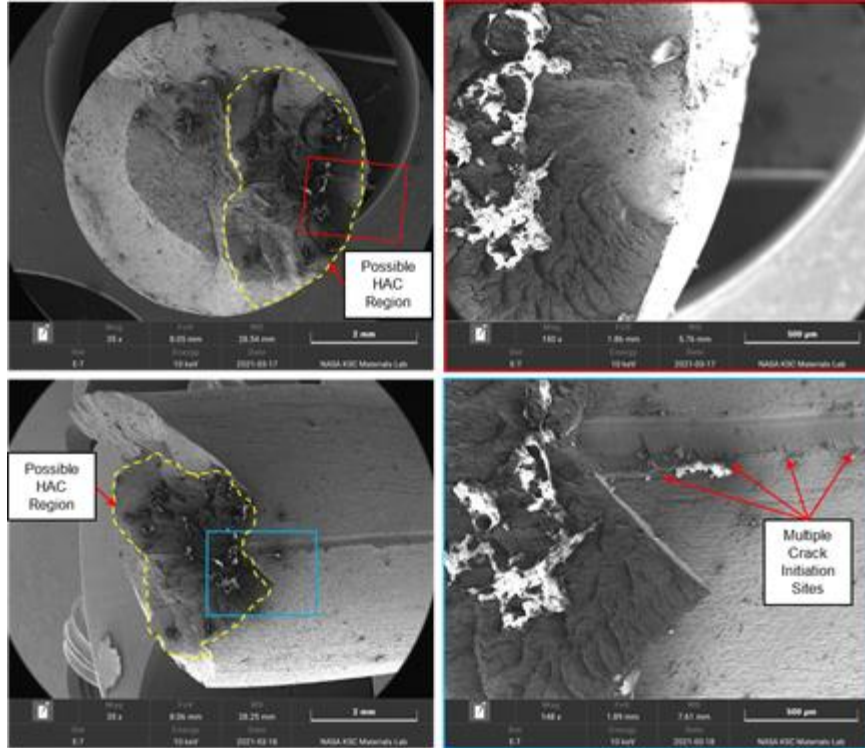
Figure 7.2.3.2-4. SEM Images of Surface Defect found on Wire BA

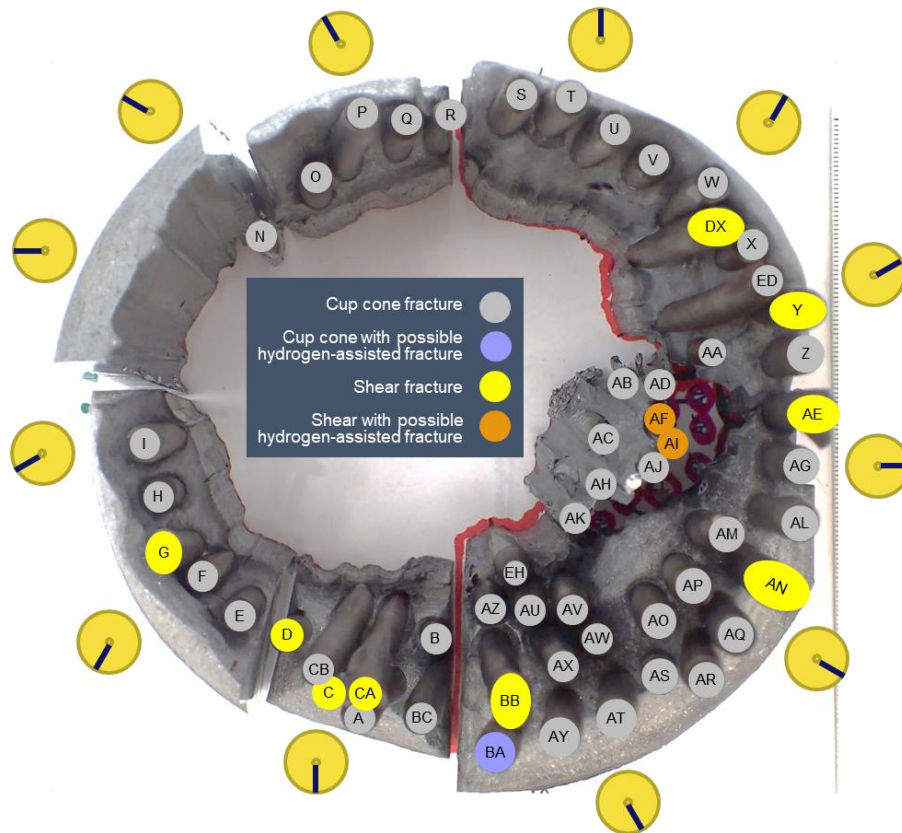
Figure 7.2.3.2-5. Reconstruction of Wire Locations following Zinc Removal with Identified Fracture Morphology

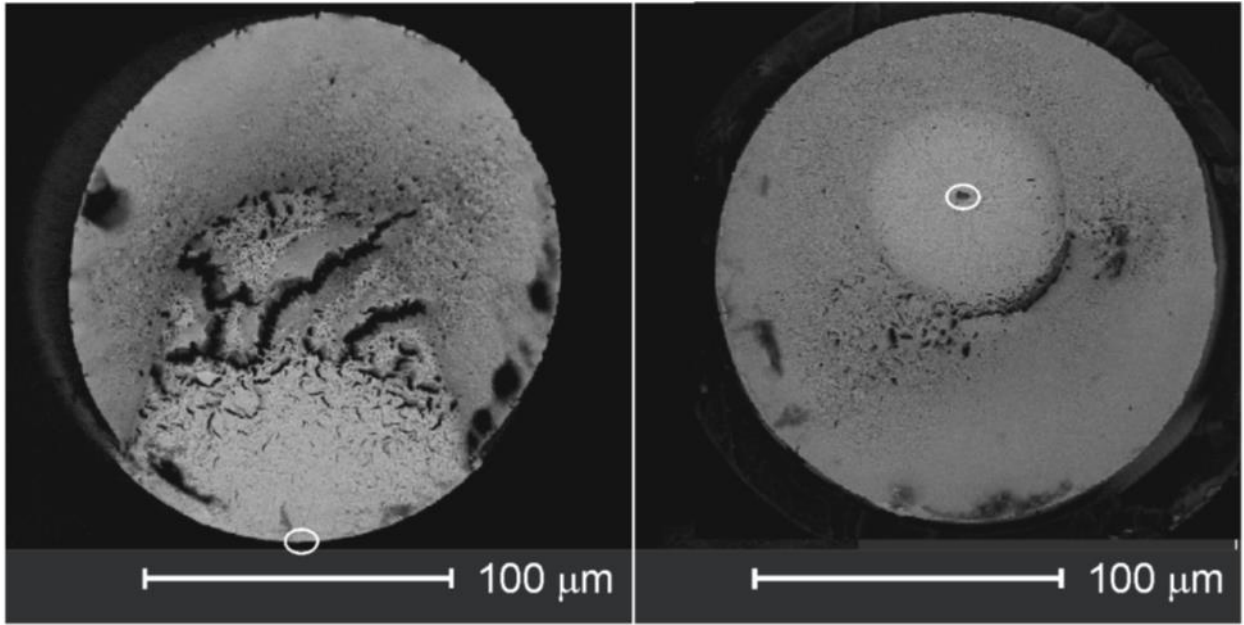
Figure 7.2.3.2-6. Fatigue Cracking in Heavily Drawn Steel Wires [ref. 9]

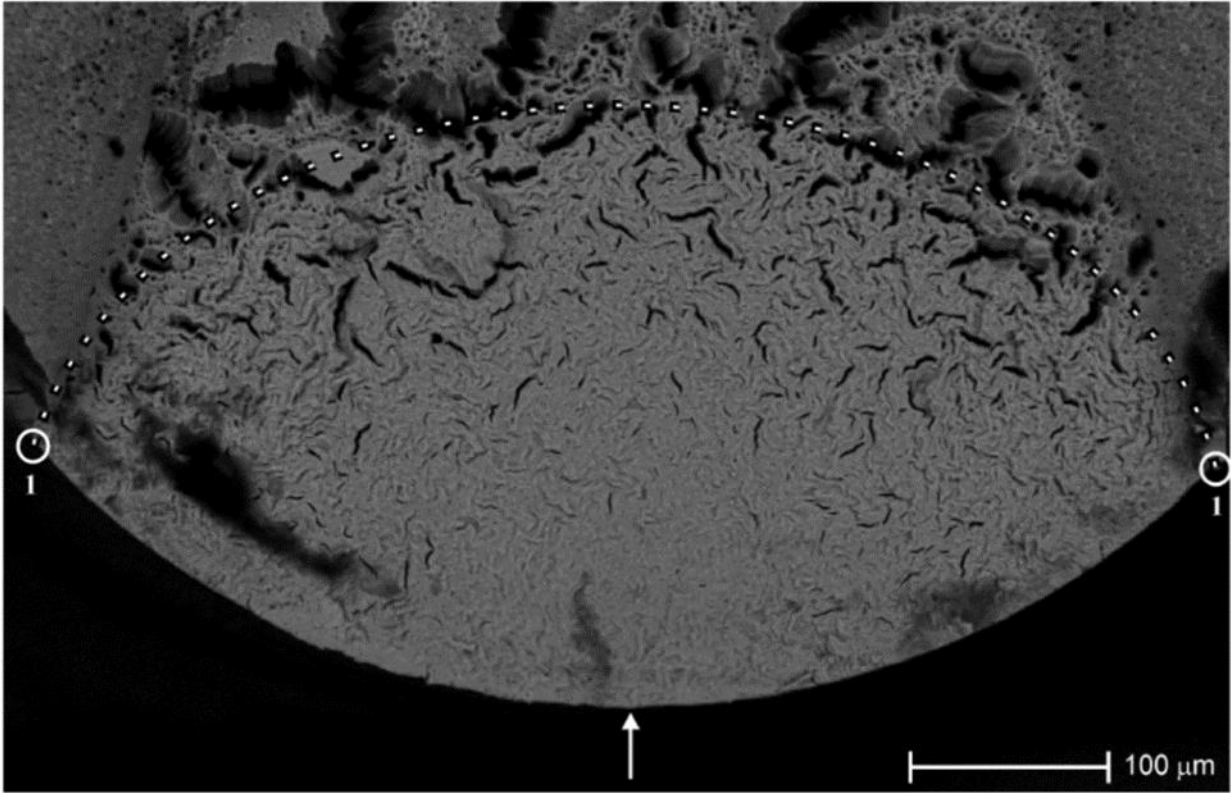
Figure 7.2.3.2-7. Closer Image of Surface-initiated Fatigue Crack in Heavily Drawn Steel Wire [ref. 9]

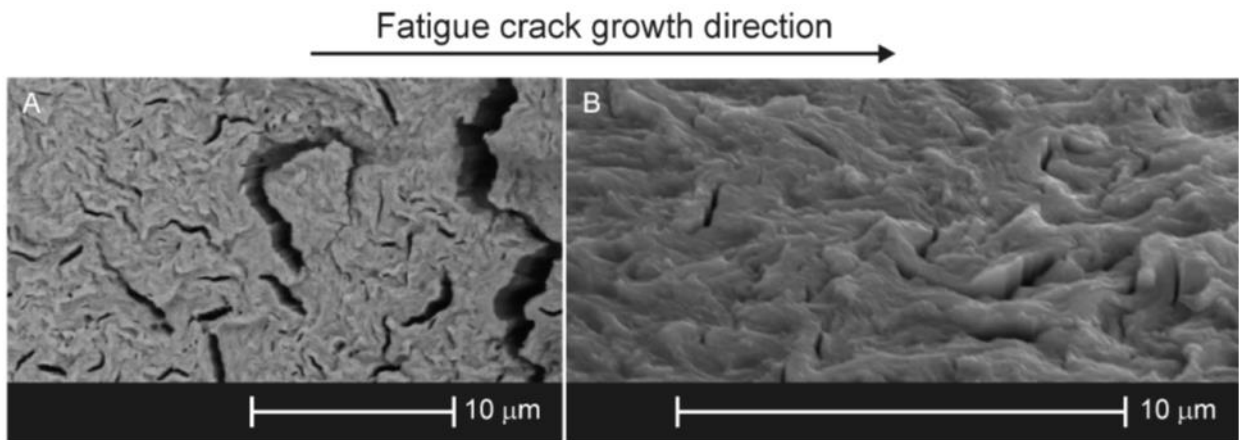
Figure 7.2.3.2-8. Fatigue Fracture Surface with Secondary Cracks
((A) looking down on fracture plane; (B) profile view of fracture plane) [ref. 9]

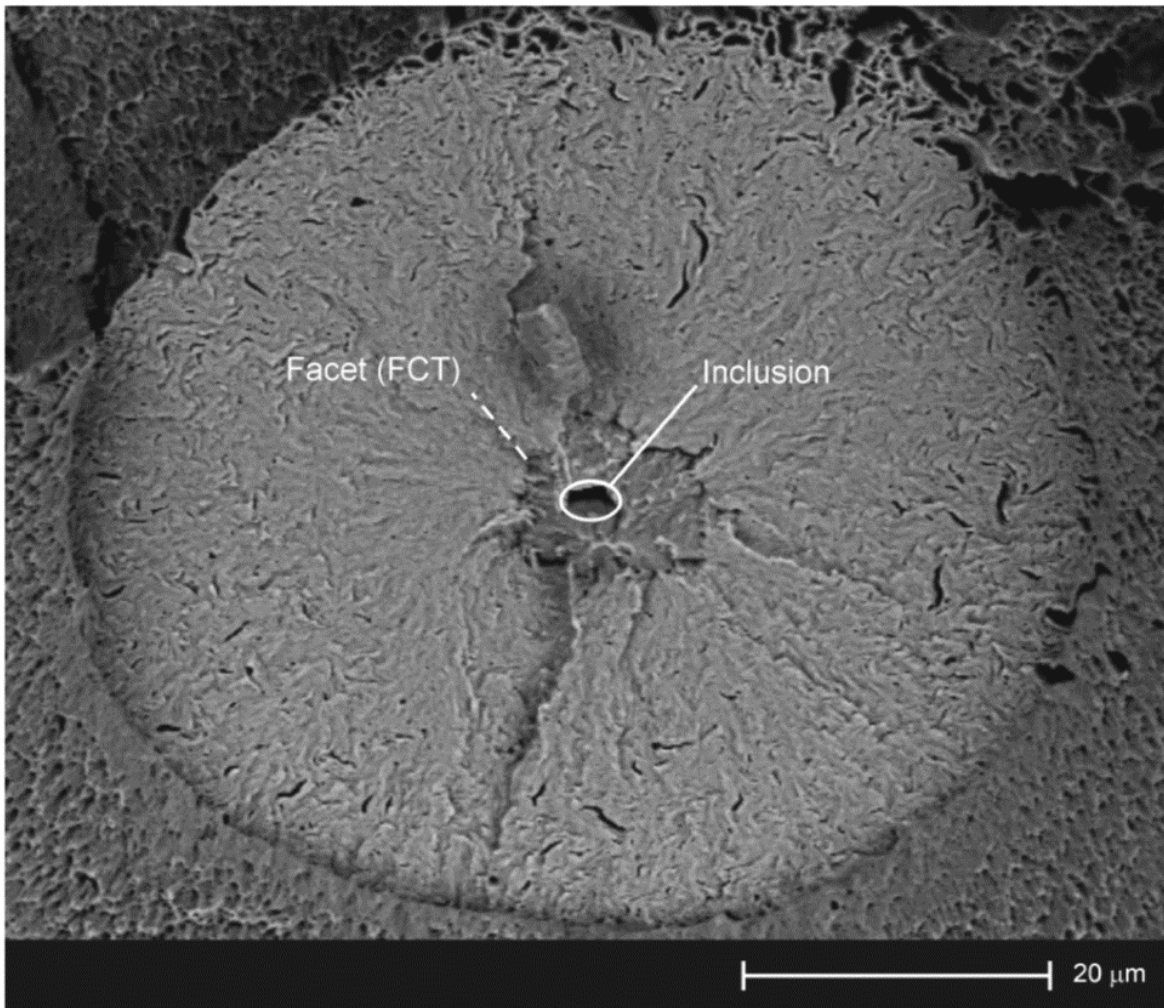
Figure 7.2.3.2-9. Closer Image of Internally Initiated Fatigue Crack, showing Facet Area [ref. 9]

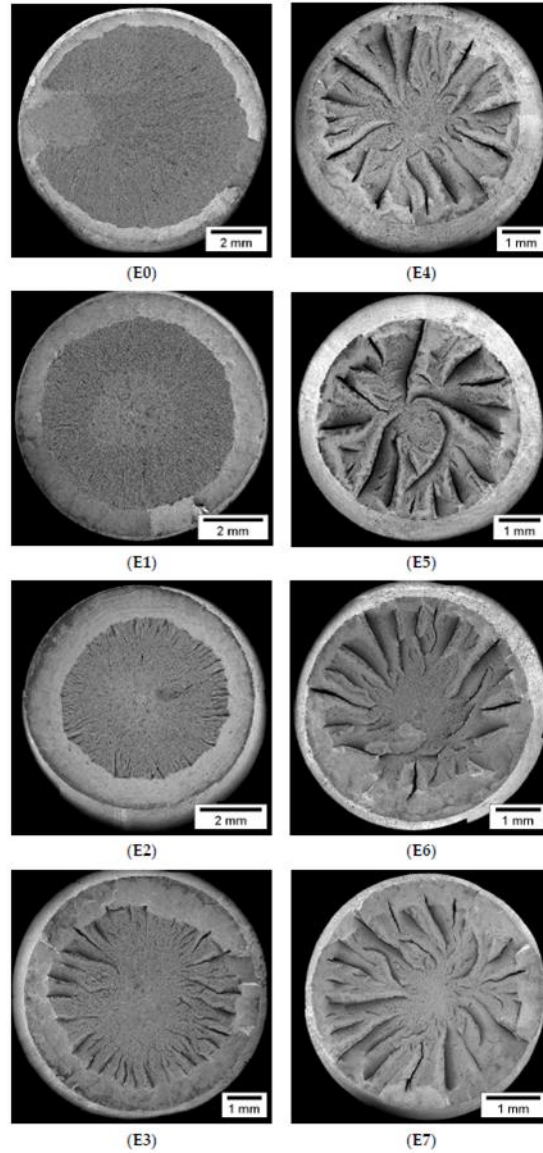
Figure 7.2.3.2-10. Images of Gradually More Progressively Cold-drawn Pearlitic Steel Wire Specimens Failed by Tensile Overload [ref. 10]

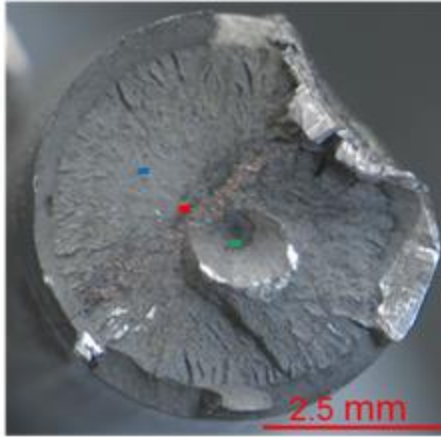
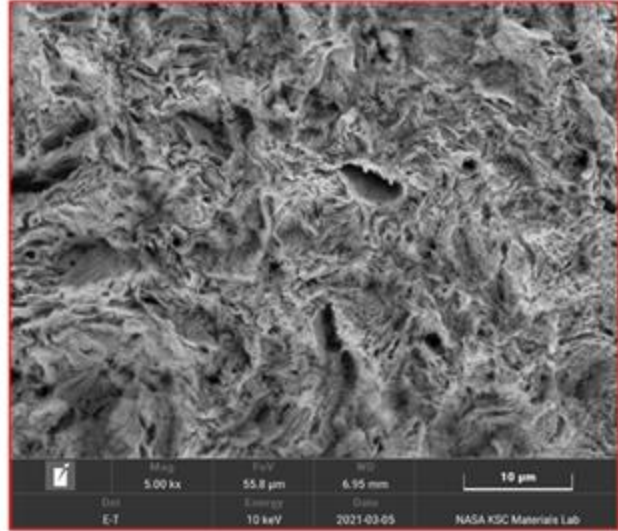
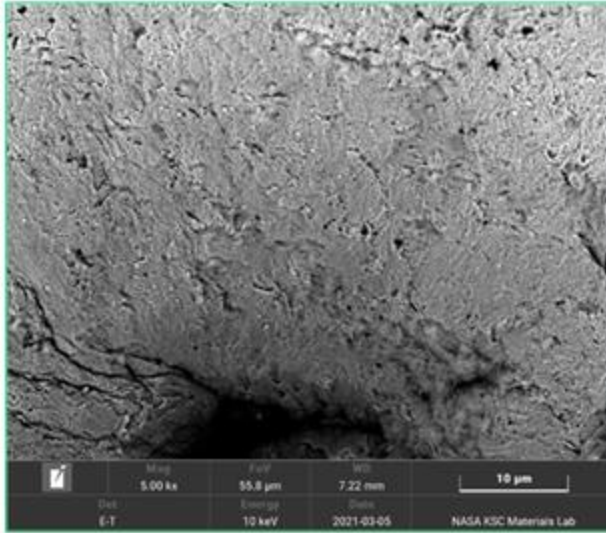
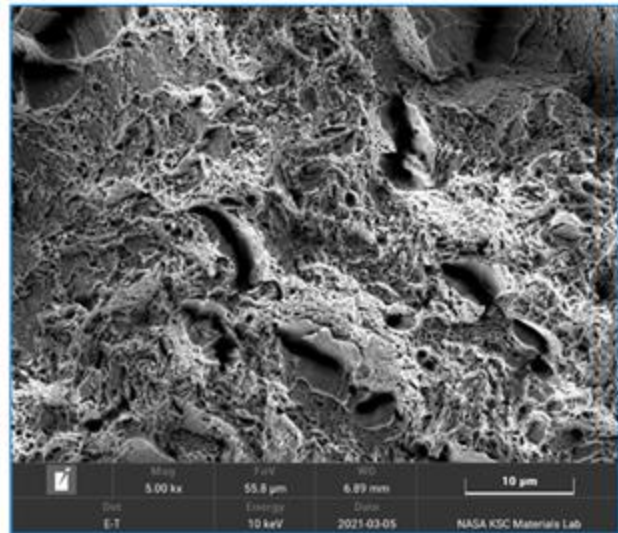
Figure 7.2.3.2-15. Images of Aux M4N Socket Wire S

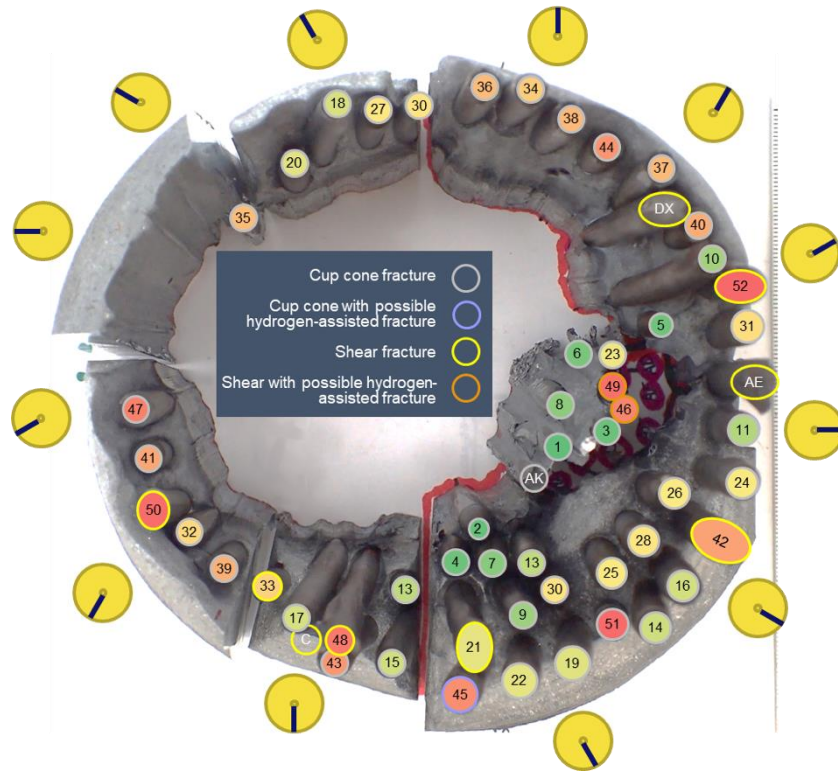
Figure 7.2.3.2-16. Reconstruction of Wire Locations following Zinc Removal with Identified Fracture Morphology (outline color of overlay) and Percent Necking (fill color of overlay)
