NASA/TM-20210017934
NESC-RP-20-01585

Arecibo Observatory Auxiliary M4N Socket Termination Failure Investigation

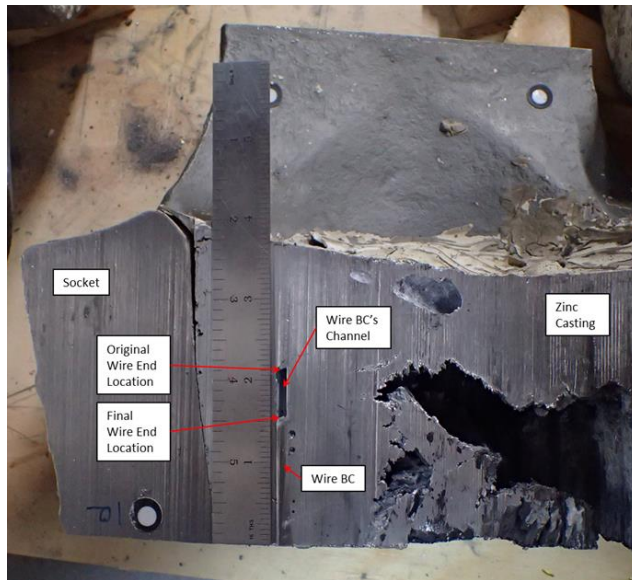
Figure 7.2.3.3-1 (Appendix A Figure 58). Measurement of Wire-end Displacement of Wire BC within Zinc Casting (image was taken from 3 o'clock half)

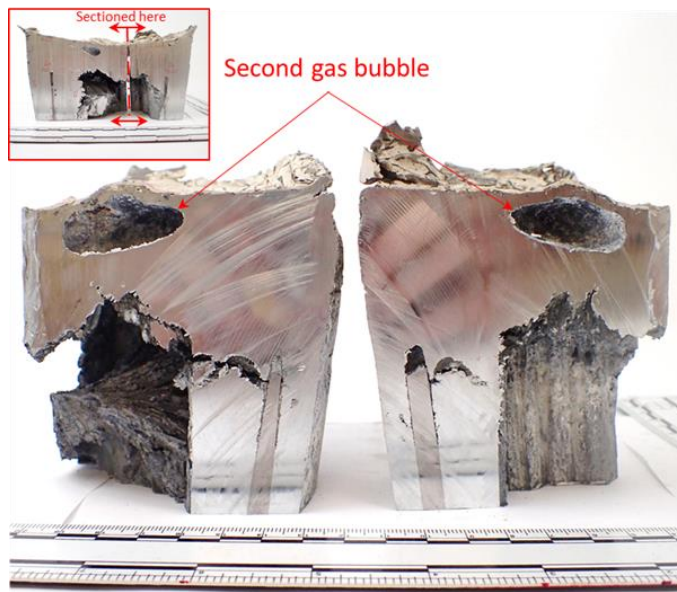
Figure 7.2.3.3-2 (Appendix A Figure 71). Slice 3a was Sectioned Longitudinally, Revealing Second Gas Bubble below Casting Cap

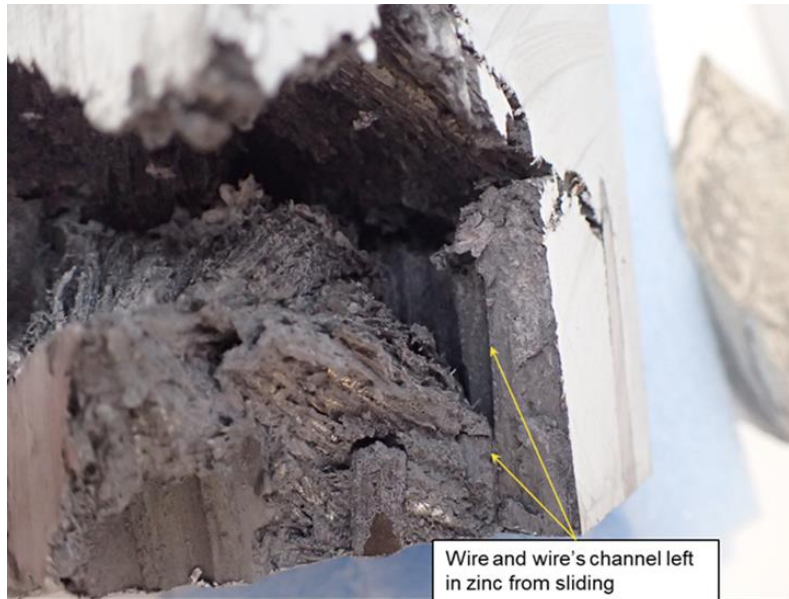
Figure 7.2.3.3-3 (Appendix A Figure 89). Wire Embedment in Zinc Casting

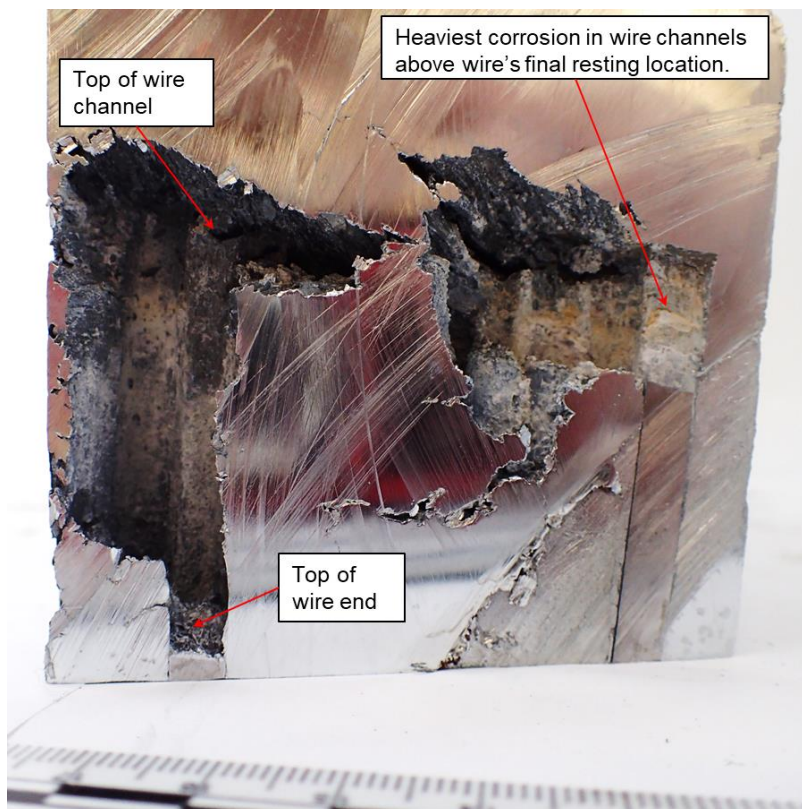
Figure 7.2.3.3-4 (Appendix A Figure 102). Relatively Large Volumes of Corrosion Visible in Wire Channels above Wires

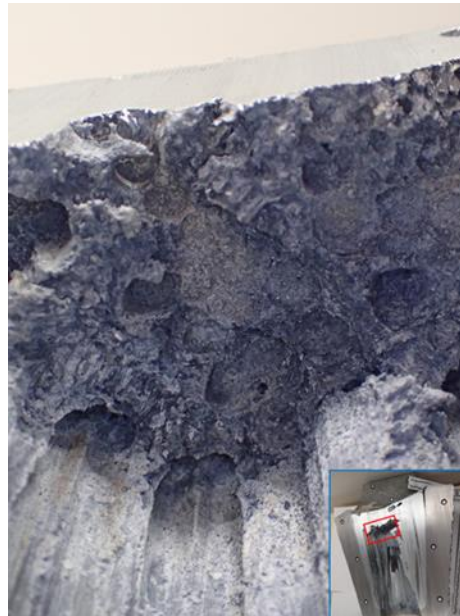
Figure 7.2.3.3-5 (Appendix A Figure 69). Closer View of Back of Socket Cavity on Slice 9a (view 1)

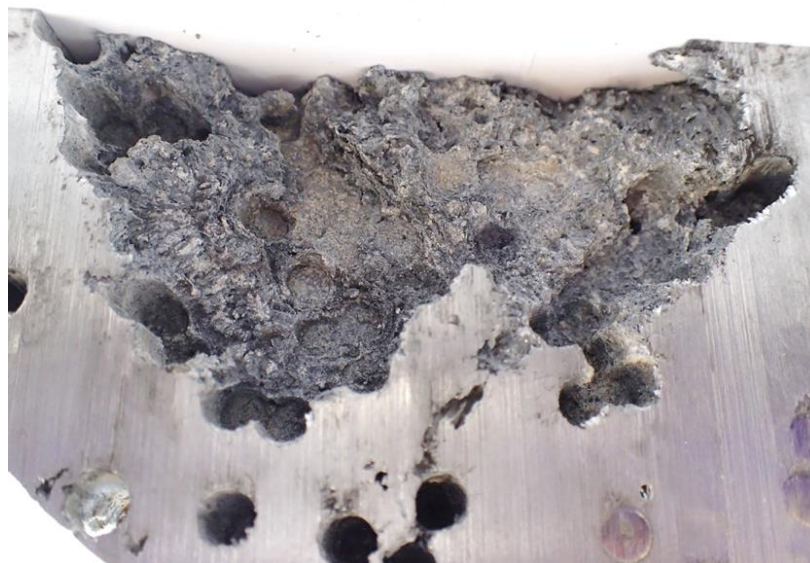
Figure 7.2.3.3-6 (Appendix A Figure 70). Closer View of Back of Socket Cavity on Slice 9a (view 2)

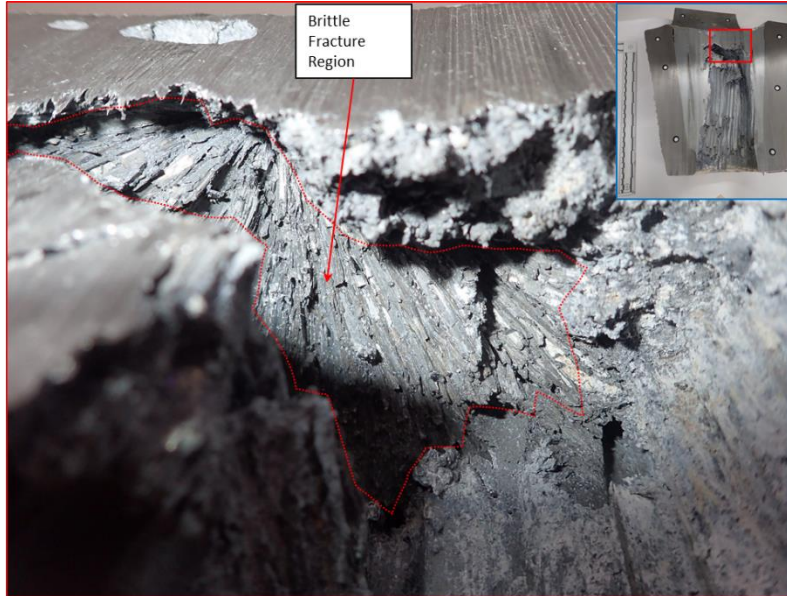
Figure 7.2.3.3-7 (Appendix A Figure 65). View of Casting Cap Side of Brittle Fracture Region in Back of Socket Cavity on Slice 3a (view 1)

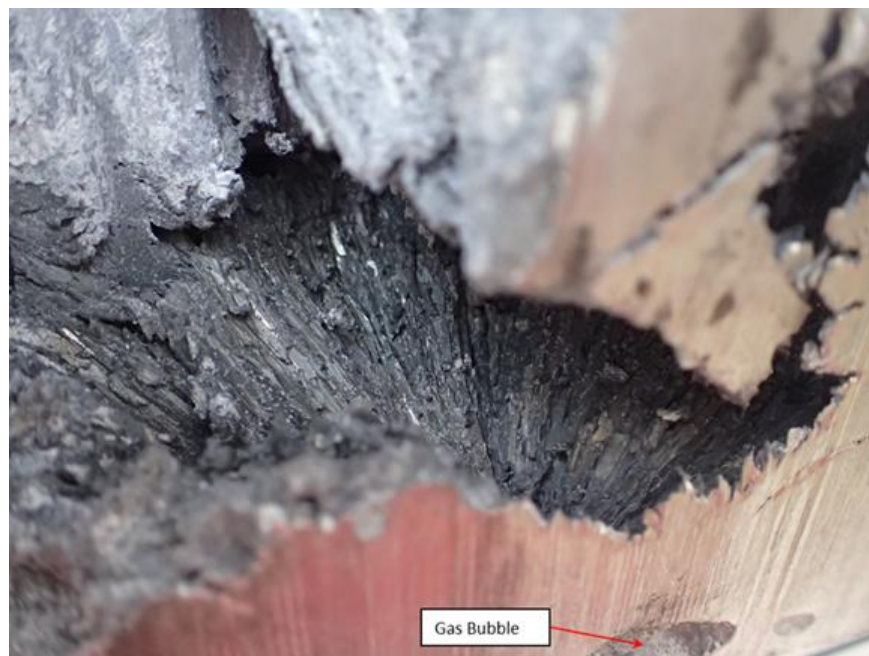
Figure 7.2.3.3-8 (Appendix A Figure 66). View of Casting Cap Side of Brittle Fracture Region in Back of Socket Cavity on Slice 3a (view 2)

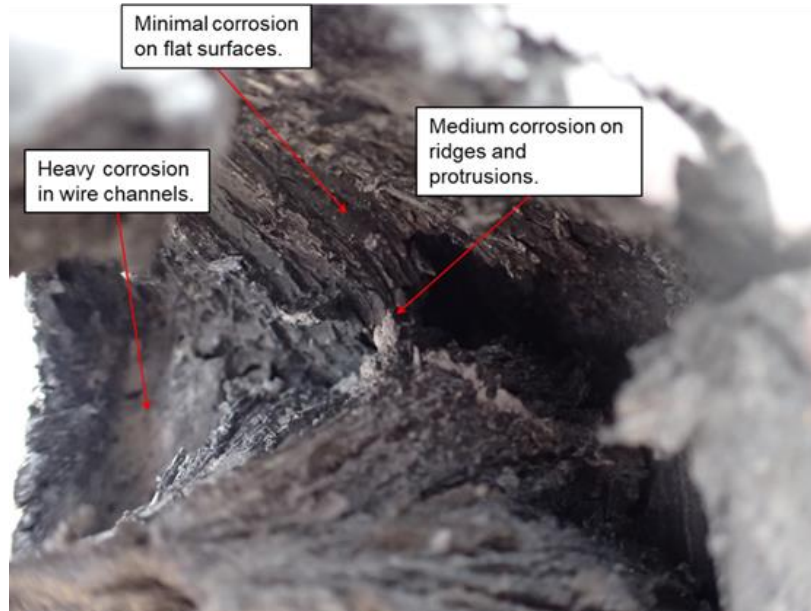
Figure 7.2.3.3-9 (Appendix A Figure 104). Image of Faceted Surface within Socket Cavity

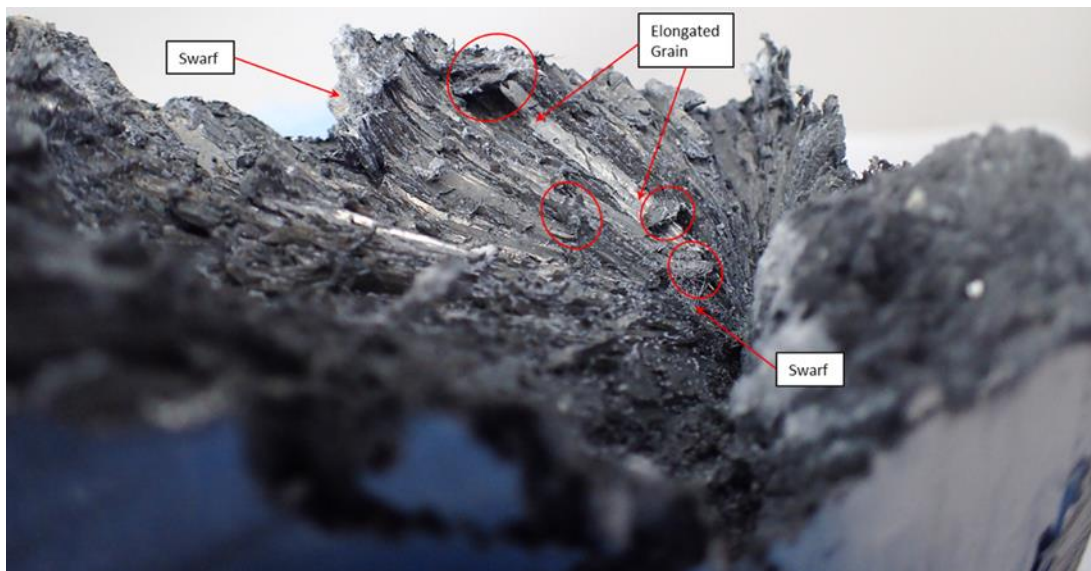
Figure 7.2.3.3-10 (Appendix A Figure 68). View of Casting Cap Side of Brittle Fracture Region in Back of Socket Cavity on Slice 3a

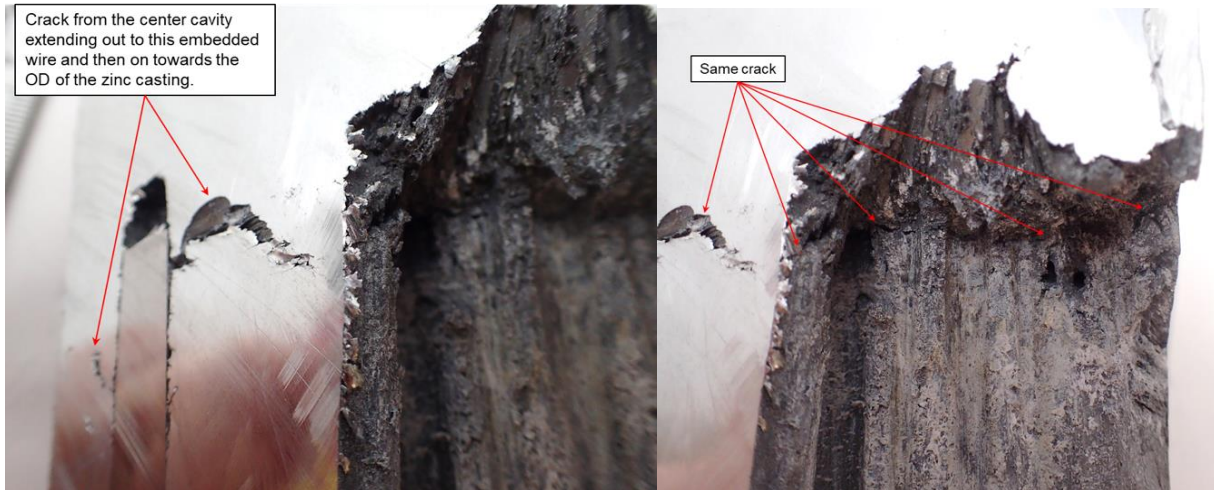
Figure 7.2.3.3-11 (Appendix A Figures 85, 86). Surface of Additional Longitudinal Cut made on Slice 3a

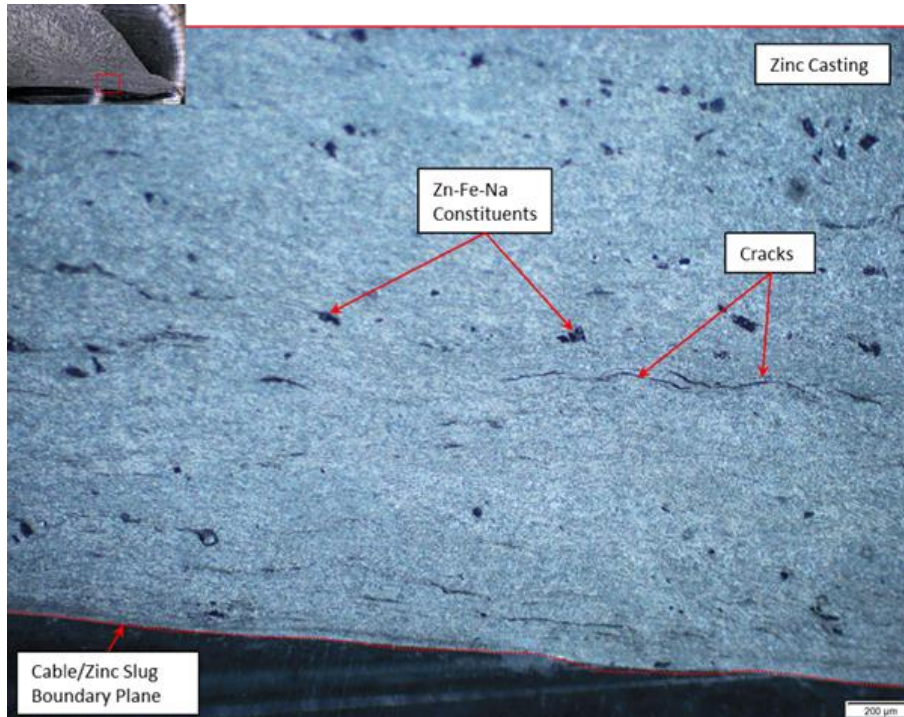
Figure 7.2.4-1 (Appendix A Figure 79). Zinc Grain Structure Adjacent to Cable/Zinc Slug

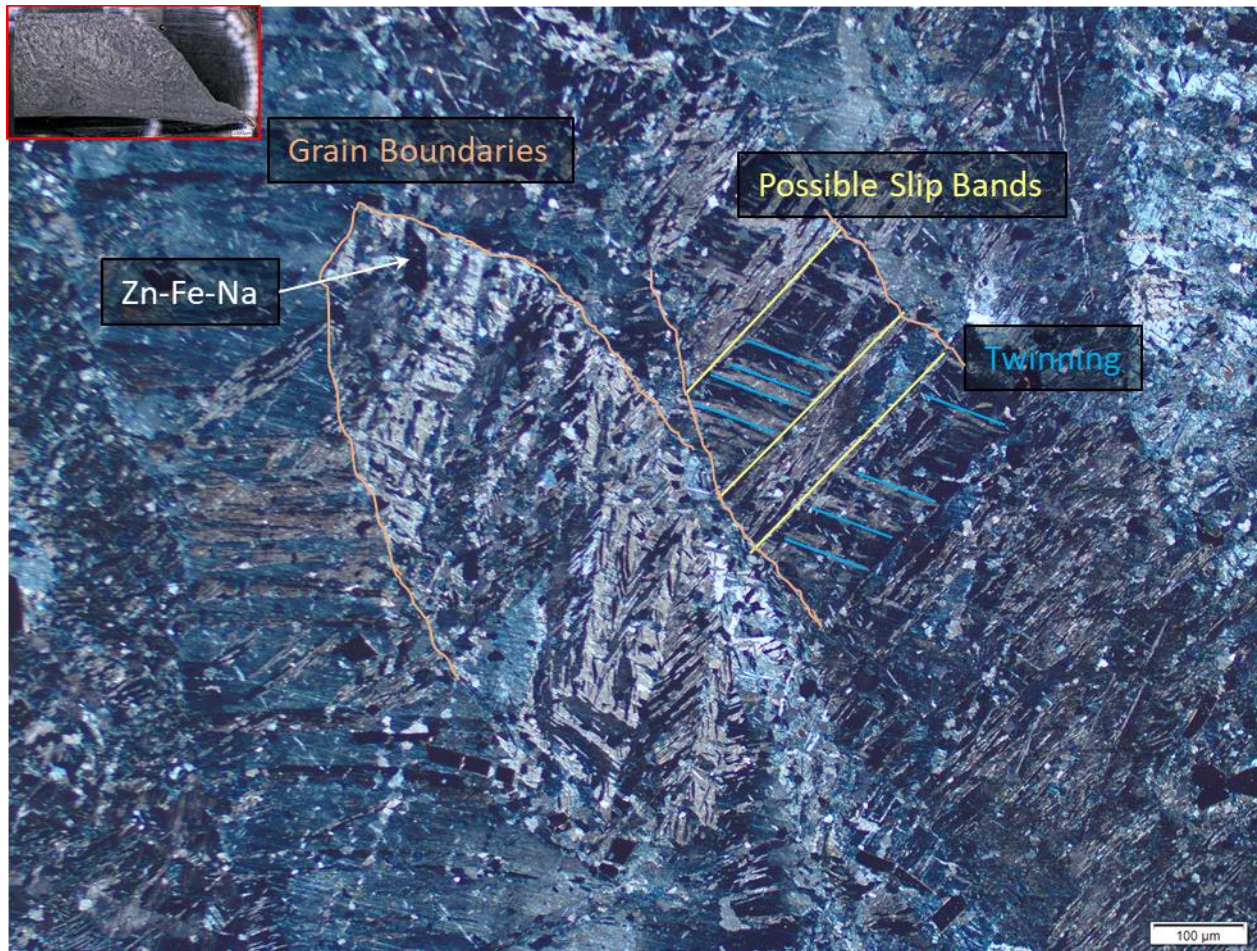
Figure 7.2.4-5 (Appendix A Figure 80). Metallograph Image of Tint Etch of Large Grains Near Socket Base and Zinc Casting Outer Diameter

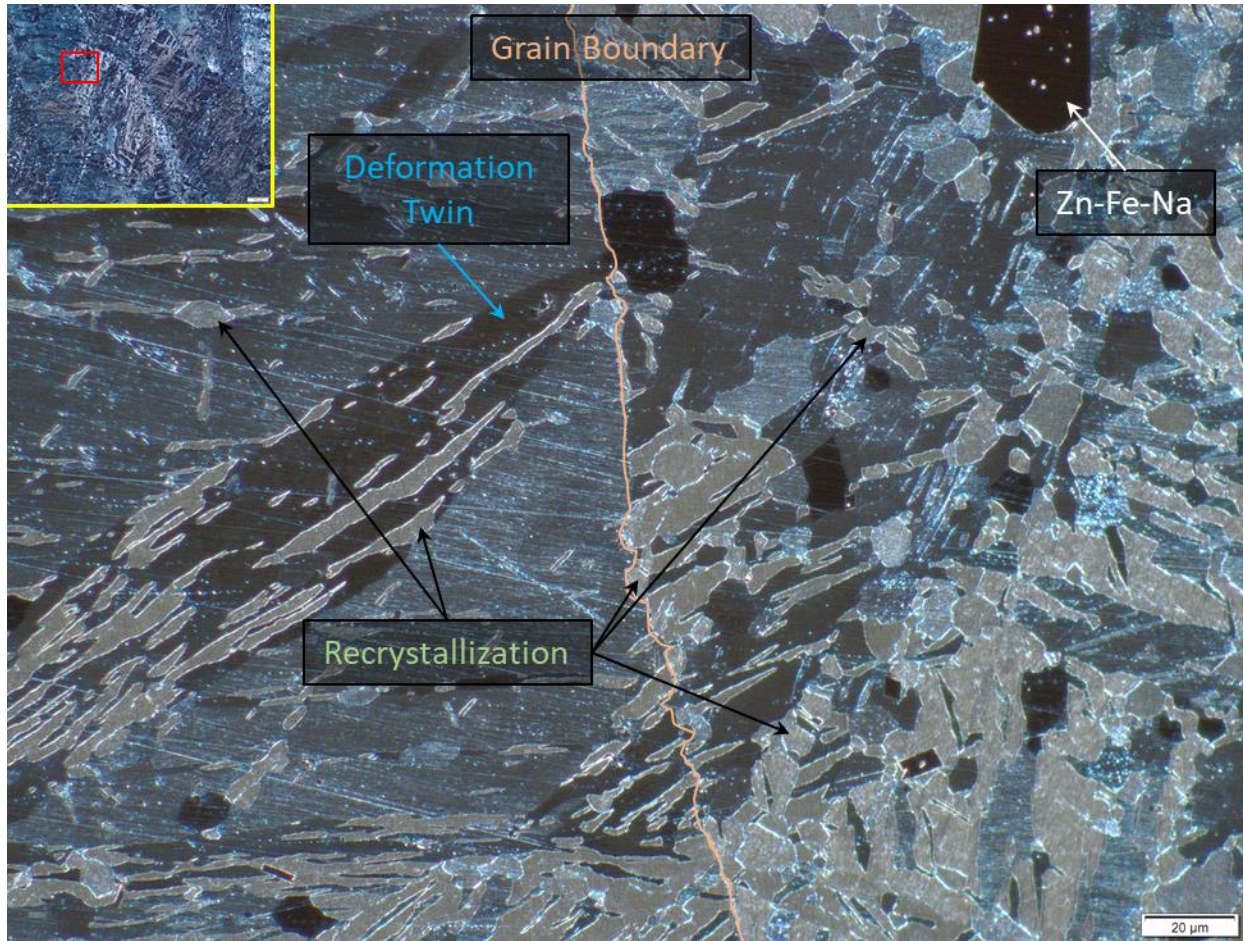
Figure 7.2.4-6 (Appendix A Figure 81). Metallograph Image of Tint Etch of Large Grains Present Near Socket Base and Zinc Casting Outer Diameter

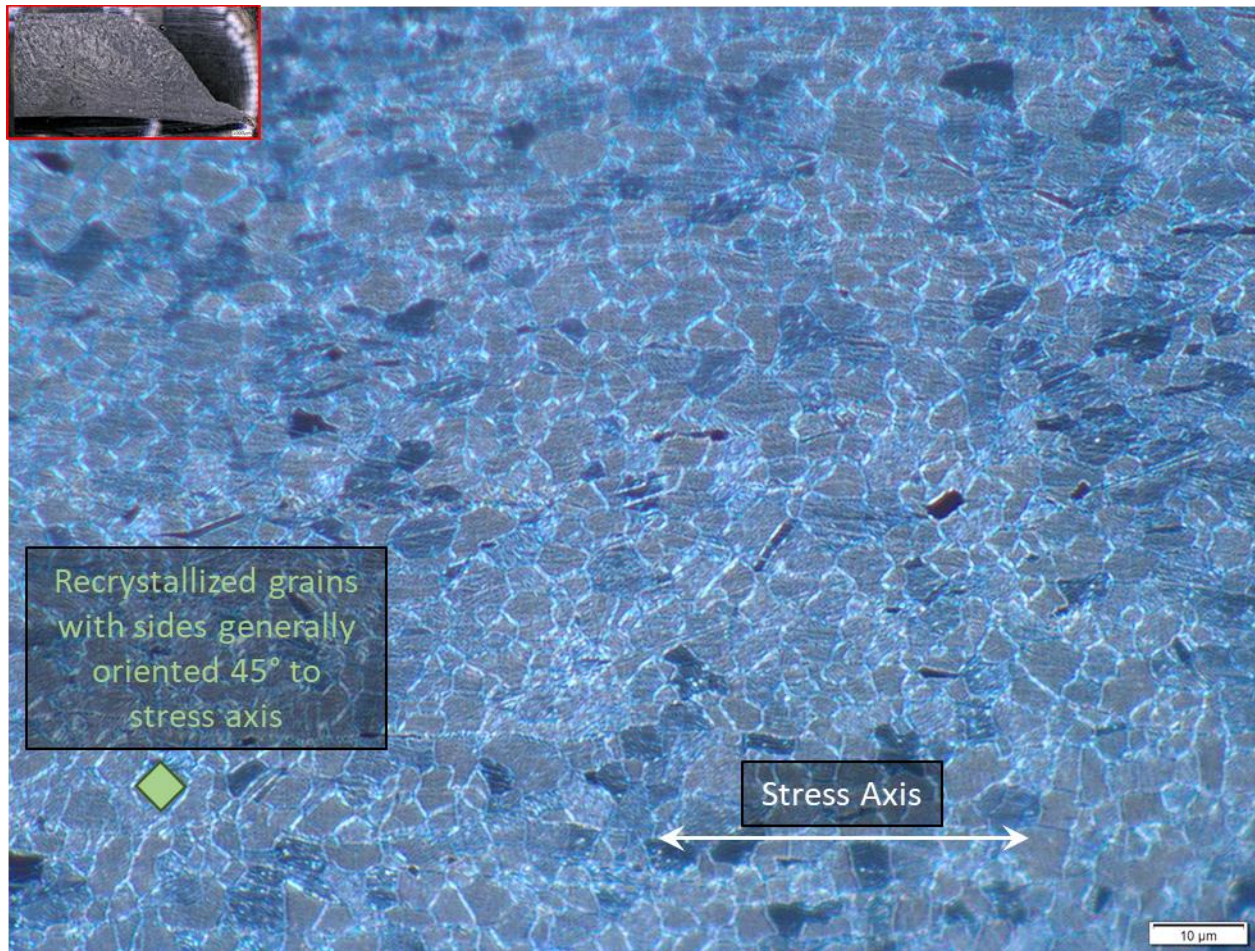
Figure 7.2.4-7 (Appendix A Figure 82). Metallograph Image of Tint Etch of Small Grains Present Near Socket Base and Cable/Zinc Slug Boundary

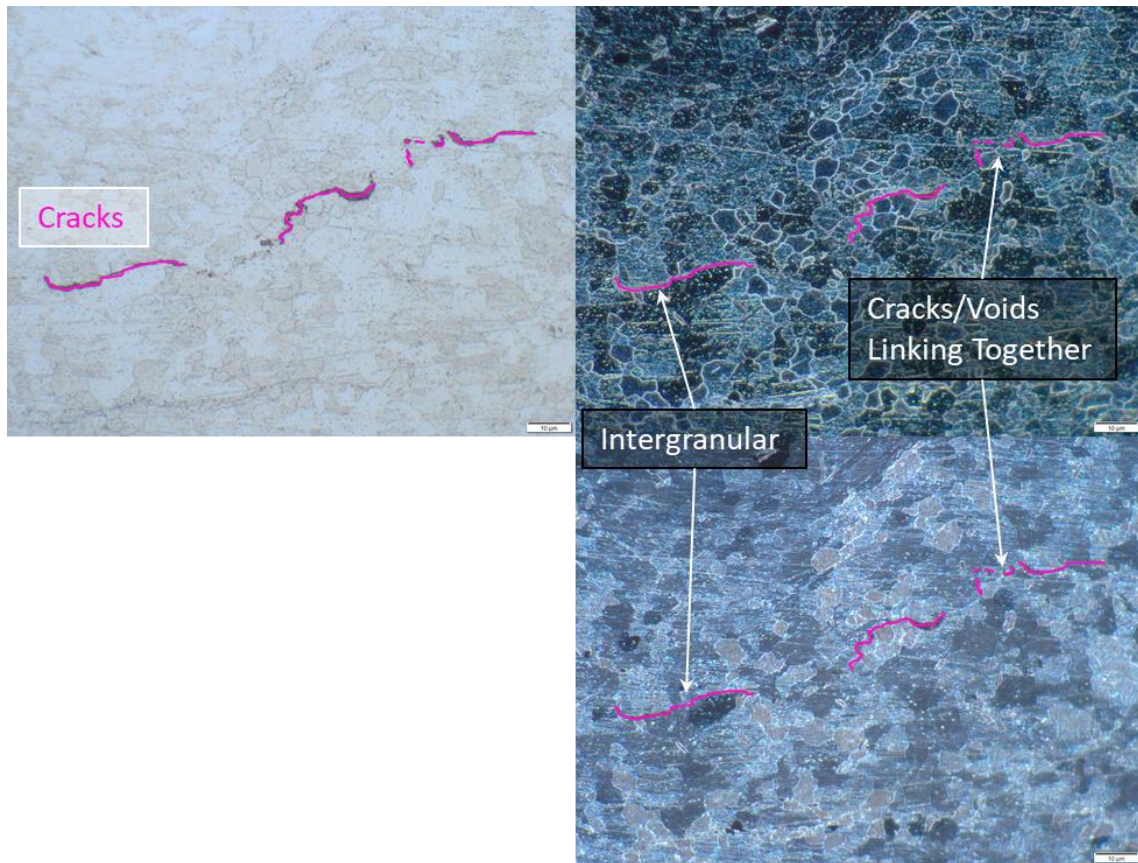
Figure 7.2.4-8 (Appendix A Figure 83). Cracks Present in Appendix A Figure 295 Adjacent to Cable/Zinc Slug Boundary

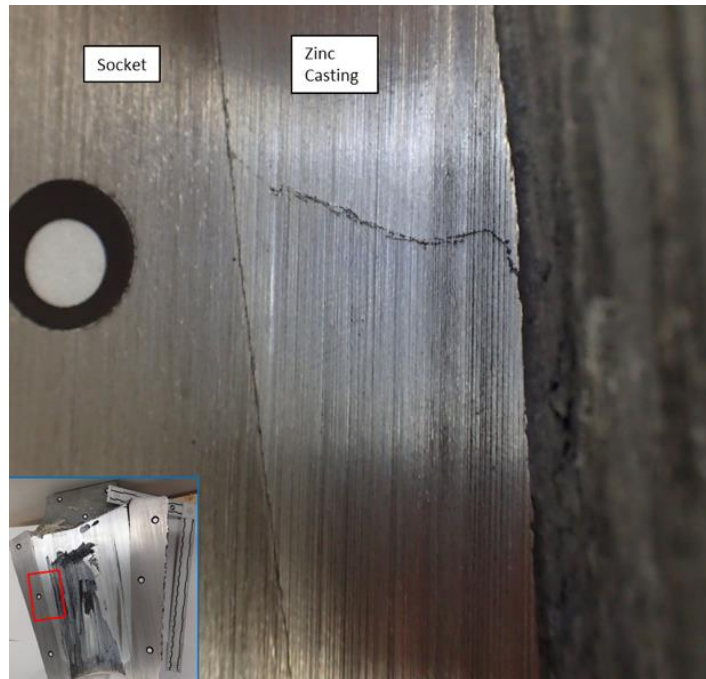
Figure 7.2.4.1-1 (Appendix A Figure 55). Close-up View of Crack Present in Zinc Casting at 12 o'clock (9 o'clock half)

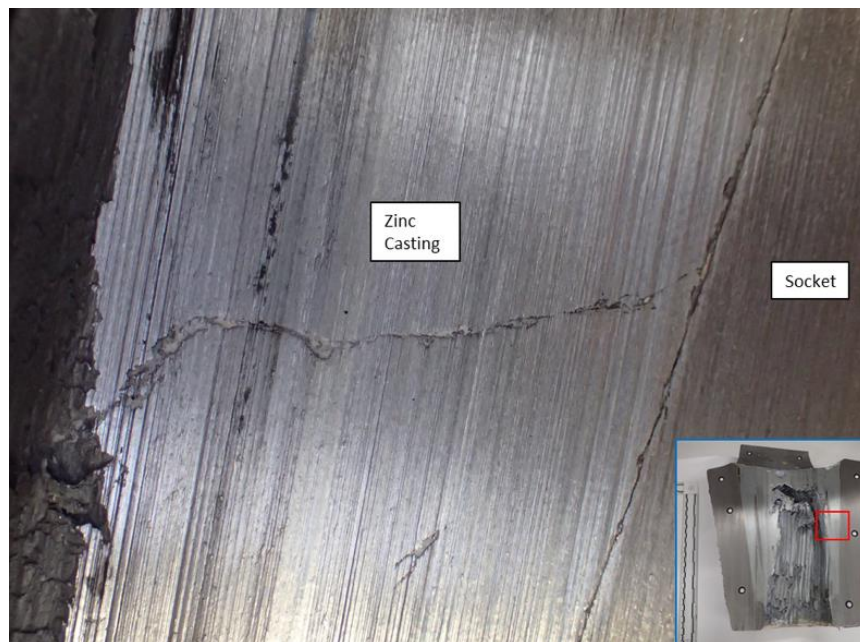
Figure 7.2.4.1-2 (Appendix A Figure 56). Close-up View of Crack Present in Zinc Casting at 12 o'clock (3 o'clock half)

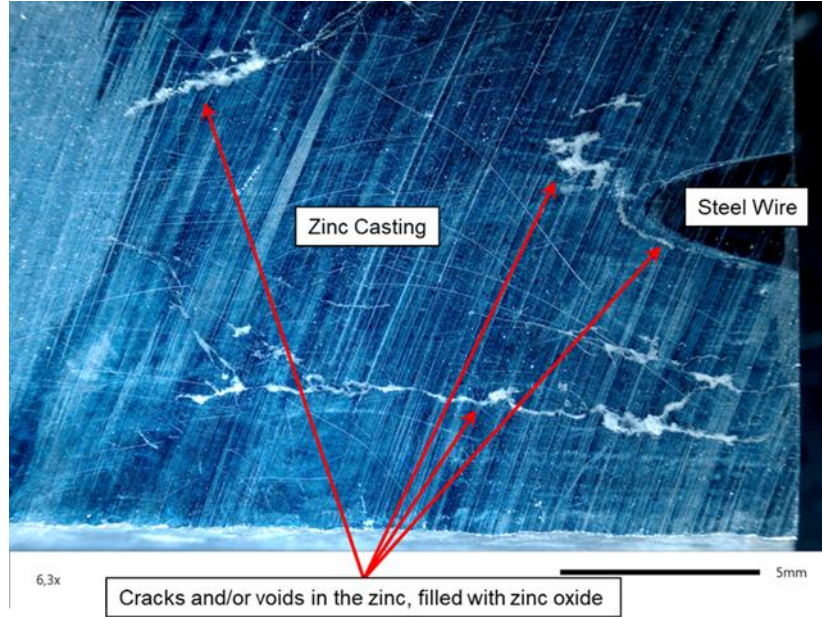
Figure 7.2.4.1-3 (Appendix A Figure 84). Cracks and Voids Found during Metallography of Slice 3c

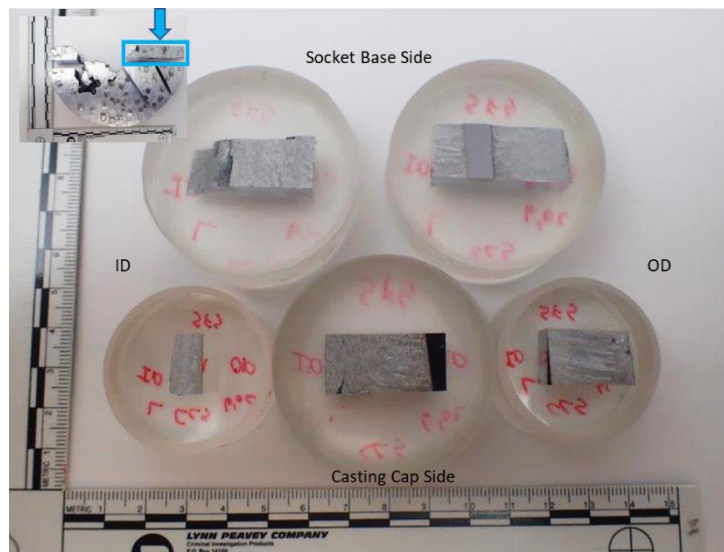
Figure 7.2.4.1-4 (Appendix A Figure 287). Metallographic Specimens of 6 o'clock Side of Longitudinal Cut Face of Slice 3c

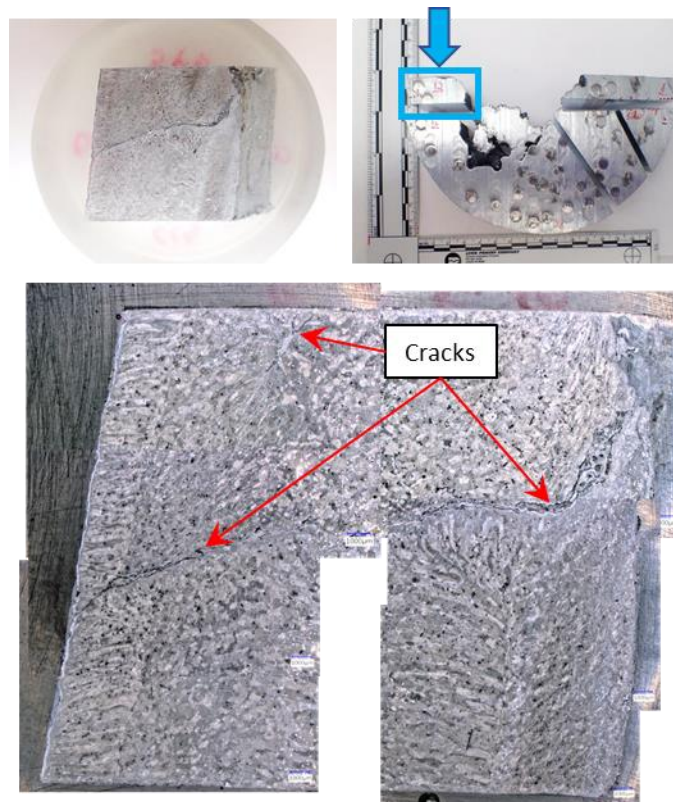
Figure 7.2.4.1-6 (Appendix A Figure 289). Metallographic Specimen of 12 o'clock Side of Longitudinal Cut Face of Slice 3c

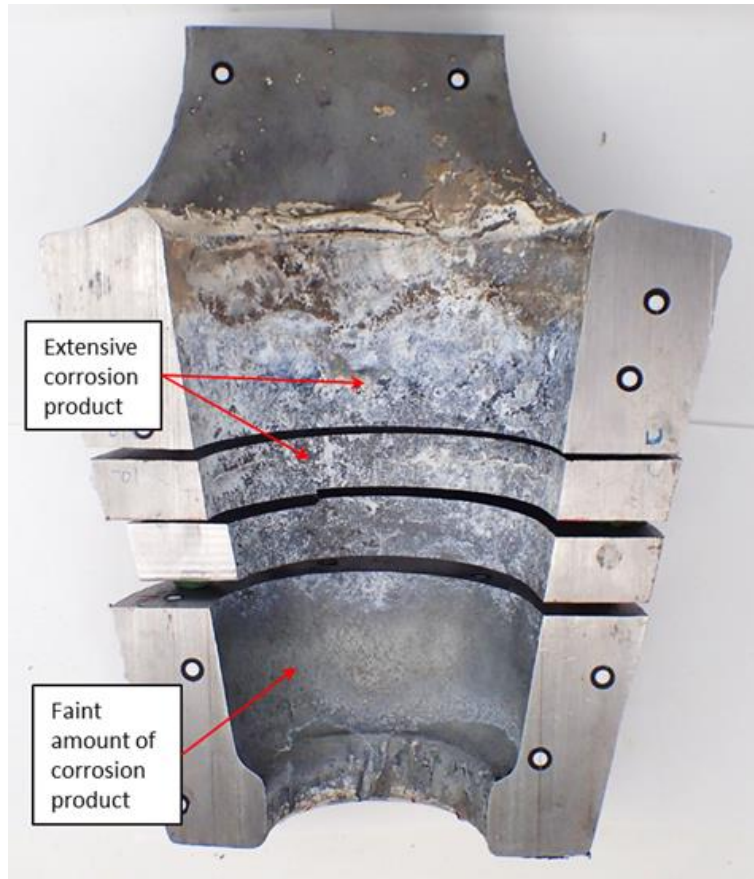
Figure 7.2.5-1 (Appendix A Figure 96). 3 o'clock Side of Inner Diameter Socket Wall, showing Surface behind Outer Diameter of Zinc Casting

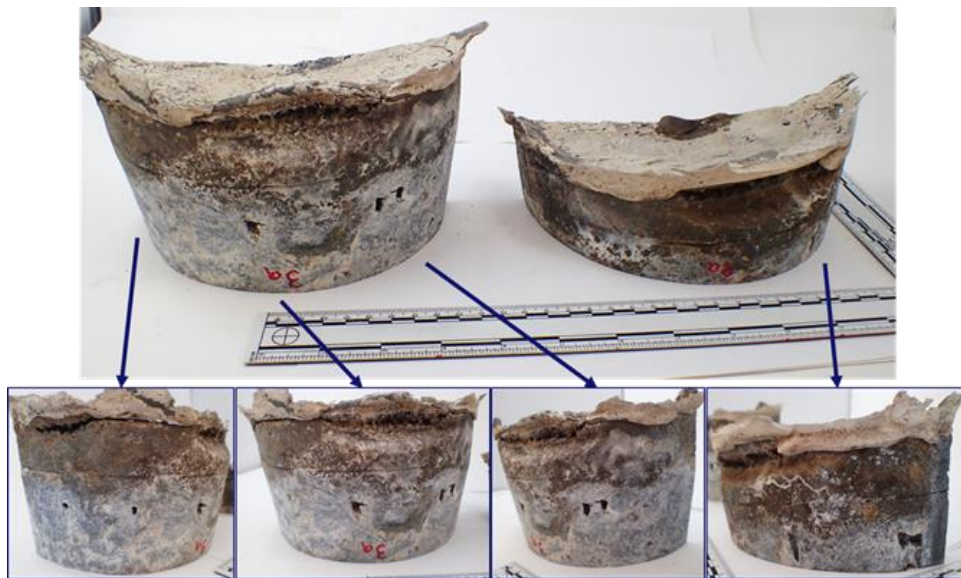
Figure 7.2.5-4 (Appendix A Figure 99). Wire Holes in Zinc Casting

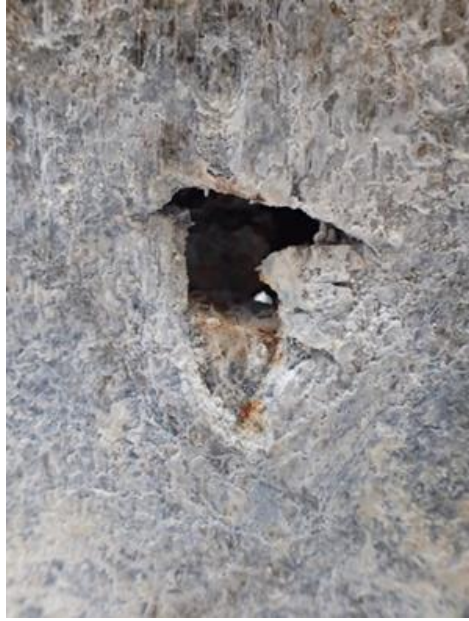
Figure 7.2.5-5 (Appendix A Figure 100). Corrosion around Wire Hole

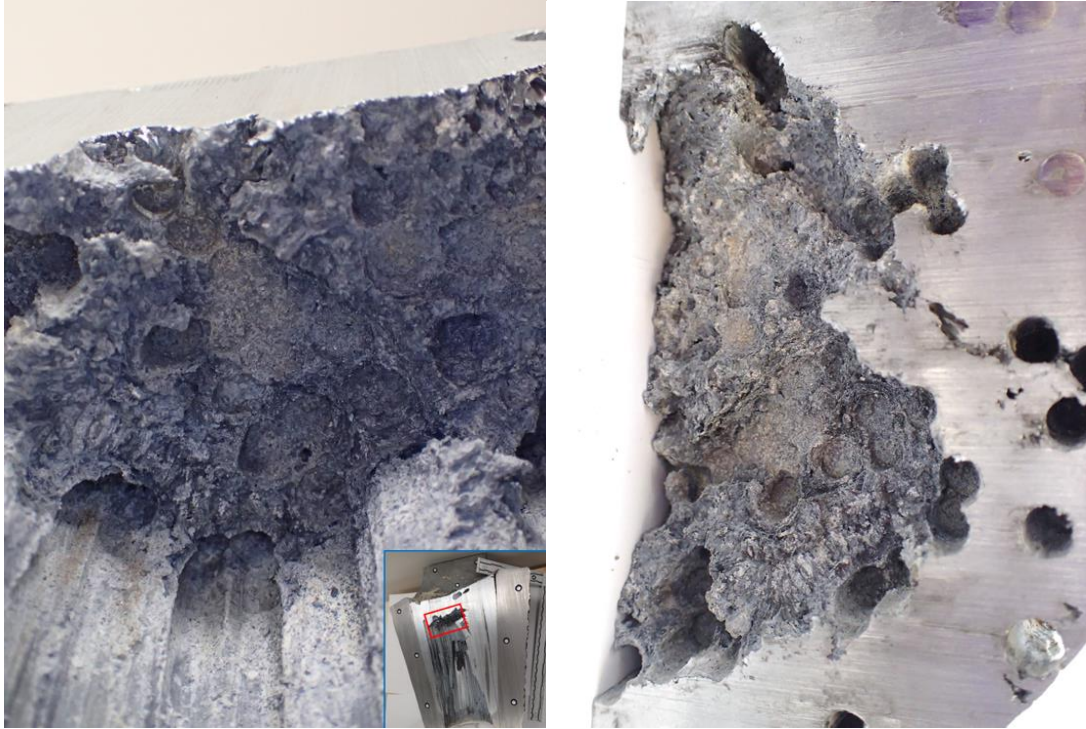
Figure 7.2.5-6 (Appendix A Figures 69 and 70). Closer View of Back of Socket Cavity on Slice 9a

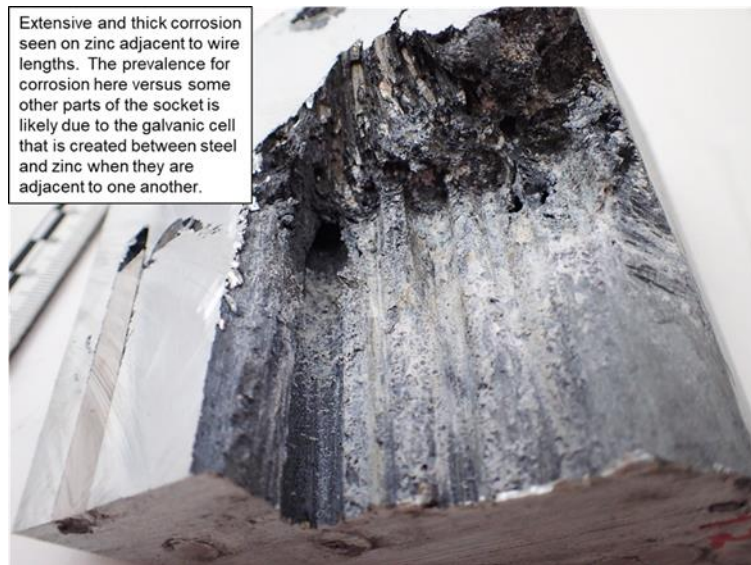
Figure 7.2.5-7 (Appendix A Figure 101). Extensive and Relatively Thick Corrosion on Zinc Casting Wire Channels

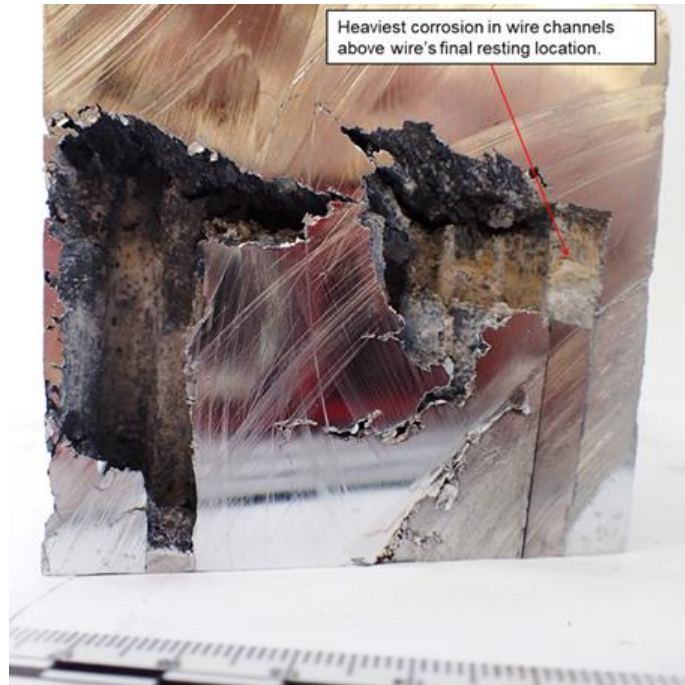
Figure 7.2.5-8 (Appendix A Figure 102). Relatively Large Volumes of Corrosion Visible in Wire Channels above Wires (wire channel for Wire AN is pointed to here)

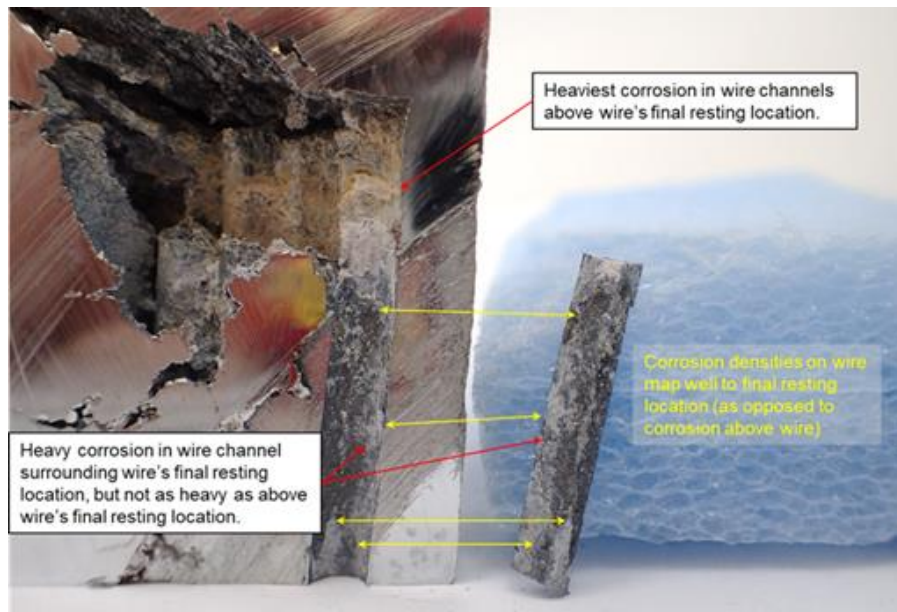
Figure 7.2.5-9 (Appendix A Figure 103). Embedded Wire (wire AN) removed from Wire Channel

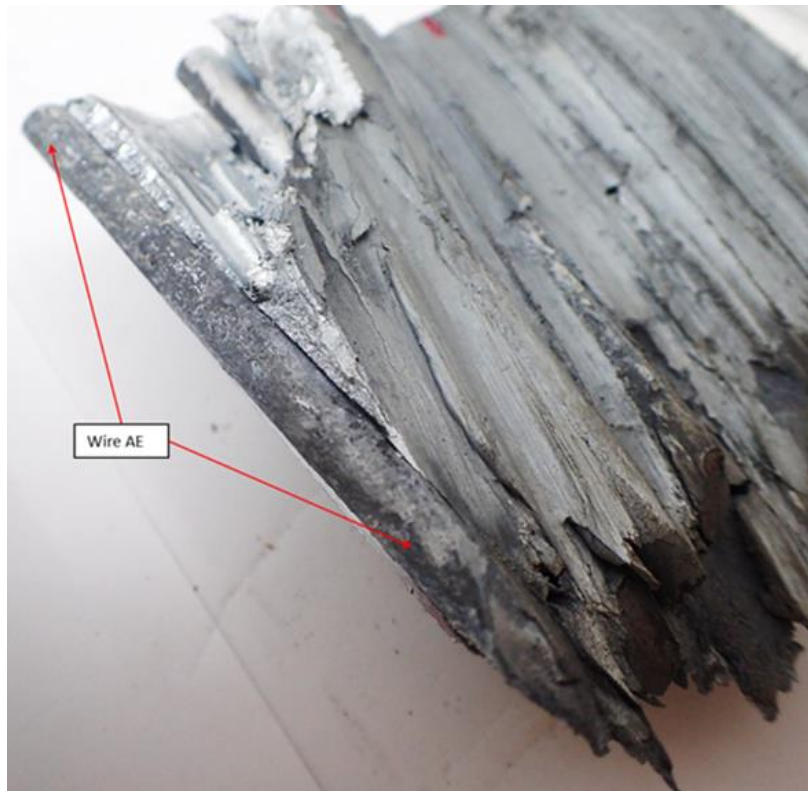
Figure 7.2.5-10 (Appendix A Figure 105). Wire AE, Mechanically Removed, showed Similar Quantity of Corrosion along Length of Wire embedded in Slice 3g, as seen on Wire AN in Figure 7.2.5-9

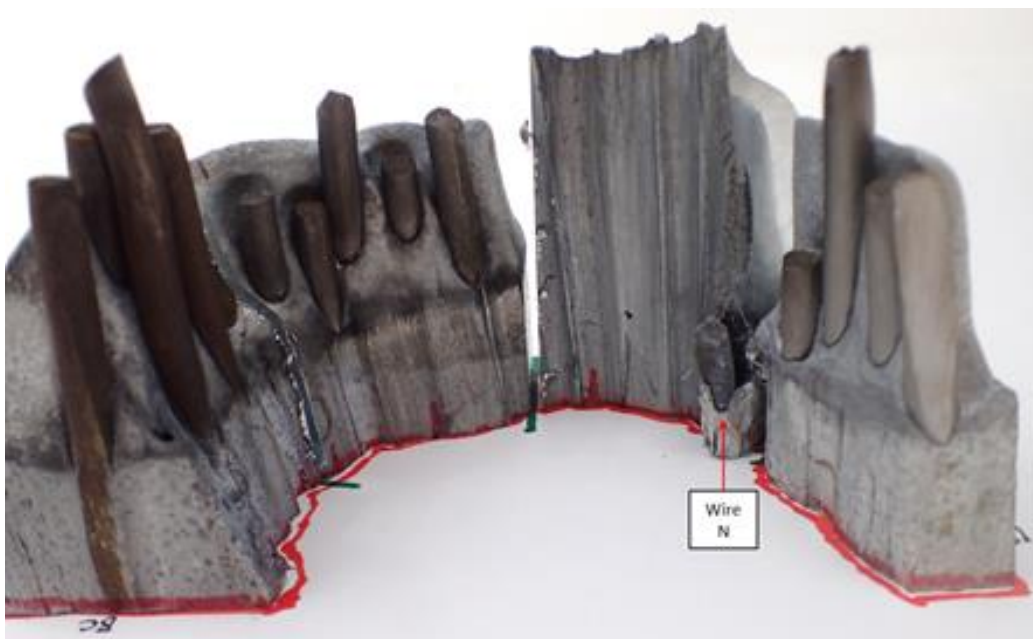
Figure 7.2.5-11 (Appendix A Figure 172). Hydrochloric Acid Wire Fracture Reveal on Slice 9g
 Note that the 9-10 o'clock piece was not acid etched, and the one wire within that piece, wire N, was mechanically removed.

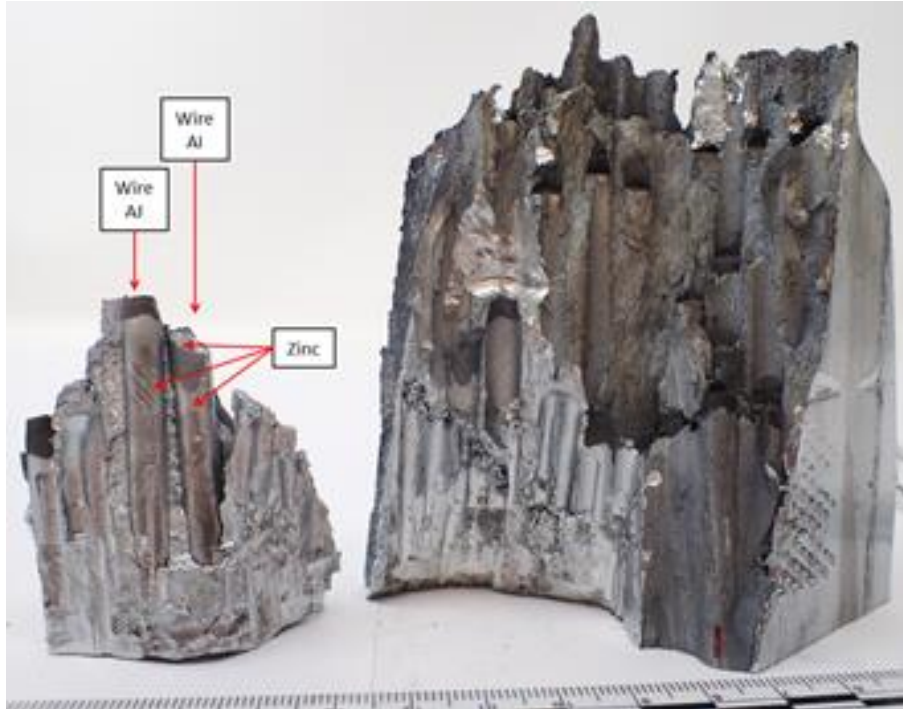
Figure 7.2.5-12 (Appendix A Figure 106). Wires AI and AJ had Visibly Good Adhesion of Zinc along Wire Surfaces that were Embedded in Slice 3g

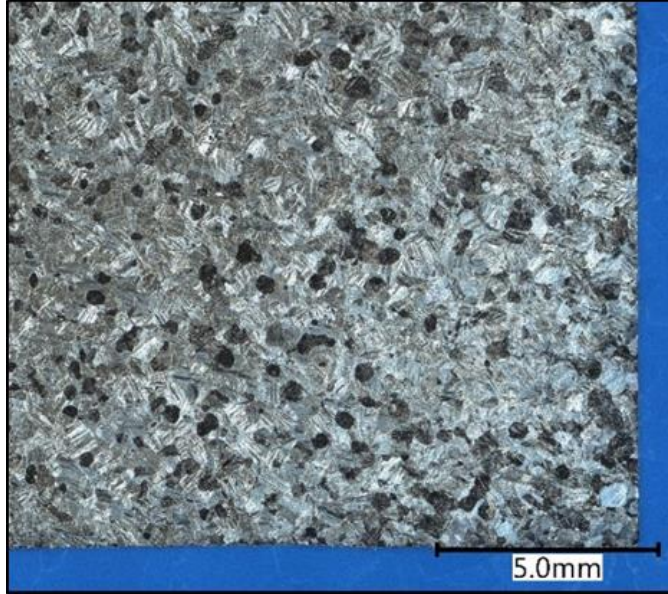
Figure 7.2.7.2-1. Metallography of Socket Slug Material

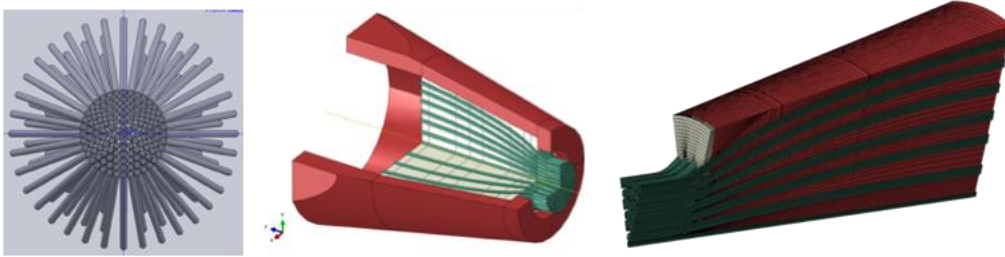
Figure 7.3.1-1. Socket is Modeled as a Simplified Version that does not consider Clevis Pin and Holes

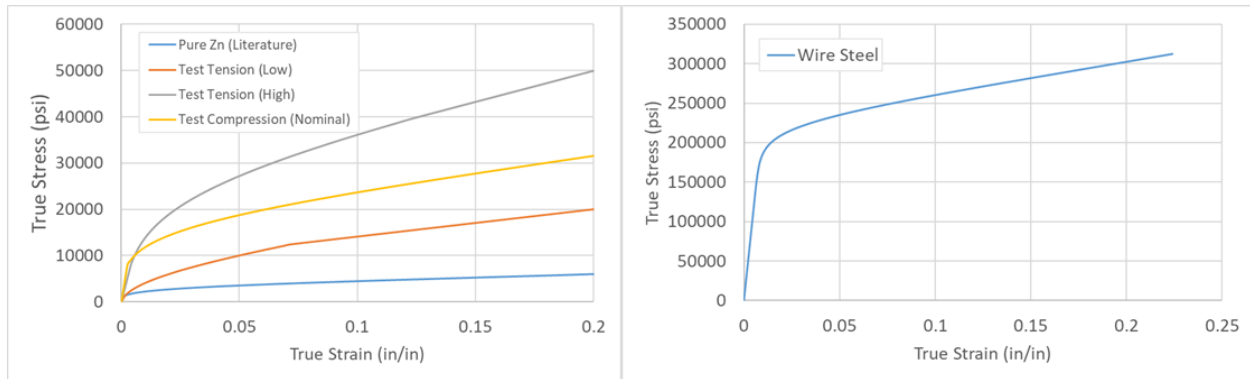
Figure 7.3.2-1. True Stress-Strain Curves for the Range of Zinc Material Properties (left) and Baseline Steel Material Property (right)

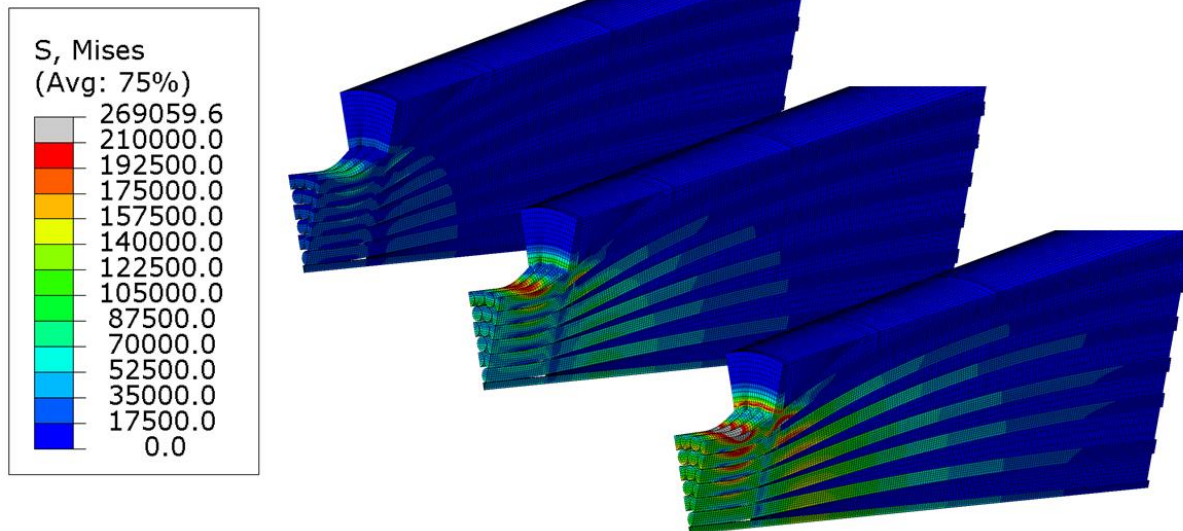
Figure 7.3.4-1. As Loading in Cables Increases (left to right), the Zinc Distributes Load amongst Wires within the Socket in a Mechanism Analogous to Metal Matrix Reinforced Composites
Note: The magnitude of the contour stress plots is not particularly relevant for this demonstration.

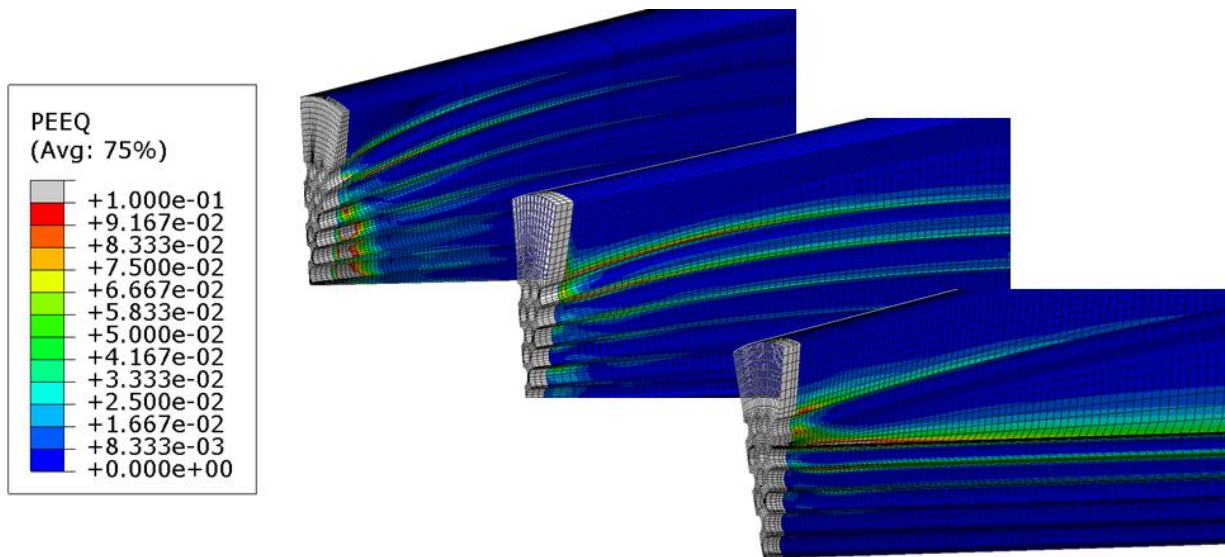
Figure 7.3.4-2. Comparison of Representative Zinc Plastic Strain Fields for Three Different Wire Brooming Configurations highlighting Bands of Significant Shear for Less-broomed Cable Ends

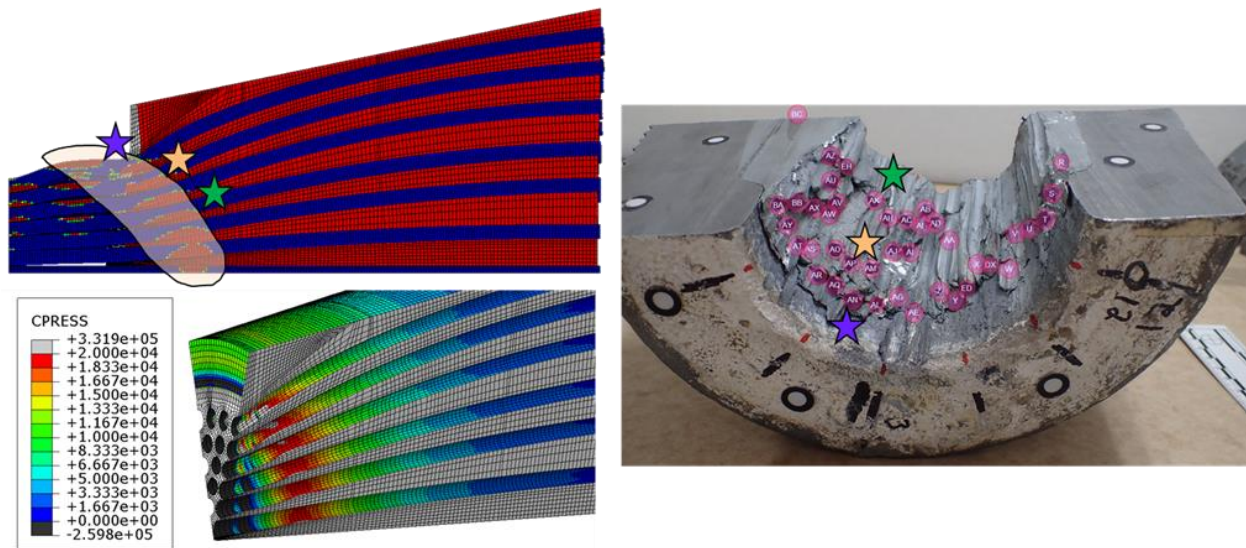
Figure 7.3.5-1. Highest Stresses were not Predicted to be Planar; Failure Surface followed a Spheroid Shape, matching Stepped Patterns seen in Forensic Investigation
Regions of colored stars show the different "steps" of failure in the socket. Note that the yellow shading in the top left figure and the red high stress zones in the lower left figure match the shape of the failure surfaces in the right figure.
