NASA/TM-20210017934
NESC-RP-20-01585

Arecibo Observatory Auxiliary M4N Socket Termination Failure Investigation

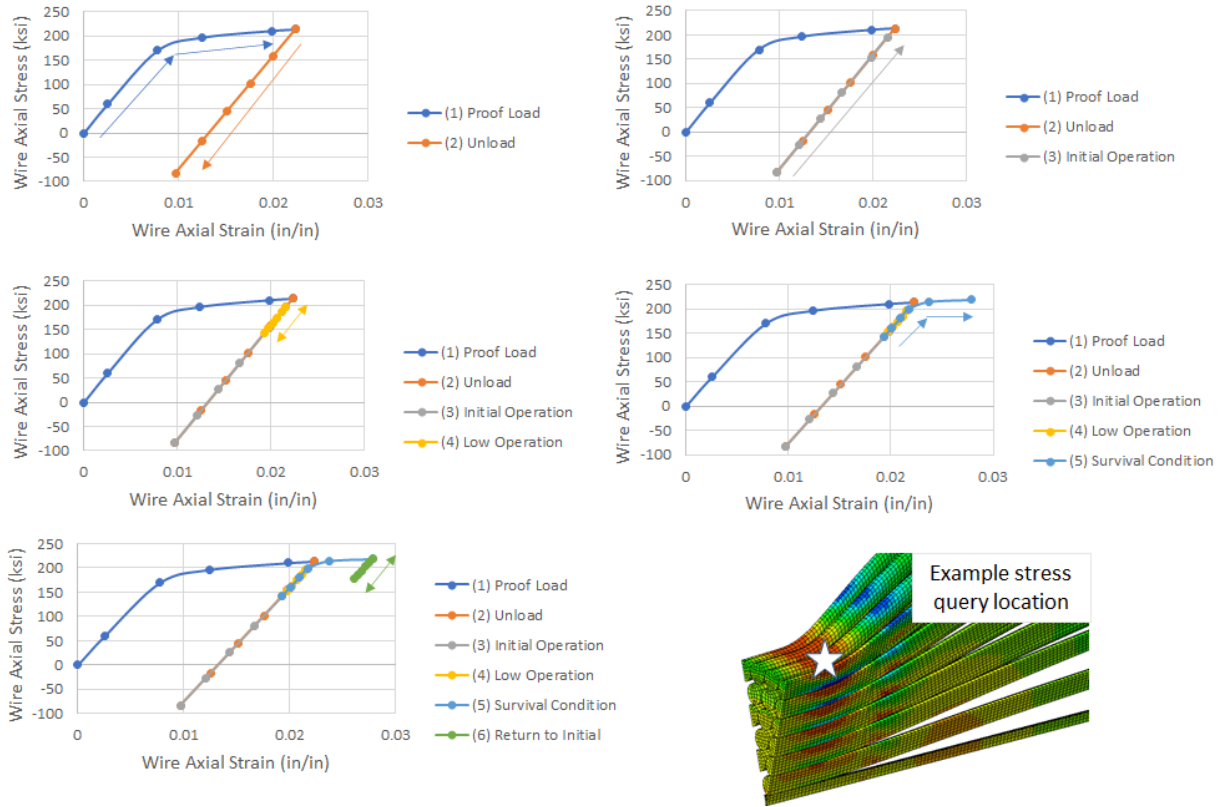
Figure 7.3.7-1. Stress History and Hysteresis from Repeated Loading above Proof Load Level
Stresses Shown from Starred Location in Bottom Right Graphic.

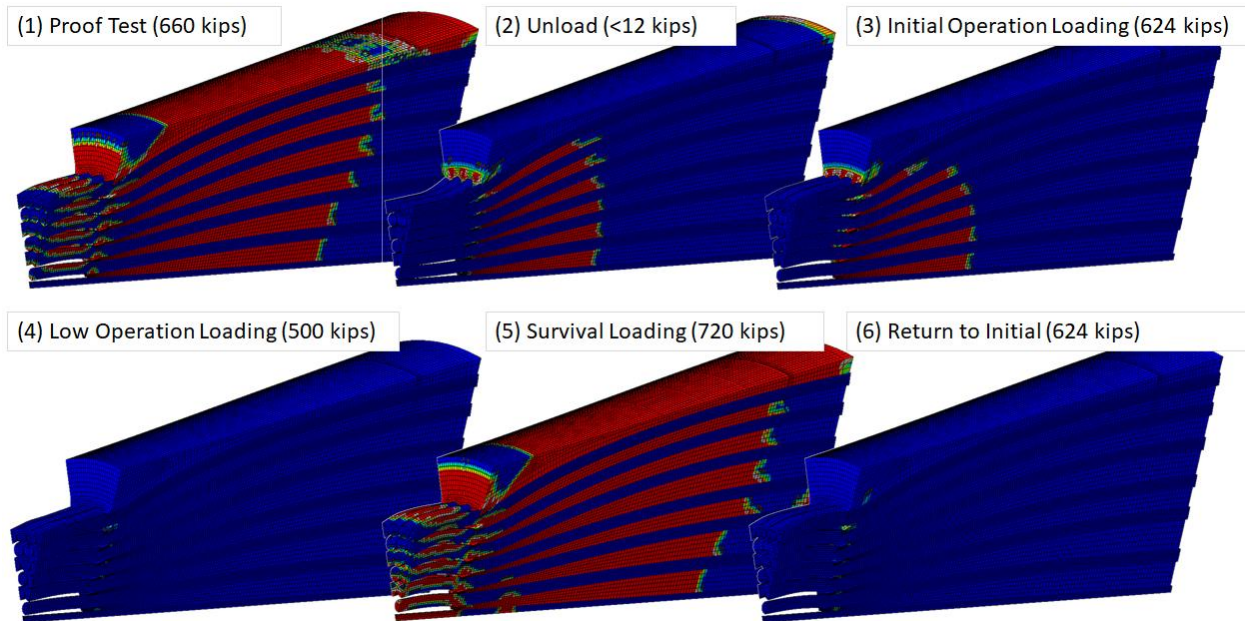
Figure 7.3.7-2. Yield State Shown in Red for Zinc and Wires for each Analysis Step

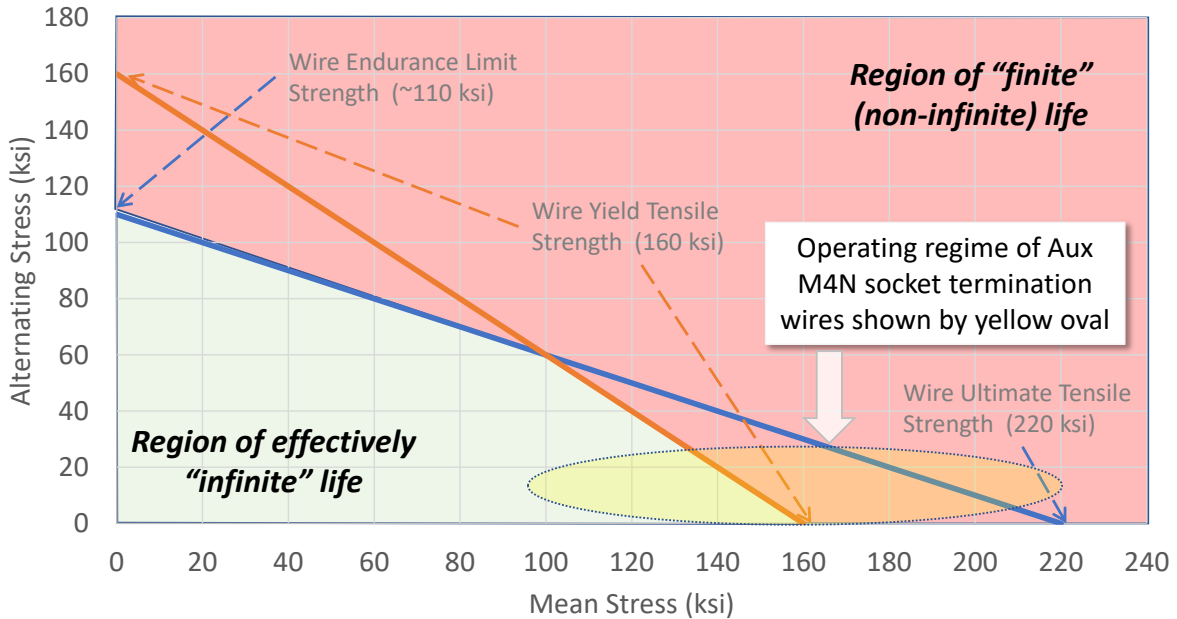
Figure 7.3.7-3. Modified Goodman Diagram showing Separation of Finite and Infinite Life Regions with Annotations for Aux M4N Operational Space

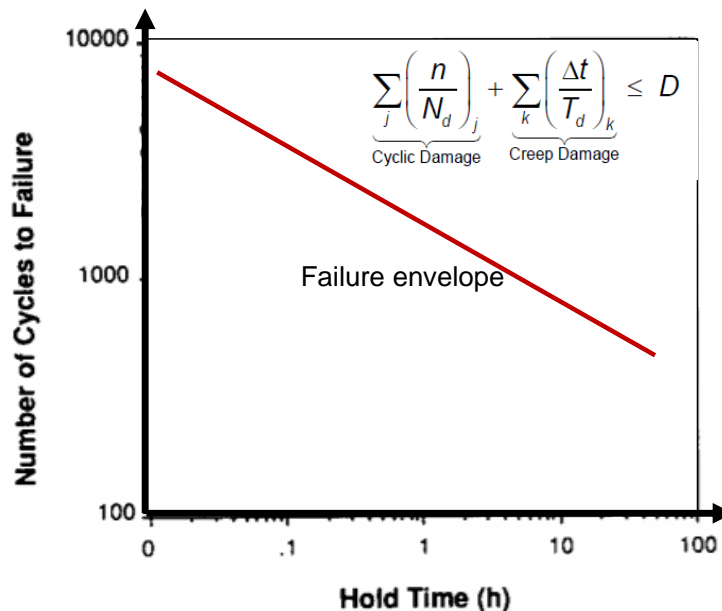
Figure 7.3.7-4. Cumulative Damage Can Occur due to Combination of Cyclic Loading and Sustained Loading

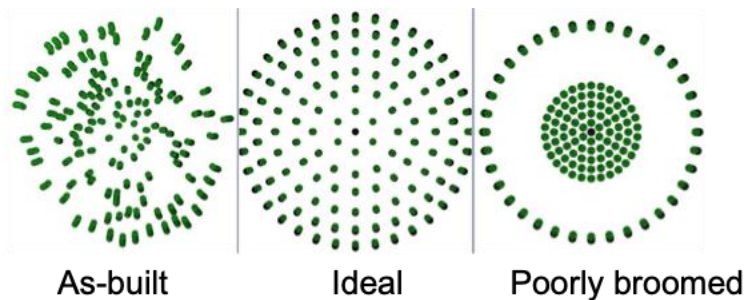
Figure 7.3.9-1. As-built Wire Distribution compared with Ideal Brooming Configuration and Poorly Broomed Configuration

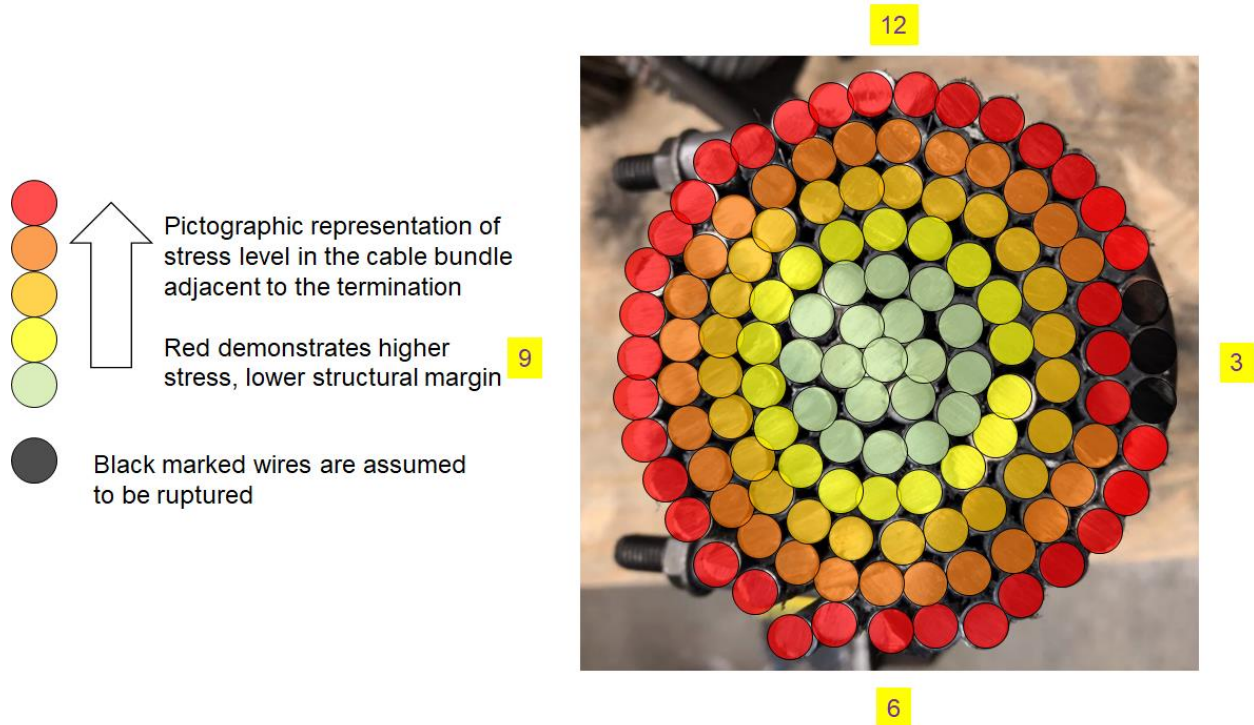
Figure 7.3.10-1. Pictographic Representation of Wire Stress over Cross Section and Initially Failed Wires at 3 o'clock Side

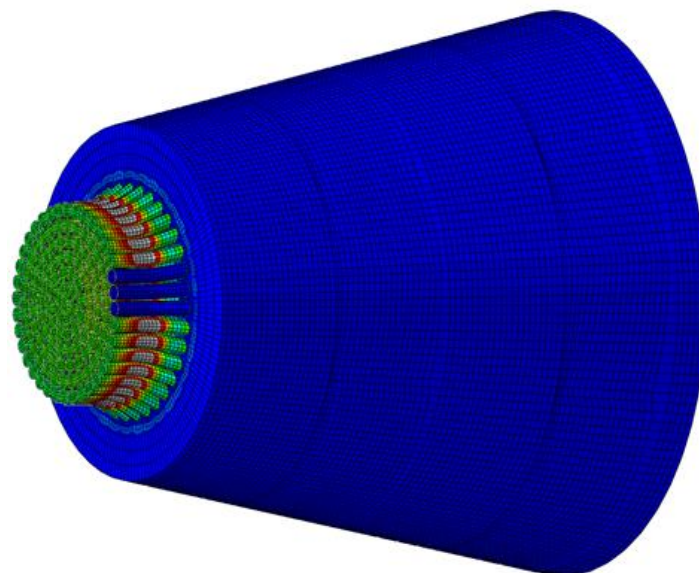
Figure 7.3.10-2. Finite Element Model Visualization of Three Initially Failed Wires

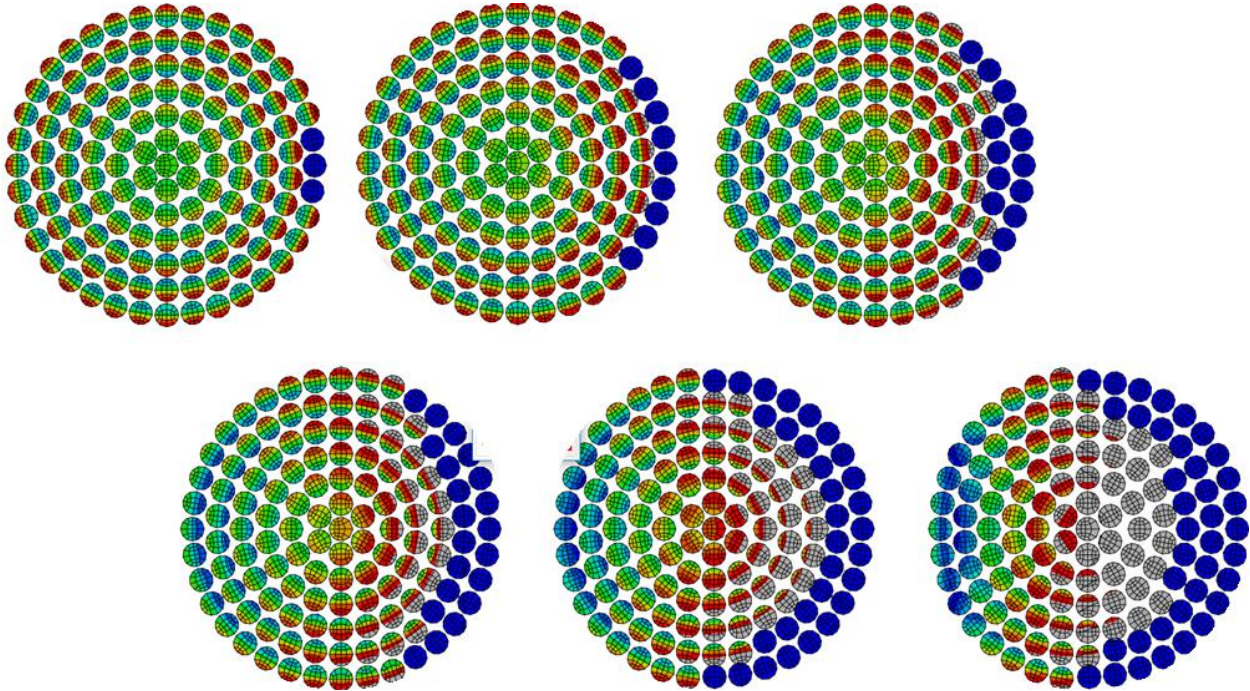
Figure 7.3.10-3. Model Cross-sectional Stresses for Differing Numbers of Failed Wires showing Stress Redistribution Radially and Circumferentially

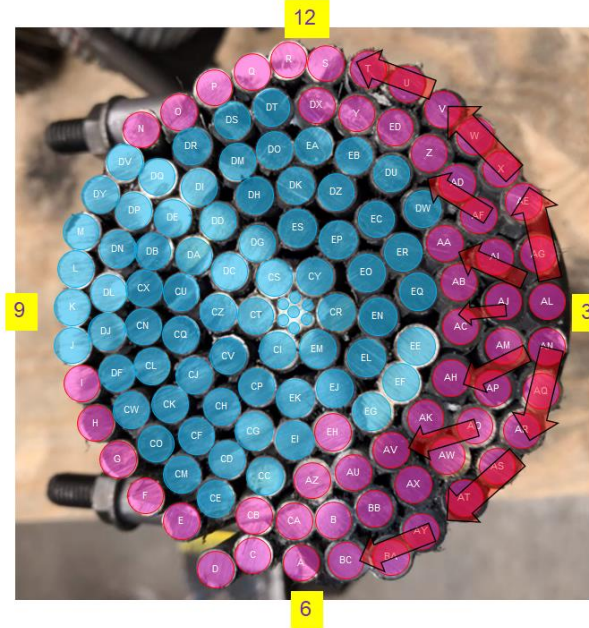
Figure 7.3.10-4. Pictographic Representation of Failure Progression Overlaid on Forensics Failure Mode Coloring

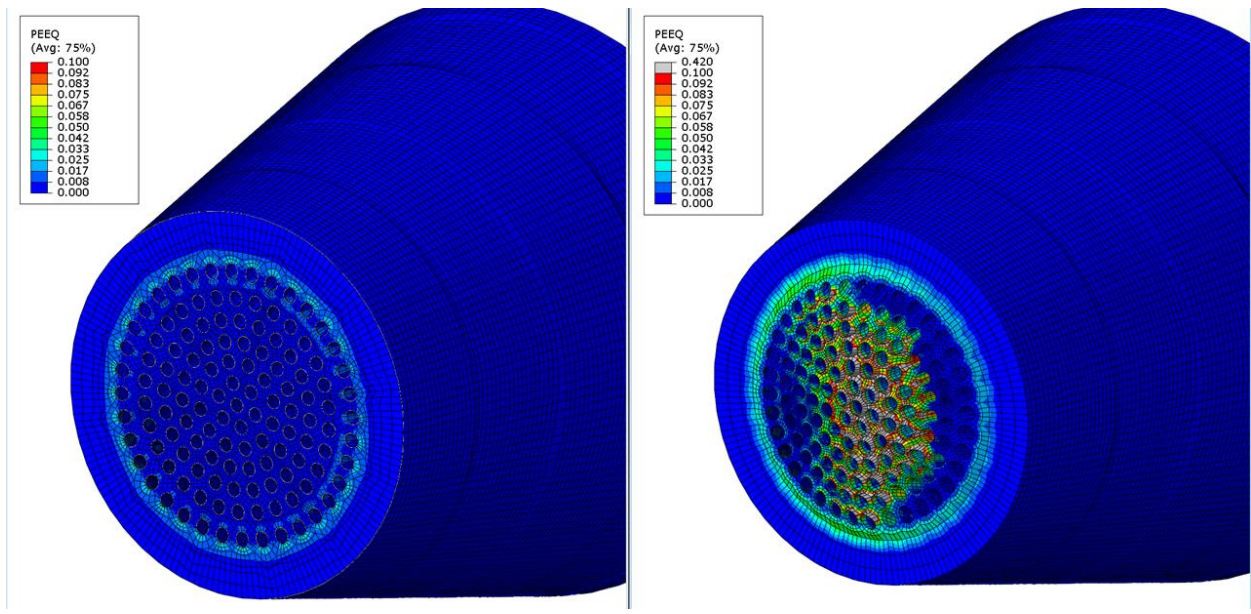
Figure 7.3.10-5. Plastic Strain Field Comparison between Three Failed Wires (left) and 38 Failed Wires (right)

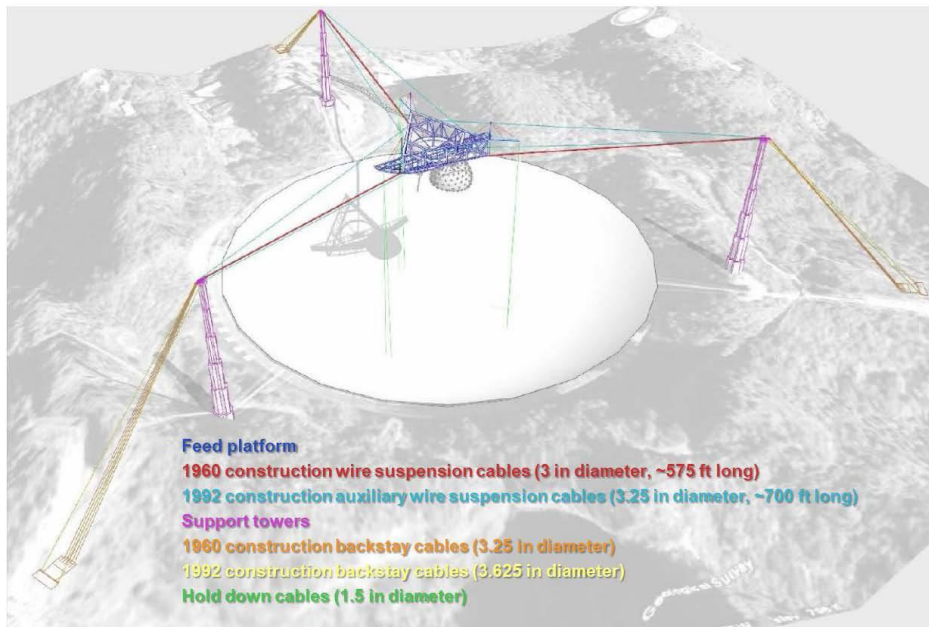
Figure 1. Color-coded diagram of the Feed Platform support structure.¹

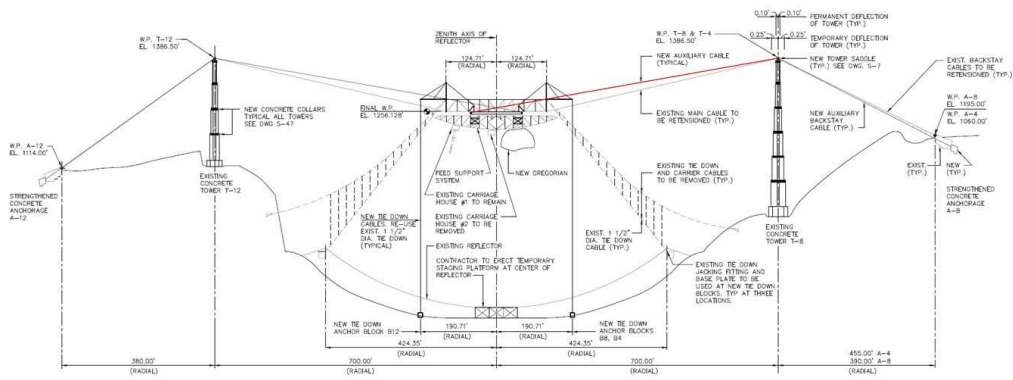
Figure 2. Elevation Drawing S-2, highlighting the failed M4N auxiliary cable in red.²

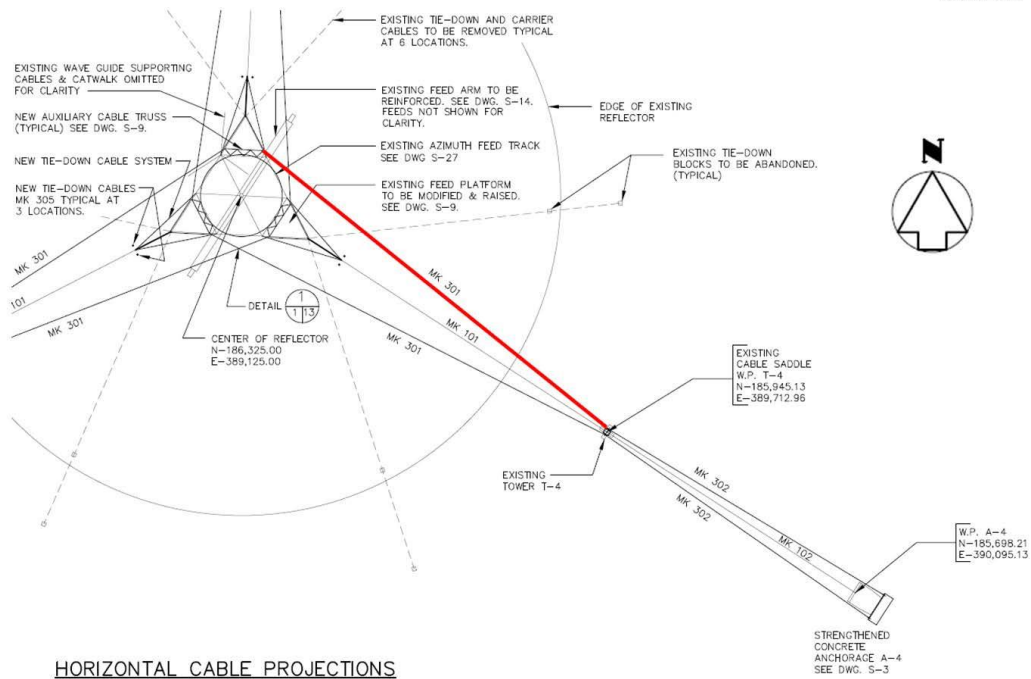
HORIZONTAL CABLE PROJECTIONS

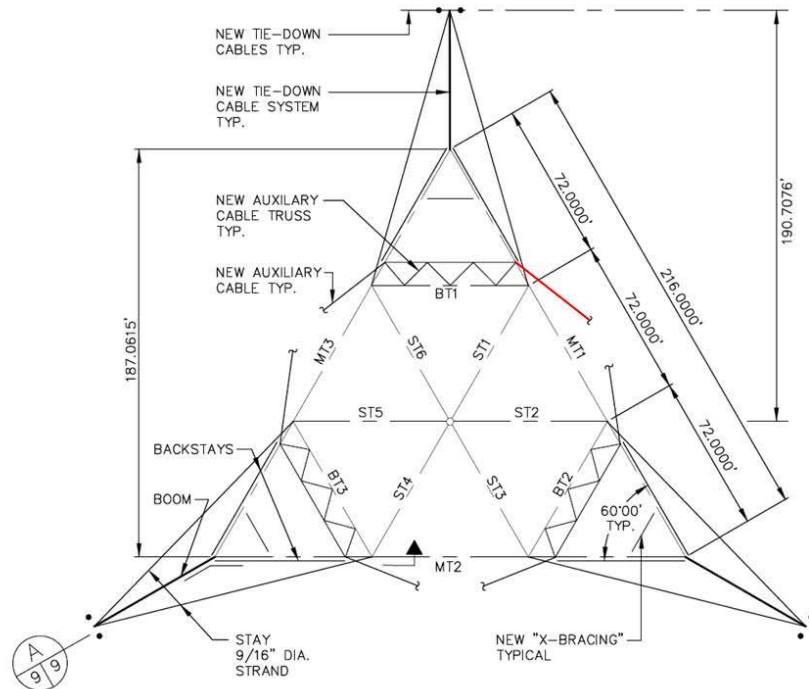
Figure 3. Horizontal cable projections, drawing S-1, highlighting the failed M4N auxiliary cable in red.²

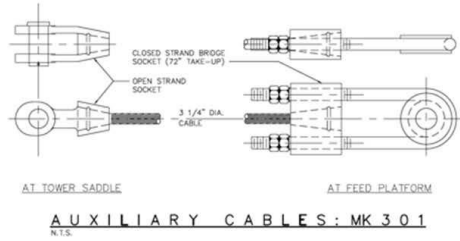
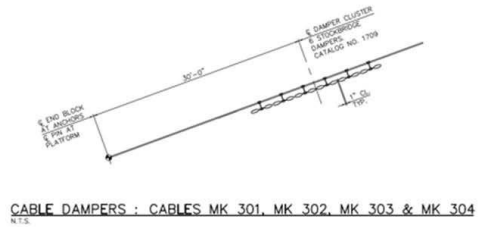
Figure 5. Cable details, drawing S-13, specific to the failed M4N auxiliary cable.²

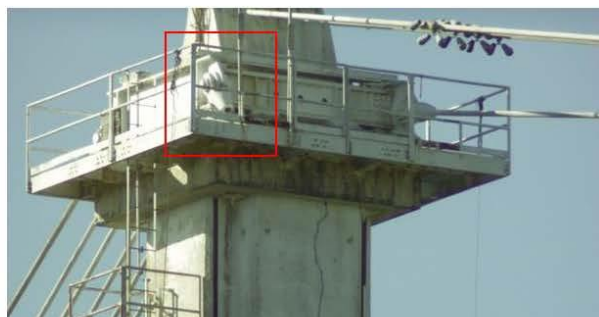
Figure 7. Photo, provided by WJE, of the failed M4N socket, prior to removal from Tower T4. The socket was retrieved prior to the observatory's ultimate collapse.

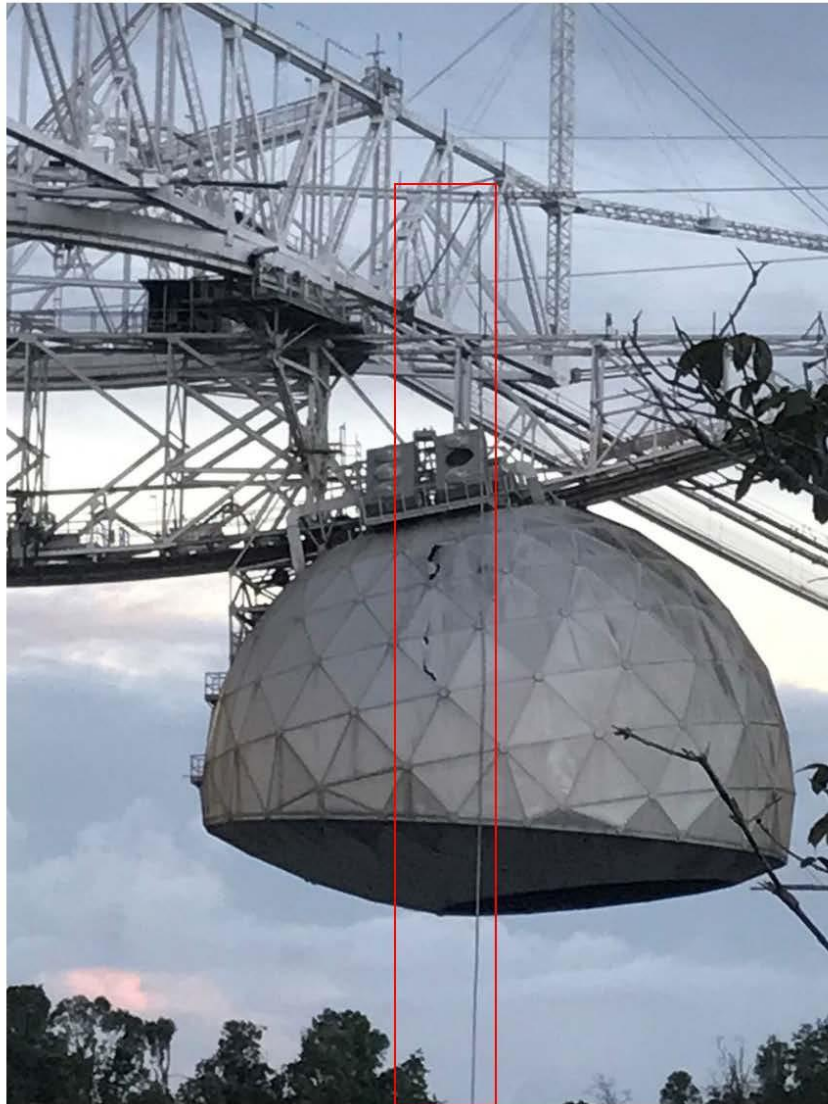
Figure 8. Photo of the failed M4N auxiliary cable, where it remained connected to the Feed Platform. This photo was taken prior to the ultimate collapse of the observatory. Photo provided by WJE.

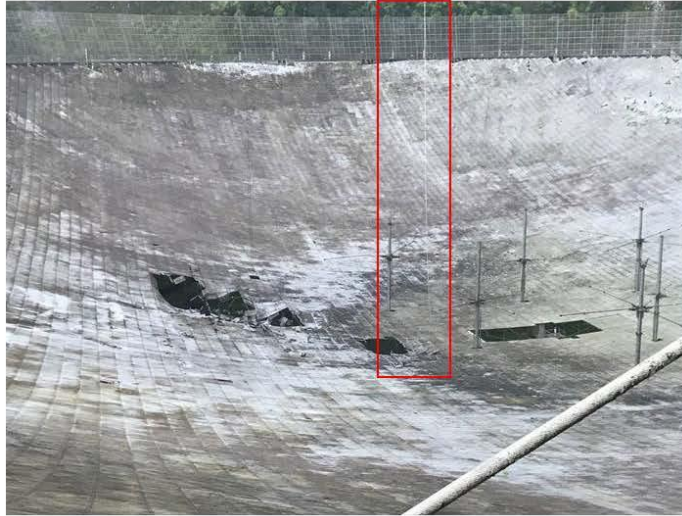
Figure 9. Photo of the failed M4N auxiliary cable, where the Tower T4 connection came to rest on the observatory dish below the Feed Platform. This photo was taken prior to the ultimate collapse of the observatory. Photo provided by WJE.

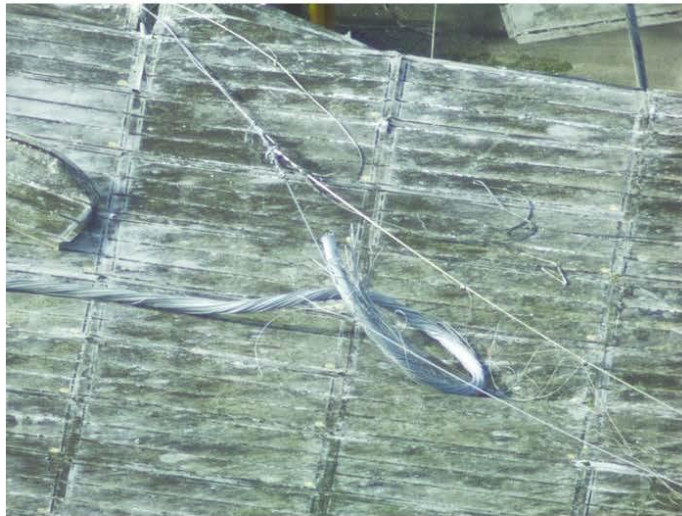
Figure 10. Close up photo of the failed M4N auxiliary cable, where the Tower T4 connection came to rest on the observatory dish below the Feed Platform. This photo was taken prior to the ultimate collapse of the observatory. Photo provided by WJE.

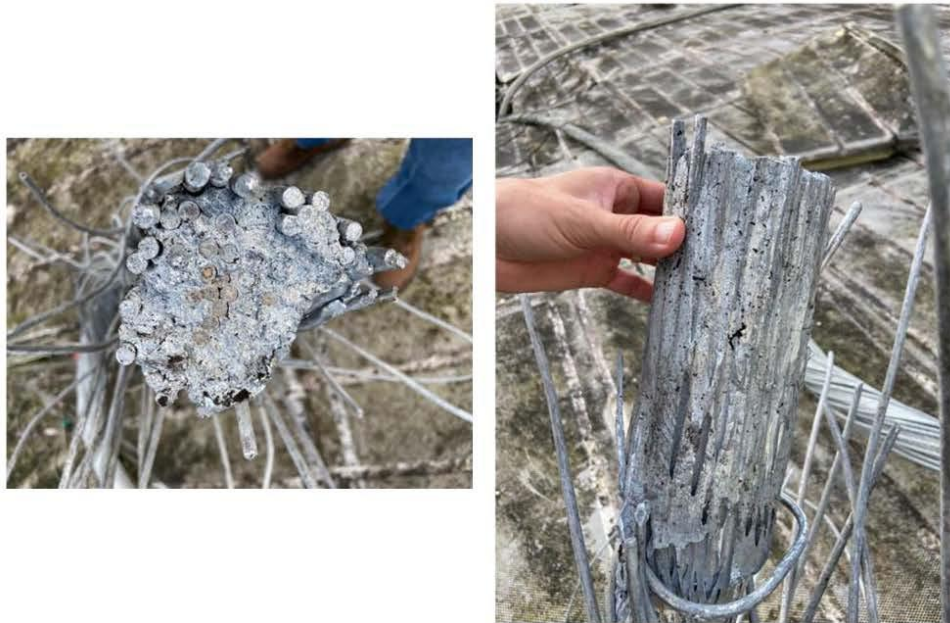
Figure 11. Photos of the failed M4N auxiliary cable-end from the Tower T4 socket connection. These photos were taken prior to the ultimate collapse of the observatory. The cable was not retrieved from the observatory site until after the ultimate collapse of the observatory. Photos provided by WJE.

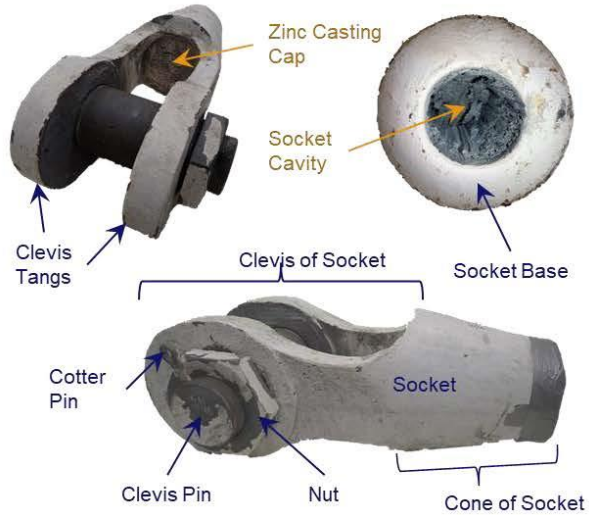
Figure 12. Nomenclature used to describe the parts of the failed spelter socket joint.

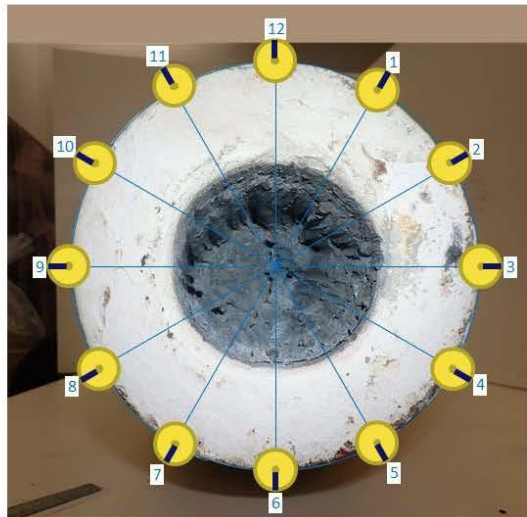
Figure 13. Clock positions used to describe the locations of the wire fractures within the socket, with 12 o'clock associated with the top of the socket.

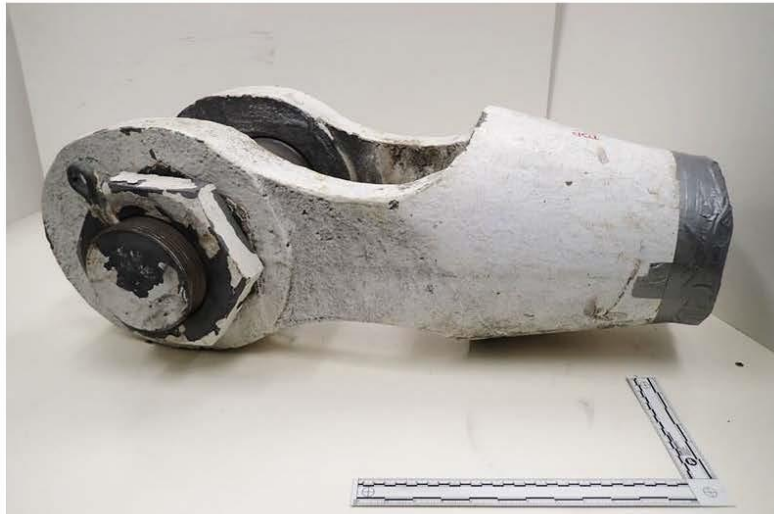
Figure 14. The as-received socket. Note that the gray material around the socket base on the right-side of the image is tape, meant to protect the socket cavity during transport. Scale in inches and centimeters.

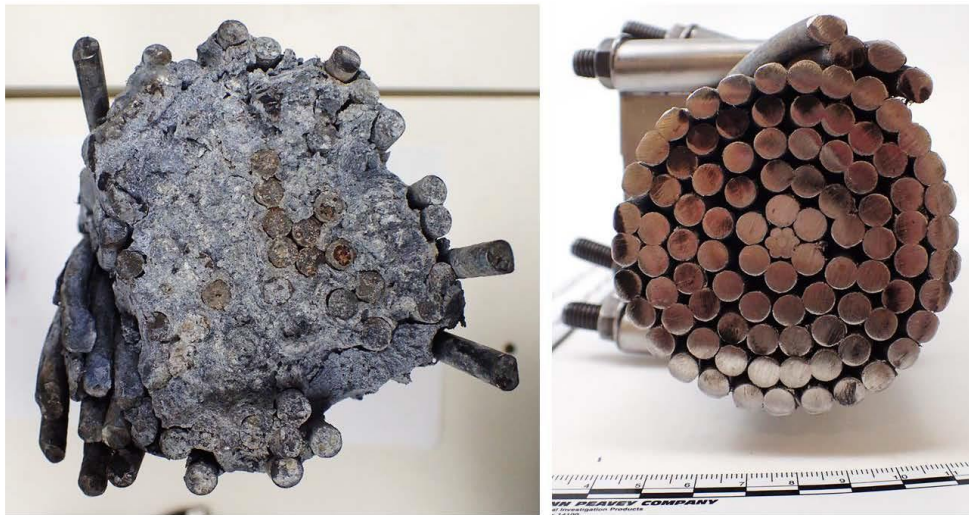
Figure 22. Photos of the as-received cable-end section. The top of the cable-end section is on the left, which would have been the end of the cable embedded in the socket, prior to failure. The top of the left image roughly corresponds with 12 o'clock, and 9 o'clock on the right-side of the left image. The bottom of the cable-end section is on the right, which is a cross-sectional cut taken a few inches outside of the socket base, towards the Feed Platform. The top of the right image roughly corresponds with 2 o'clock, and 5 o'clock on the right-side of the right image. Scale in centimeters.

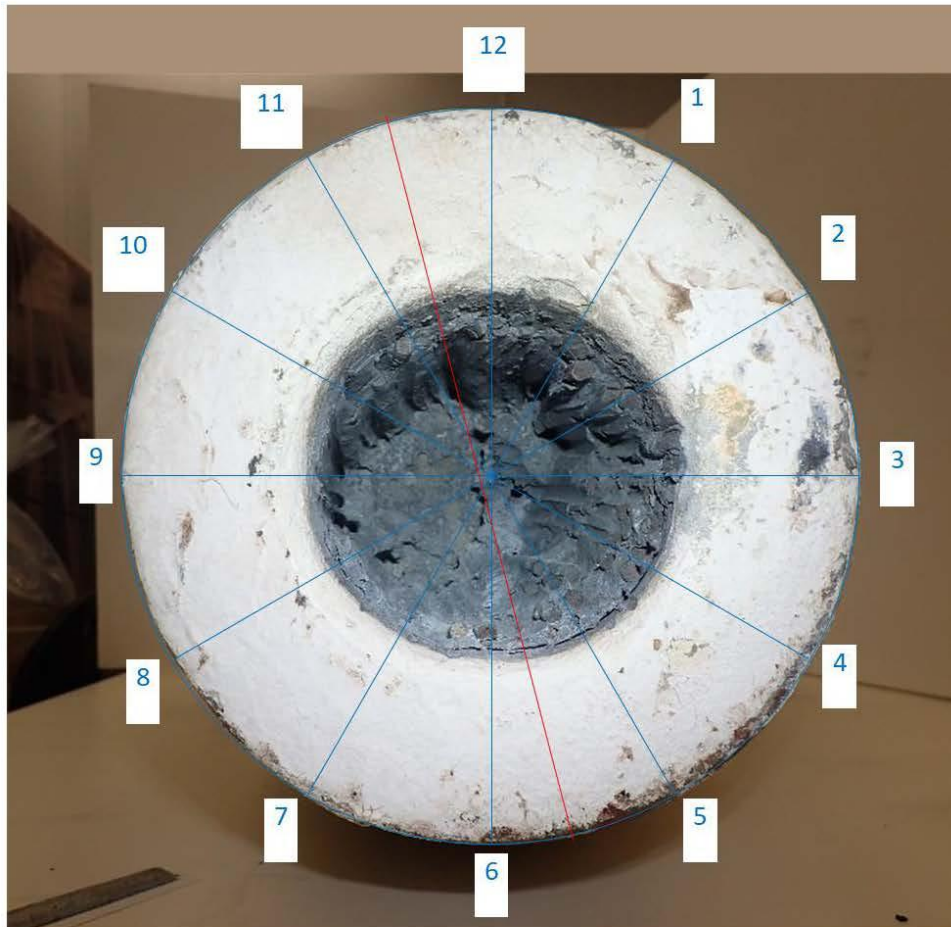
Figure 30. Photo of the socket base with the top of the socket at the top of this image. The 12 o'clock position around the socket base is associated with the top of the socket. The 3 o'clock is associated with the right side of the socket, as if viewing the socket from the feed platform, facing towards the tower. The red line identifies the intended plane for the initial longitudinal cut of the socket cone. Note that the cut was intended to be slightly off center, to attempt to avoid any visually identifiable fracture surfaces. Unfortunately, the fracture surface of wire R was partially cut.

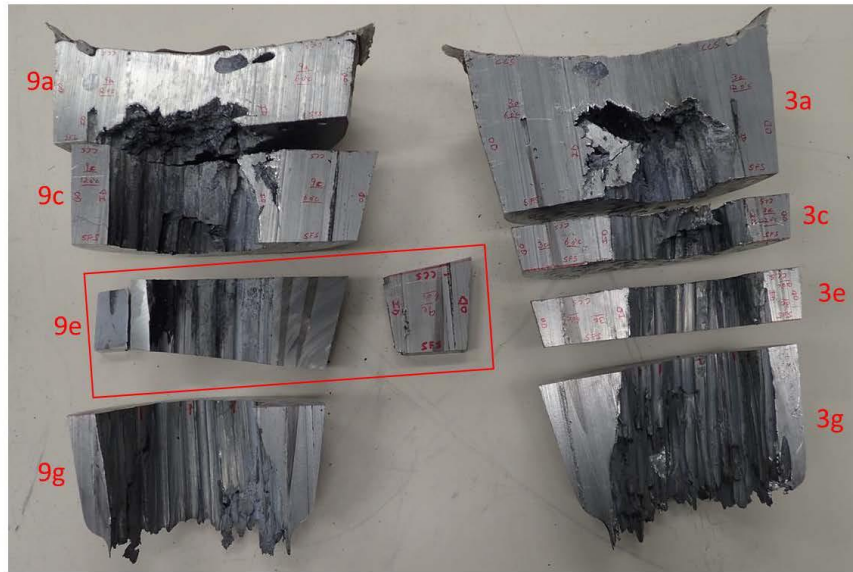
Figure 31. The zinc socket cavity transverse section labeling.

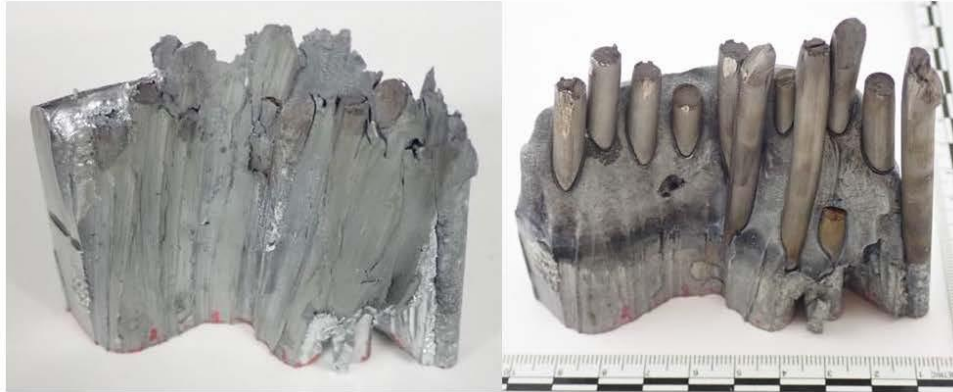
Figure 32. Section of zinc with encased wires before removal of the zinc (left) and after removal (right) via dissolution in acid. Scale in centimeters.

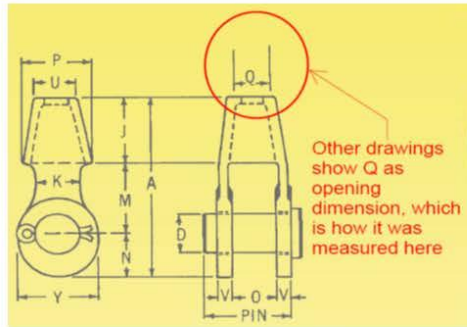
A (in)	J* (in)	K (in)	M* (in)	N (in)	O (in)	P (in)	Q (in)	U (in)	V (in)	Y (in)	Pin Bore Diameter (in)	Pin Outer Diameter (in)
Specification	3 1/2	10 1/2	6 1/8	13 1/4	7 3/4	6 3/4	11 3/4	3 3/4	7 1/2	2 3/4	11 1/4	6 1/2	6 1/2
As Measured	31.509	10.915 10.515	6.258	12.711 13.111	7.727	6.538	11.788	3.847	7.504	2.755	11.501	6.533	6.466

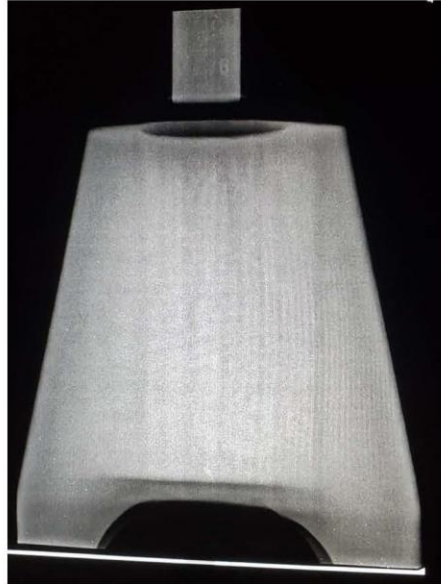
Figure 34. CR image of the double-wall radiographic exposure of the socket. Note that the vertical streaking are CR processing artifacts. No internal features of the socket cavity were discernable from this exposure.

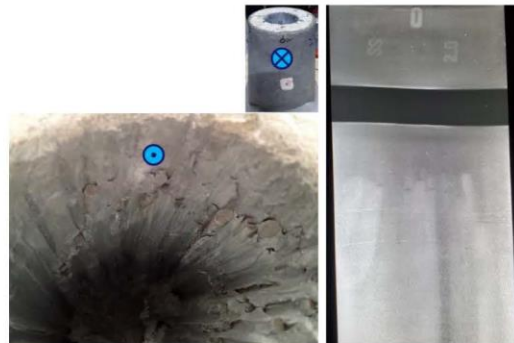
Figure 35. CR image of the single-wall radiographic exposure of the socket, position 0. The blue markers indicate the direction of gamma-rays (“x” is going into the page and “dot” is coming out of the page) and where around the perimeter the source was aligned (approximately through the socket base’s 12 o’clock position).

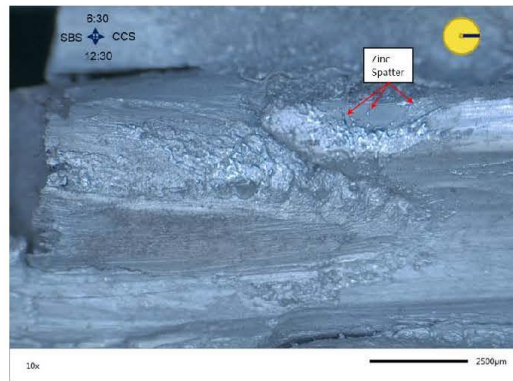
Figure 39. Inner diameter side of wire AH, exhibiting zinc spatter, from a thin layer of localized melting of the zinc. Note that the direction of flow of this layer of zinc is perpendicular to the wire channels.

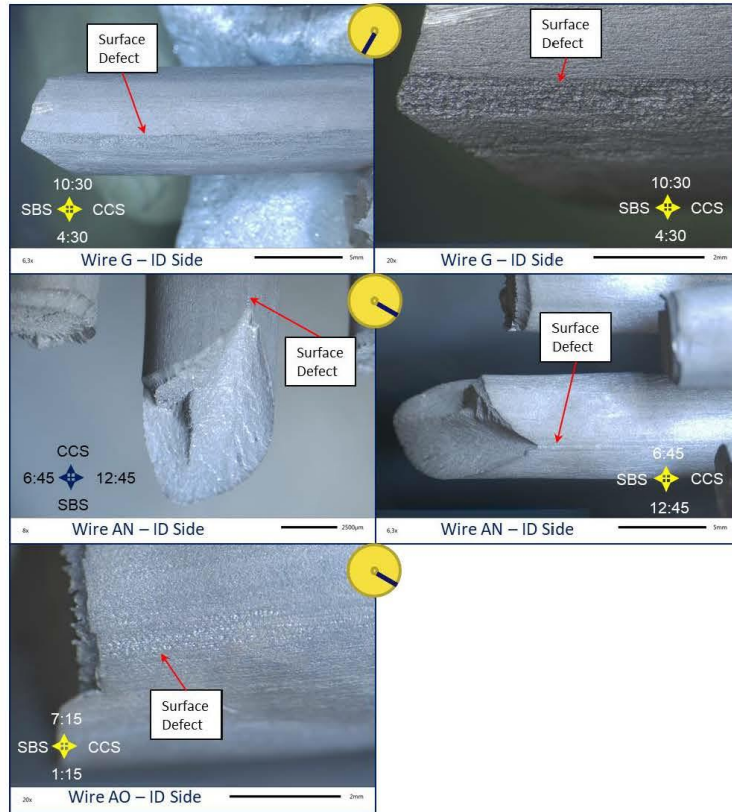
Figure 40. Stereomicroscope images of similar surface defects found on wires G, AN, and AO.

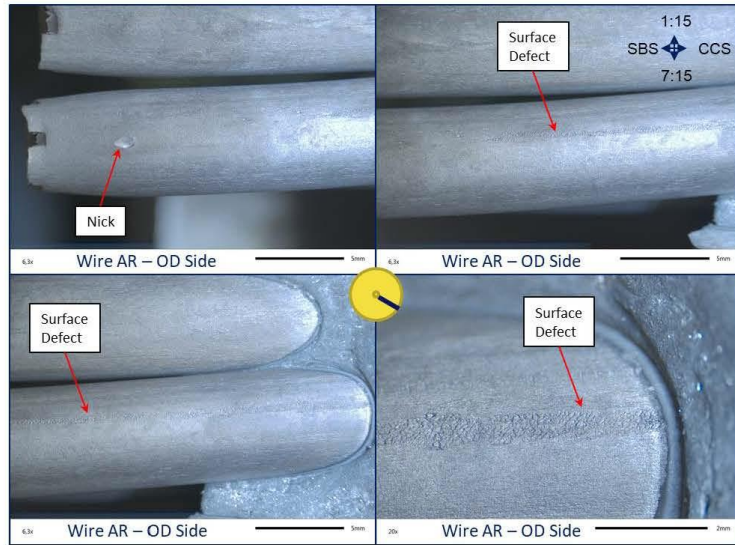
Figure 41. Stereomicroscope images of a surface defect found on wire AR. The nick visible in the top row left image was likely from sectioning.

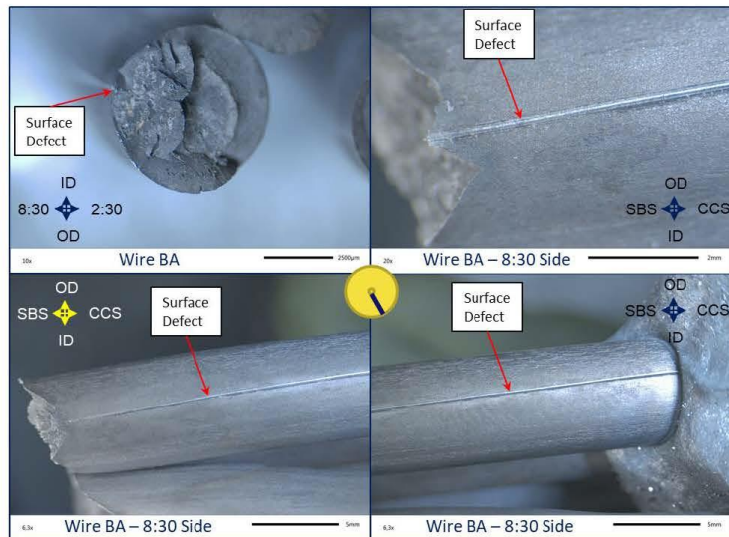
Figure 42. Stereomicroscope images of a surface defect found on wire BA.

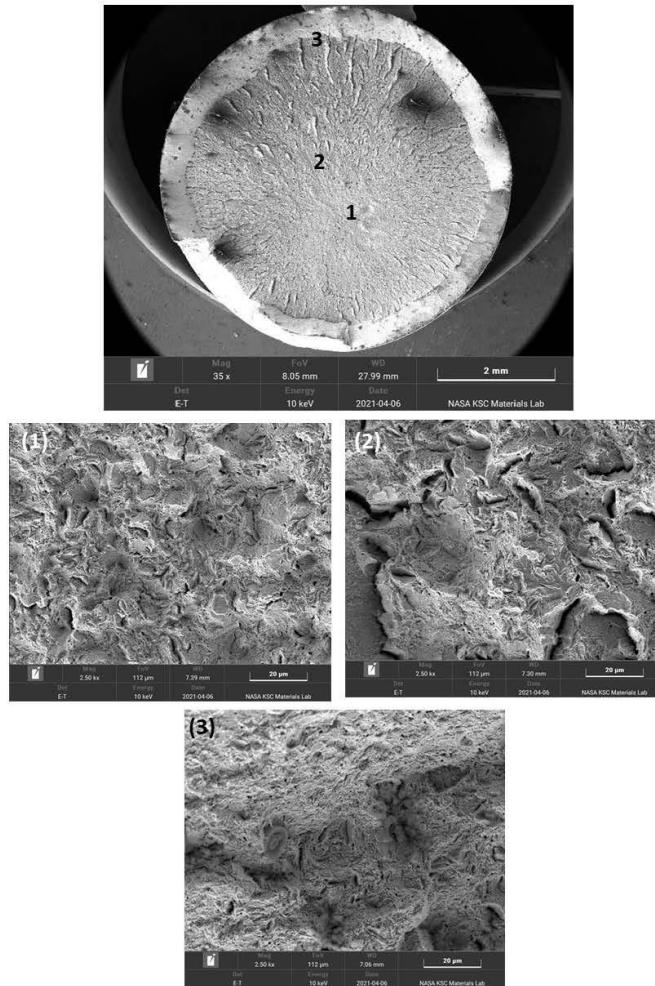
Figure 43. SEM images of a wire fracture surface displaying tensile failure (top) with higher magnification images displaying MVC and cleavage fracture (1,2) leading to a shear lip (3).

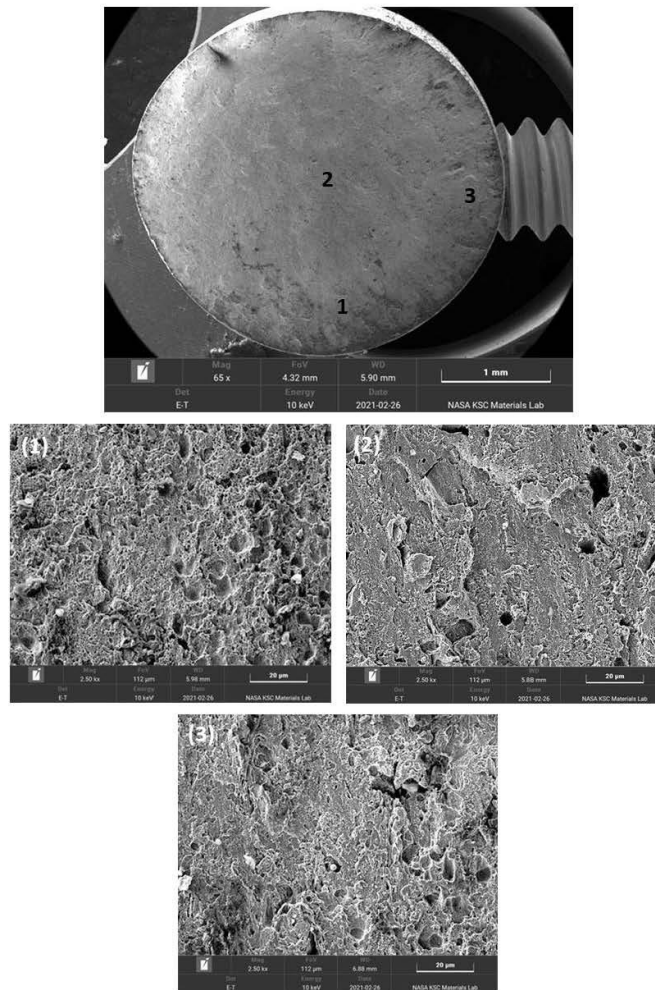
Figure 44. SEM images of a wire fracture surface displaying shear failure (top) with higher magnification images displaying the shear failure microstructure.

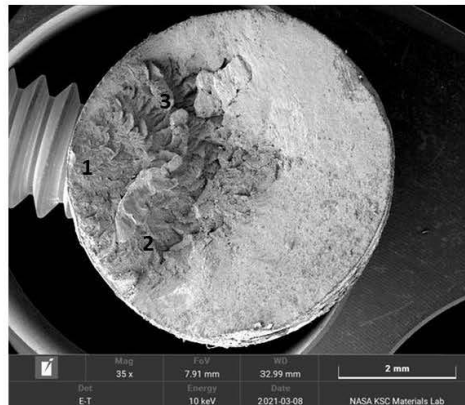
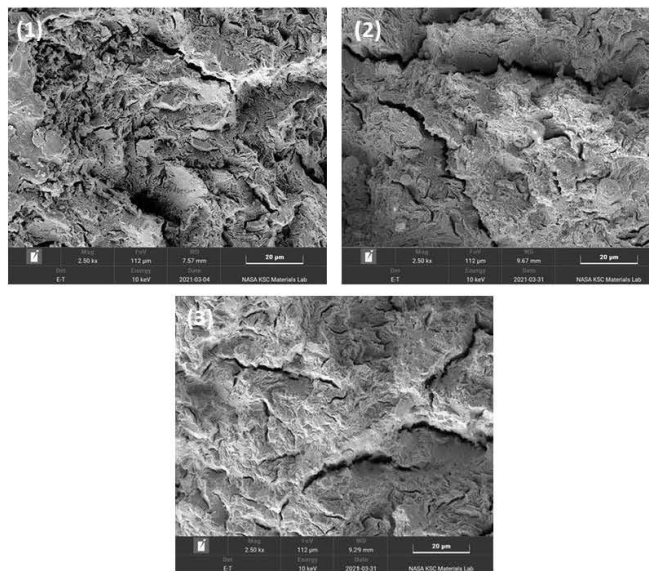
Figure 45. SEM images of a wire fracture surface displaying microstructure in the higher magnification images of HAC in the flat area of the fracture leading to a shear failure area (top).

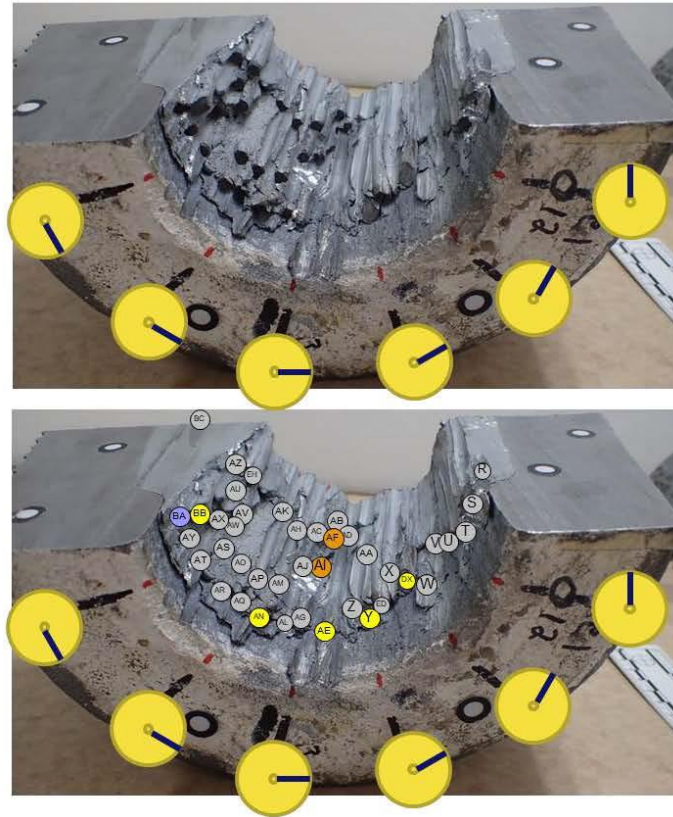
Figure 46. Slice 3g. The lower image is the same as the upper image, but with wire label overlays that correspond to the color-coding in Table 3. The wire fractures are successively stacked the further they are located within the socket.

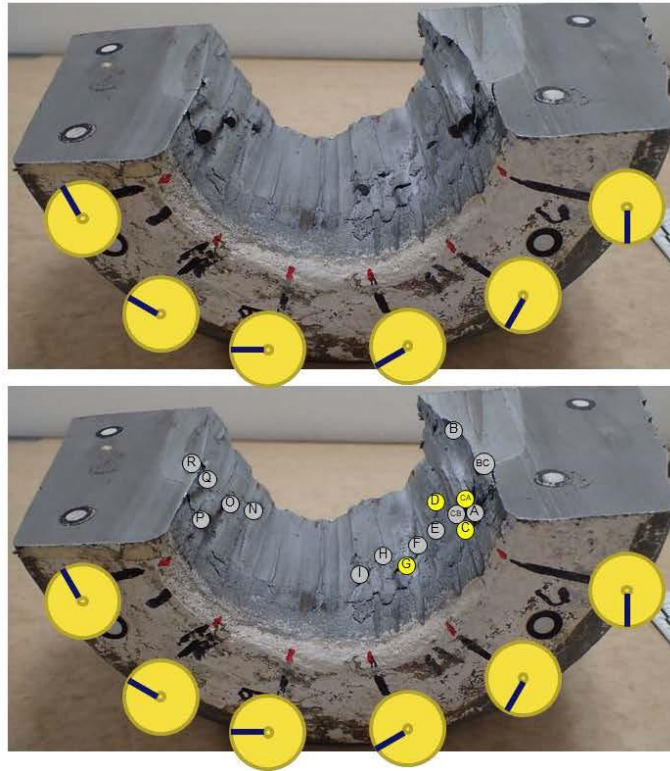
Figure 47. Slice 9g. The lower image is the same as the upper image, but with wire label overlays that correspond to the color-coding in Table 3.

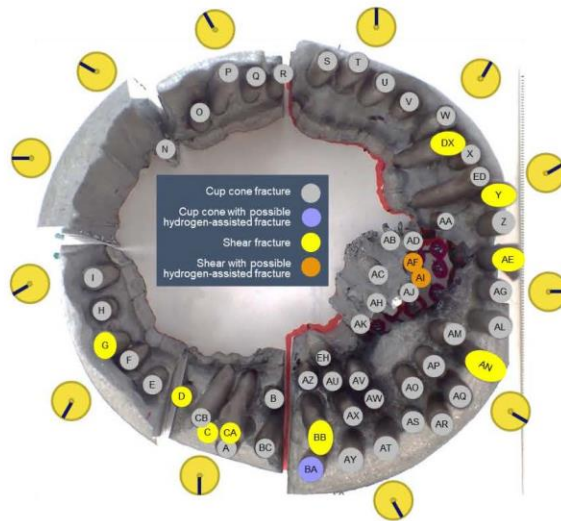
Figure 49. Rearrangement of the pieces from slices 3g and 9g back into their approximate as-built configuration, after the acid bath zinc removal process with wire label overlays that correspond to the fracture morphology identified.

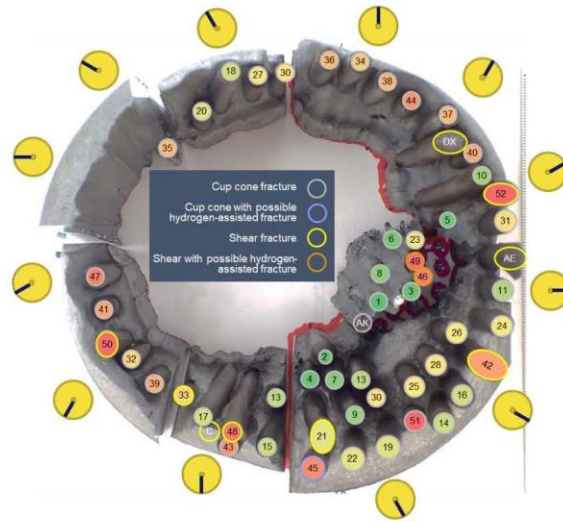
Figure 50. Rearrangement of the pieces from slices 3g and 9g back into their approximate as-built configuration, after the acid bath zinc removal process with wire label overlays that correspond to both the fracture morphology identified (outline color of the overlay) and the percent necking from Table 4 (fill color of the overlay).

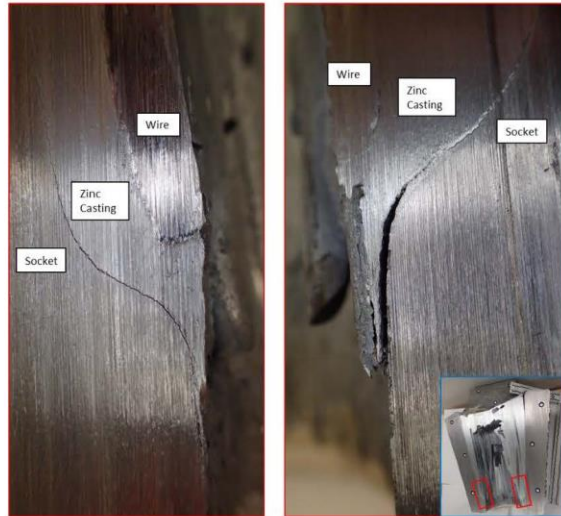
Figure 53. Close up view of the tight gap present between the socket wall inner diameter and the zinc casting outer diameter, just inside the socket base. These images were taken from the 9 o'clock half – 12 o'clock is on the left and 6 o'clock is on the right.

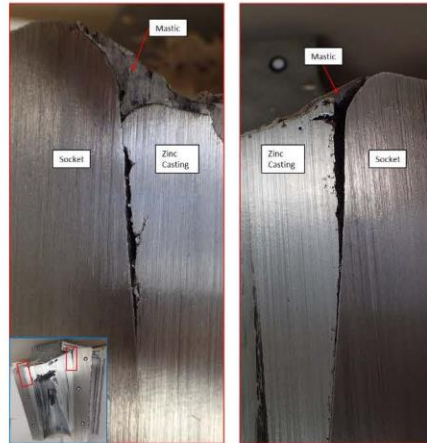
Figure 54. Close up view of the larger gap present between the socket wall inner diameter and the zinc casting outer diameter, at the casting cap. These images were taken from the 9 o'clock half – 12 o'clock is on the left and 6 o'clock is on the right.

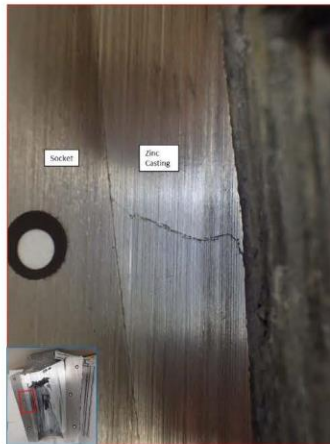
Figure 55. Close up view of the crack present in the zinc casting, running between the inner diameter of the zinc casting, where the cable/zinc slug pulled out, and the outer diameter of the zinc casting. This image was taken from the 9 o'clock half at 12 o'clock.
