NASA/TM-20210017934
NESC-RP-20-01585

Arecibo Observatory Auxiliary M4N Socket Termination Failure Investigation

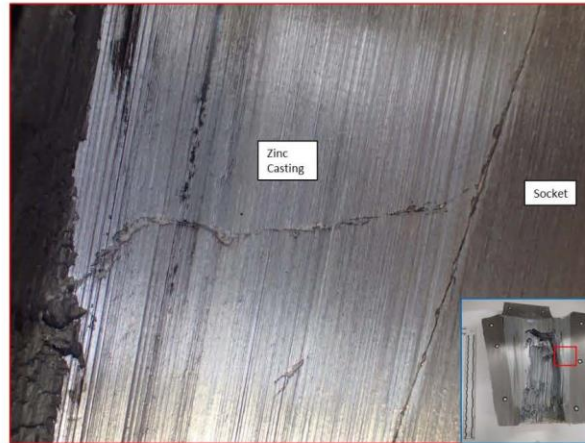
Figure 56. Close up view of the crack present in the zinc casting, running between the inner diameter of the zinc casting, where the cable/zinc slug pulled out, and the outer diameter of the zinc casting. Corrosion product, most likely zinc oxide, has completely filled the crack space. This image was taken from the 3 o'clock half at 12 o'clock.

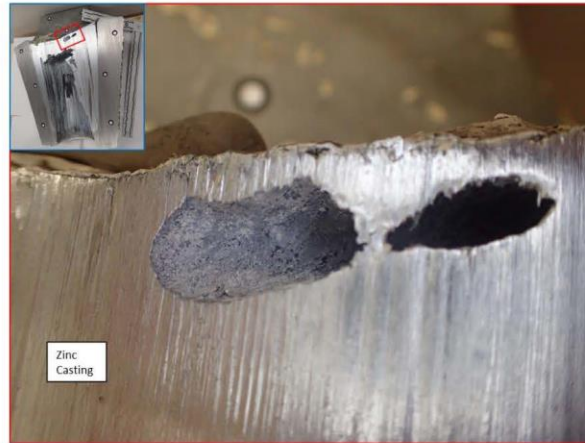
Figure 57. Close up view of the gas bubble in the zinc casting, just under the casting cap. Corrosion product, most likely zinc oxide, built up within the walls of the gas bubble. This image was taken from the 9 o'clock half.

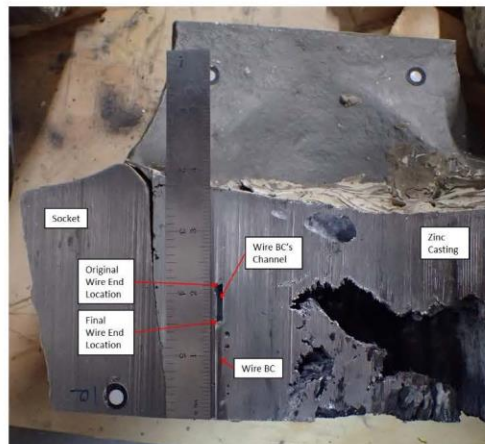
Figure 58. Measurement of wire-end displacement of wire BC within the zinc casting. This image was taken from the 3 o'clock half. Scale in inches.

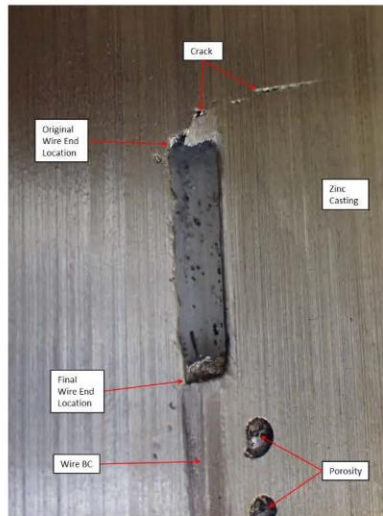
Figure 59. Close up view of the wire-end displacement of wire BC within the zinc casting. A crack appears evident on the casting cap, which would be a potential ingress route for moisture. Additionally, several pores can be seen adjacent to the wire. This image was taken from the 3 o'clock half.

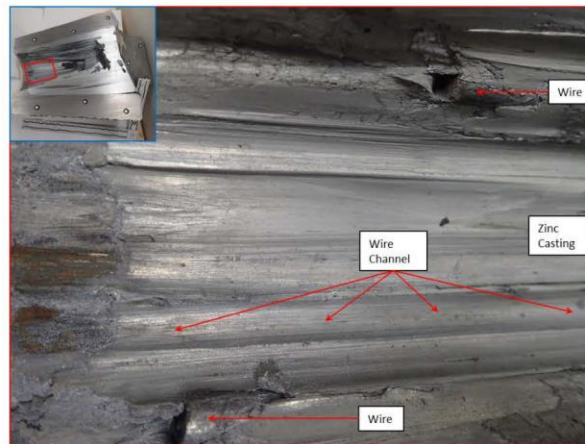
Figure 60. Close up view of the wire channels left in the zinc on the 9 o'clock side of the socket cavity. The socket base is towards the left-side of this image.

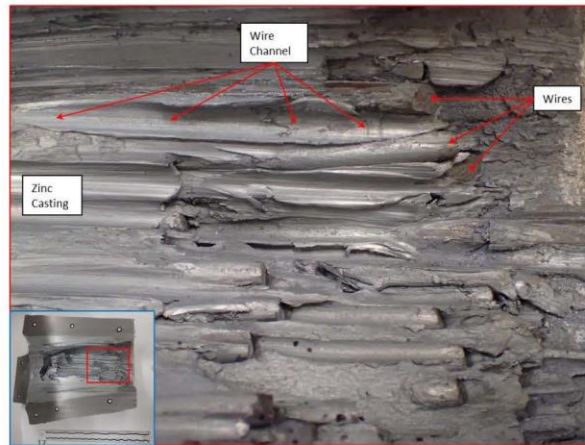
Figure 61. Close up view of the wire channels left in the zinc on the 3 o'clock side of the socket cavity. The socket base is towards the right-side of this image.

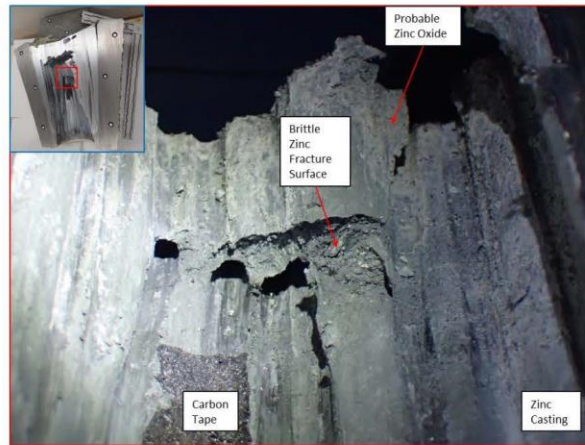
Figure 62. Close up view of slice 9c, within the socket cavity near the casting cap side of the slice, where some of the zinc between wires shows a brittle fracture surface. The wire channels in this image also appear to show a significant amount of corrosion product, most likely zinc oxide, on their surface. The black rectangular piece at the bottom left of the image is remnant carbon tape from chemical sampling.

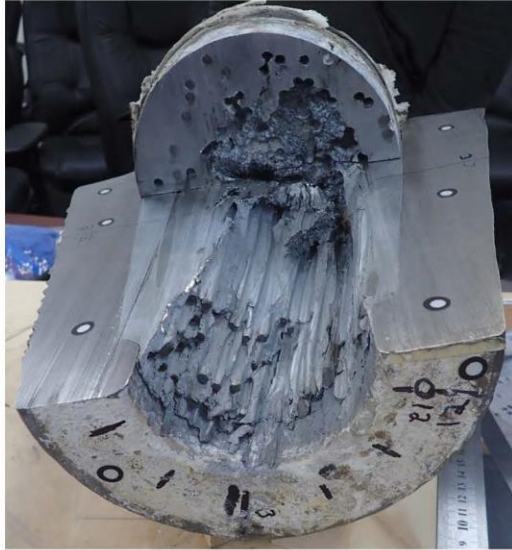
Figure 63. Slice 9a on top of the 3 o'clock half, providing a visual on how the back of the socket cavity was at the time of failure.

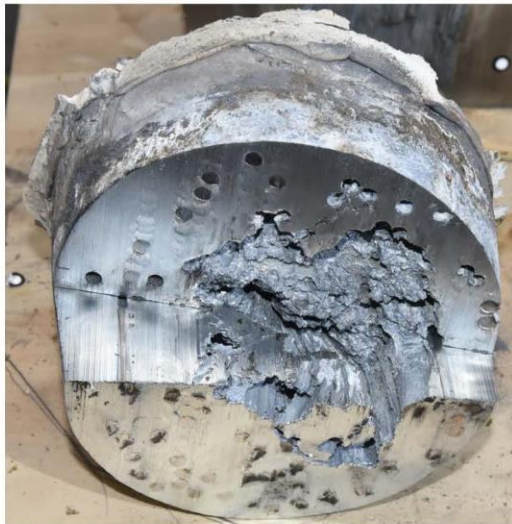
Figure 64. Slice 9a on top of slice 3a, providing a visual on how the back of the socket cavity was at the time of failure.

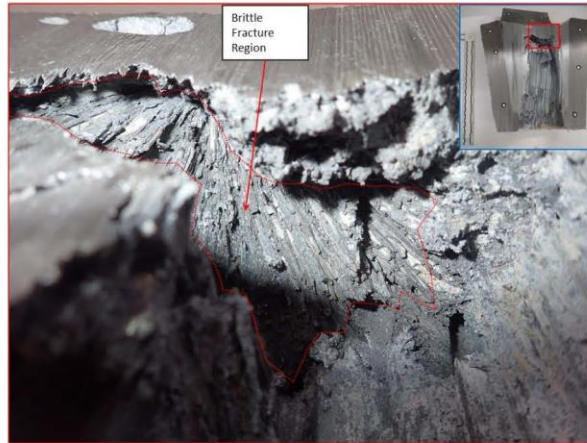
Figure 65. View of the casting cap side of the brittle fracture region in the back of the socket cavity on slice 3a. The fracture surface can be seen extending from the wire channels from the outer diameter of the cable-end section that pulled free of the socket during the ultimate failure up to a point just below the gas bubble. The gas bubble can be seen at the top left of the image.

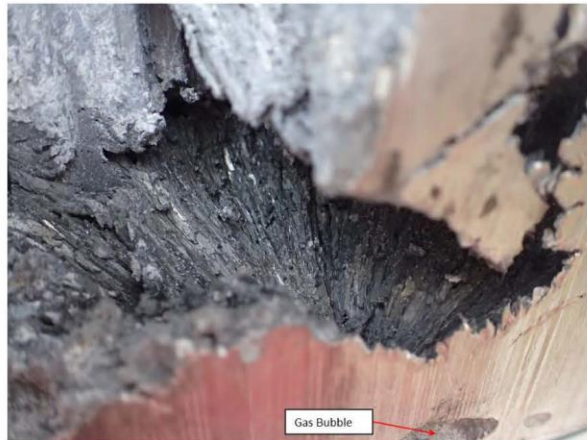
Figure 66. View of the casting cap side of the brittle fracture region in the back of the socket cavity on slice 3a. The fracture surface can be seen extending from the wire channels from the outer diameter of the cable-end section that pulled free of the socket during the ultimate failure up to a point just below the gas bubble. The gas bubble can be seen at the bottom right of the image.

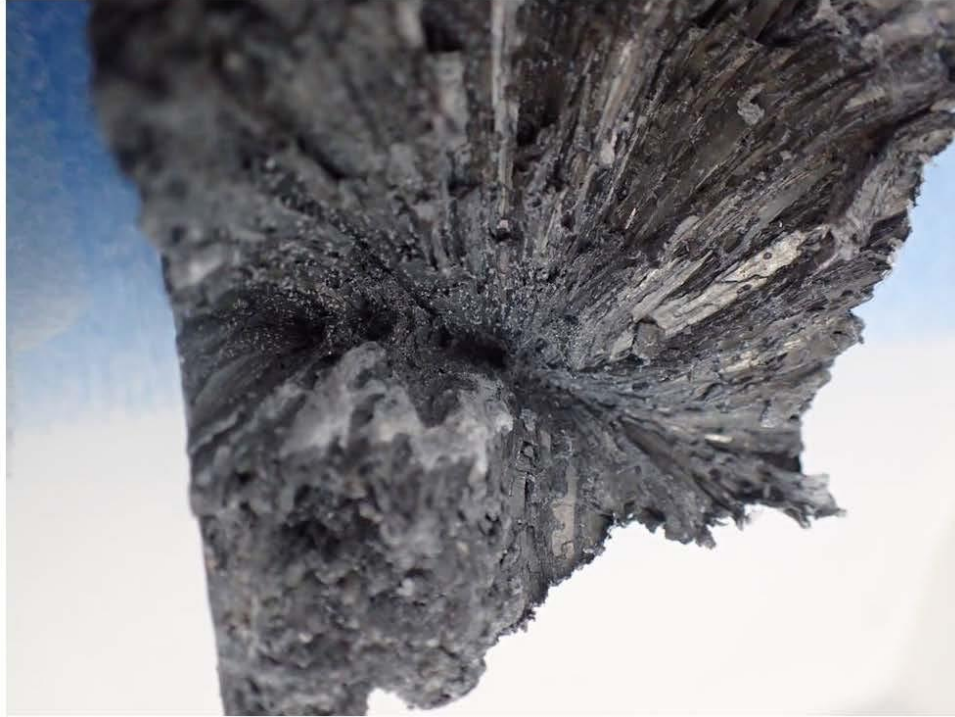
Figure 67. View of the casting cap side of the brittle fracture region in the back of the socket cavity on slice 3a, after some additional abrasive saw cuts on the left and right of this image and a third cut along the outer diameter of the zinc casting to remove the socket base side of the remaining piece. The fracture surface can be seen converging to a point just below the gas bubble (refer to Figure 66 for the location of the gas bubble).

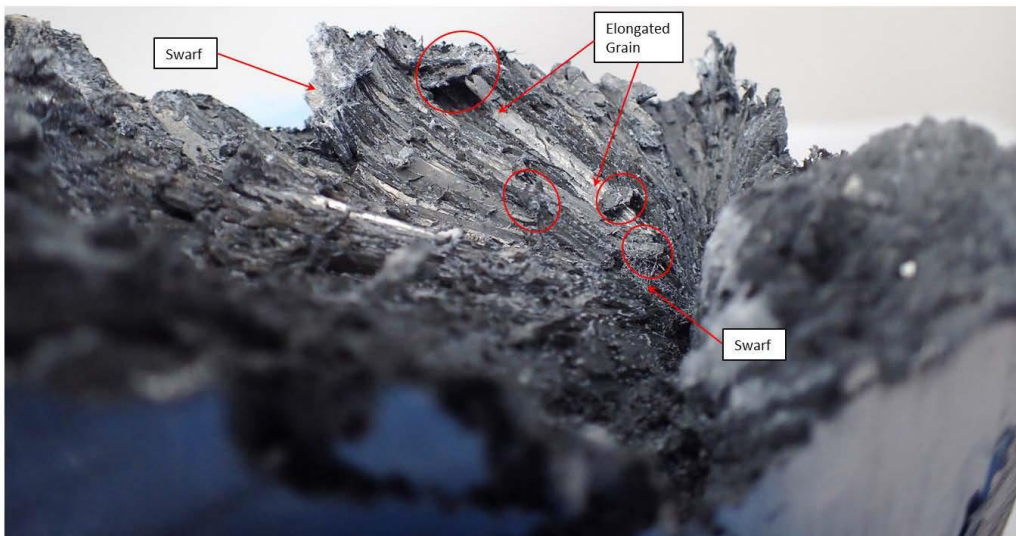
Figure 68. View of the casting cap side of the brittle fracture region in the back of the socket cavity on slice 3a. Many ends of the elongated grains appear lifted up from the surface (some have been circled in the image). Note that there is a substantial amount of swarf from the cutting process that is visibly stuck along edges and protrusions within the image.

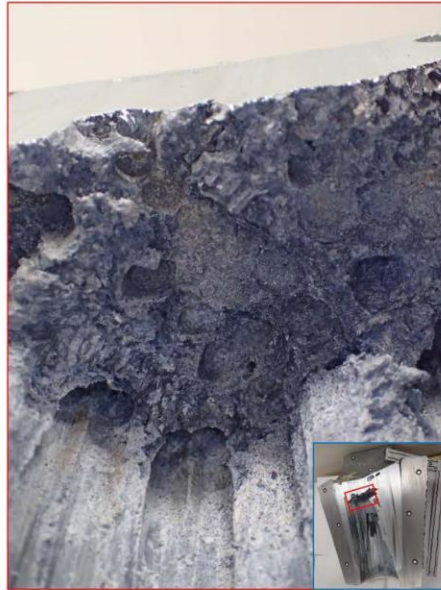
Figure 69. Closer view of the back of the socket cavity on slice 9a. This region does not exhibit the same faceted appearance as the neighboring side of the back of the socket cavity from slice 3a. Wire-end imprints and heavy amounts of probable zinc oxide and iron oxide corrosion can be seen in this area.

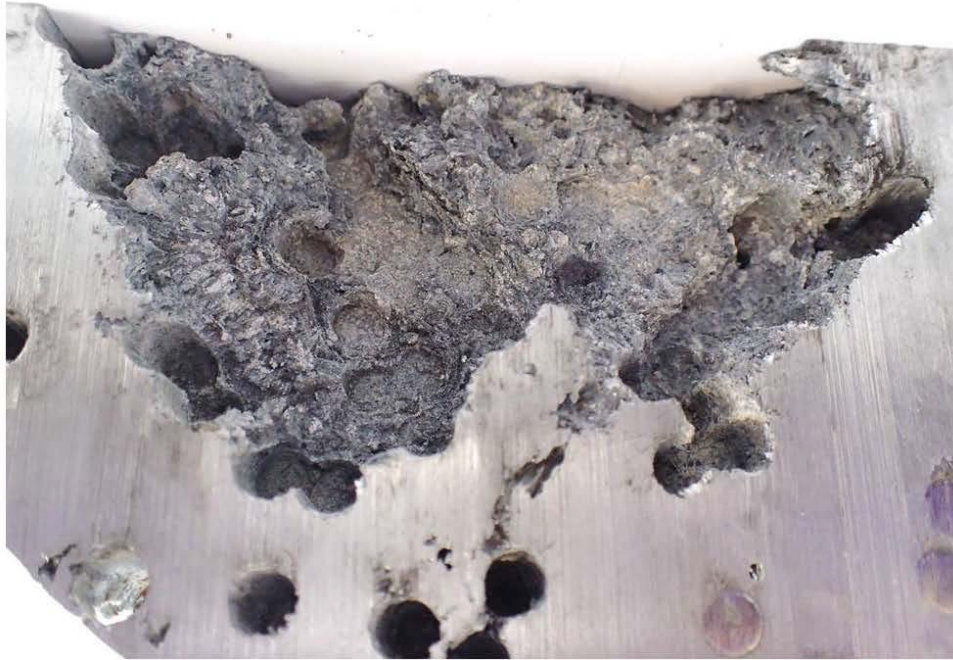
Figure 70. Closer view of the back of the socket cavity on slice 9a. This region does not exhibit the same faceted appearance as the neighboring side of the back of the socket cavity from slice 3a. Wire-end imprints and heavy amounts of probable zinc oxide and iron oxide corrosion can be seen in this area.

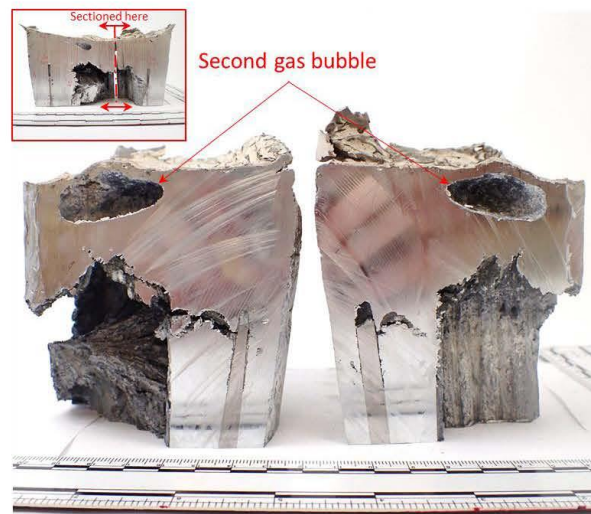
Figure 71. Slice 3a was sectioned longitudinally, revealing a second gas bubble below the casting cap.

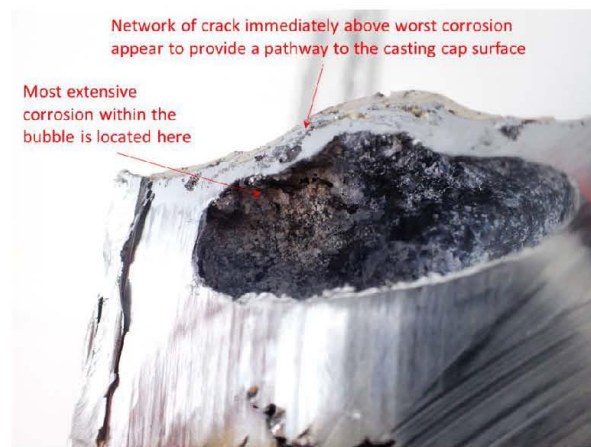
Figure 72. Close up image of the second gas bubble from Figure 71. The interior of the gas bubble is heavily corroded with white corrosion product, most probably zinc oxide, particularly just below the network of cracks between the bubble and the casting cap.

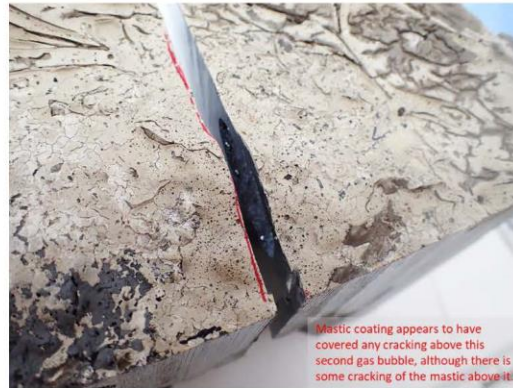
Figure 73. Oblique view of the casting cap immediately above the second gas bubble revealed in Figure 71.

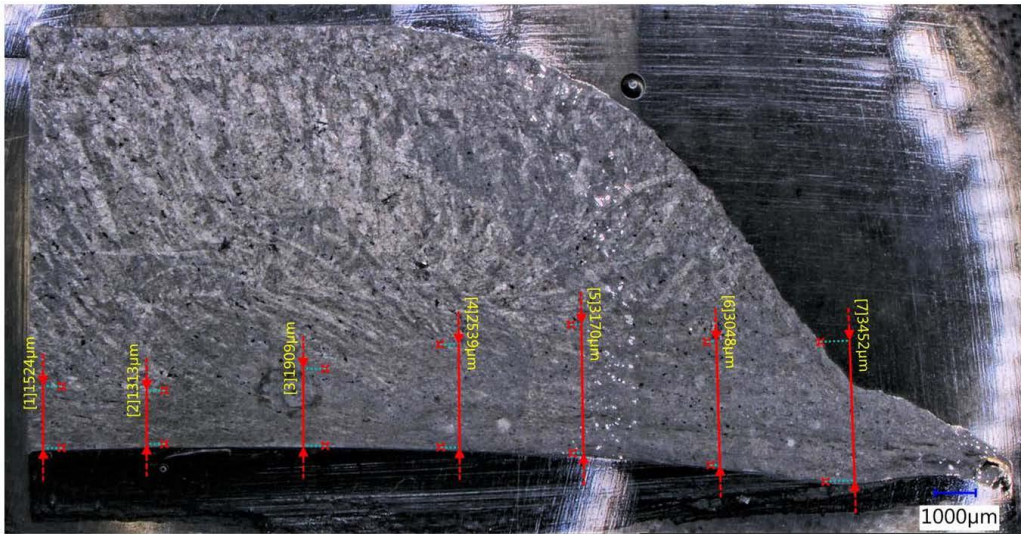
Figure 78. Measurements taken on Figure 295 from the plane adjacent to the cable/zinc slug that pulled free of the socket to the approximate location where the grains orientation begins to noticeably change from parallel to that interface.

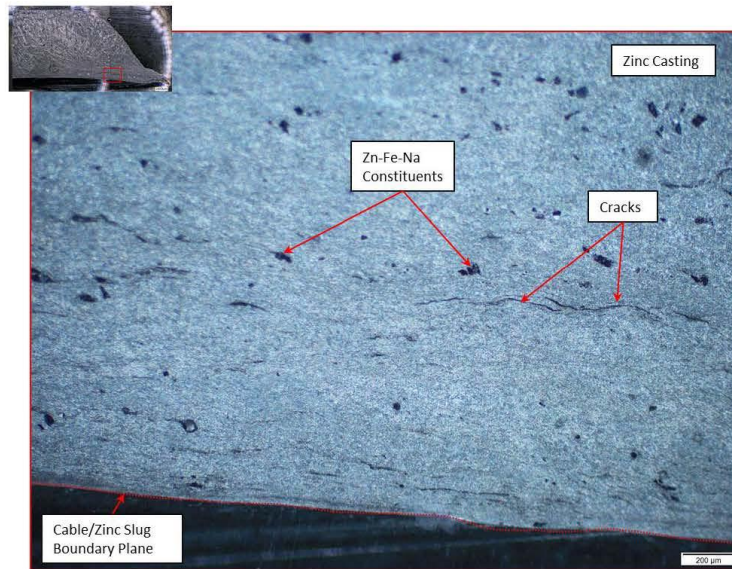
Figure 79. Zinc grain structure adjacent to the cable/zinc slug that pulled free of the socket near the socket base. Intermittent cracks are visible, running parallel with the cable/zinc slug boundary plane. (50X magnification)

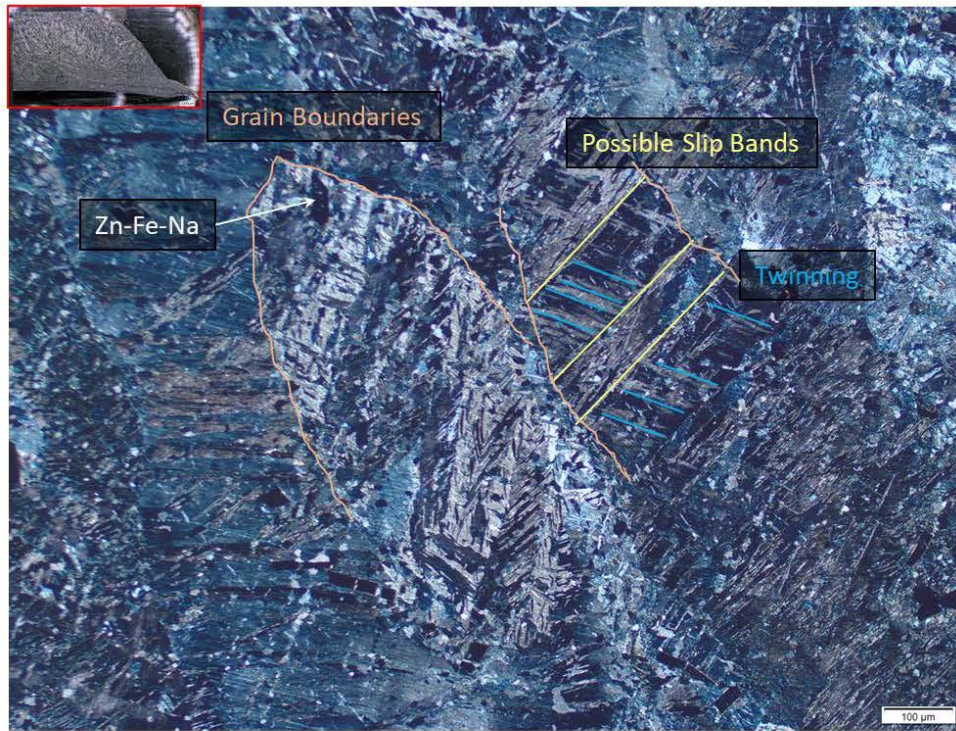
Figure 80. Metallograph image of the large grains present in Figure 78 close to the zinc casting outer diameter. Tint etch at 100X.

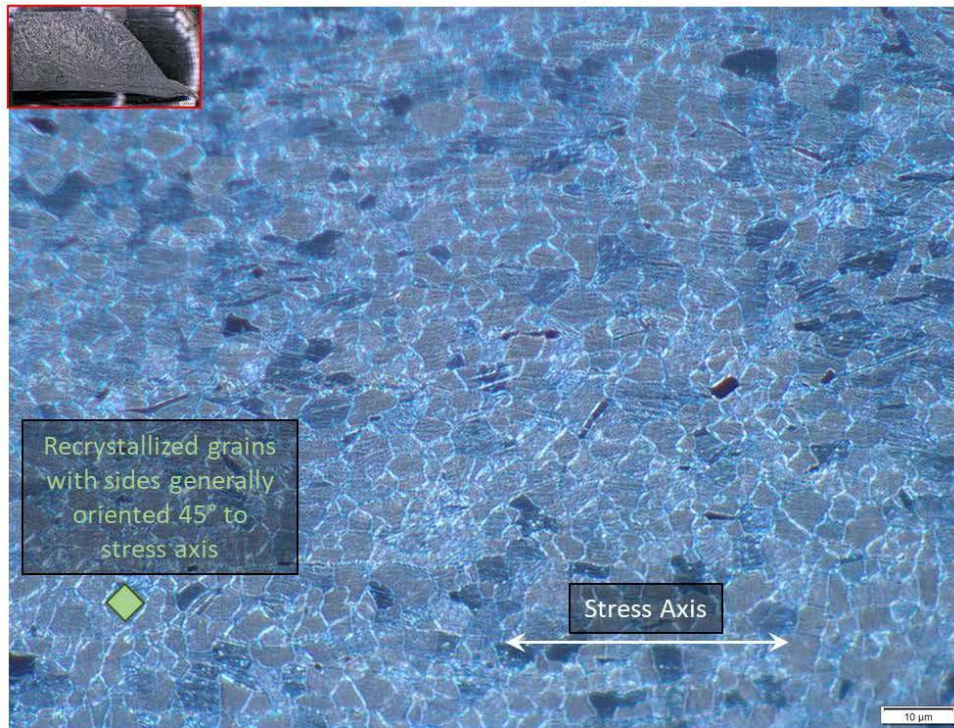
Figure 82. Metallograph image of the small grains present in Figure 78 adjacent to the cable/zinc slug boundary. Tint etch at 1000X.

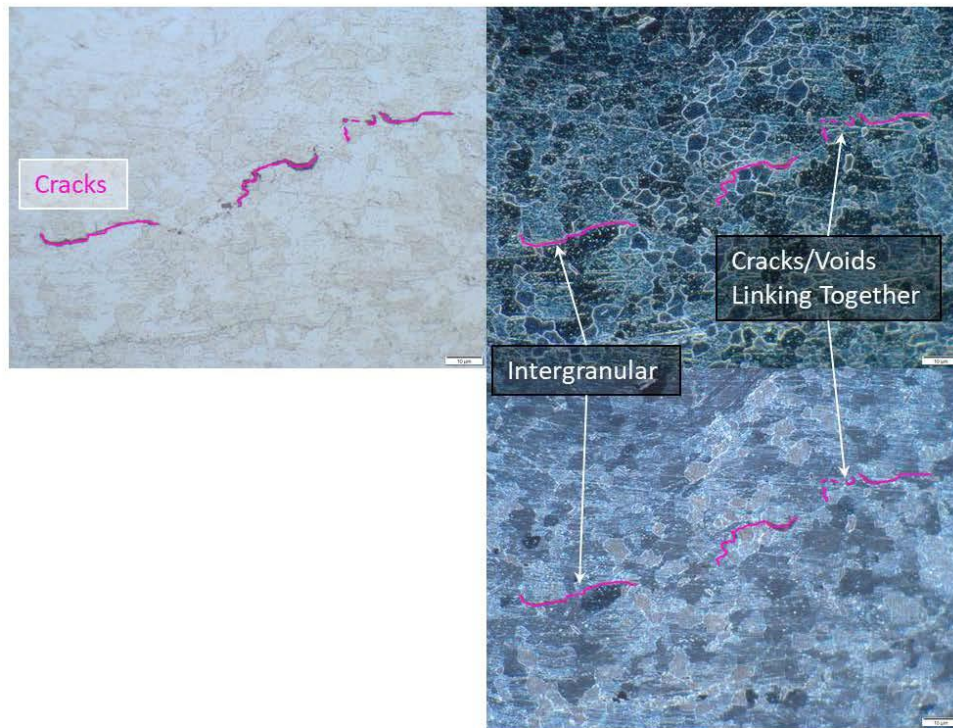
Figure 83. Close up metallograph images of cracks present in Figure 295 adjacent to the cable/zinc slug boundary. Tint etch at 1000X.

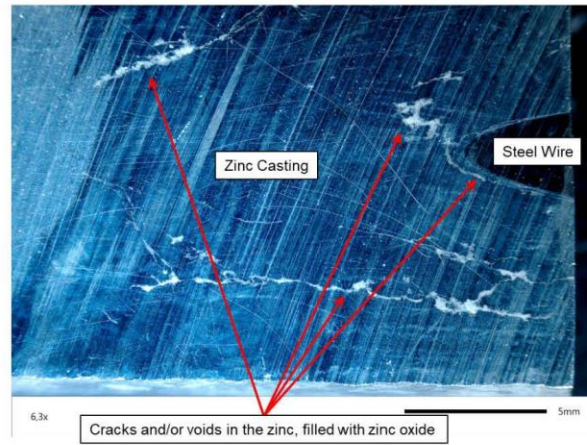
Figure 84. Cracks and voids found during metallography of slice 3c. The cracks do not follow grain boundaries, but do follow the edges of the wires. Also, the cracks and voids are filled with zinc oxide corrosion product.

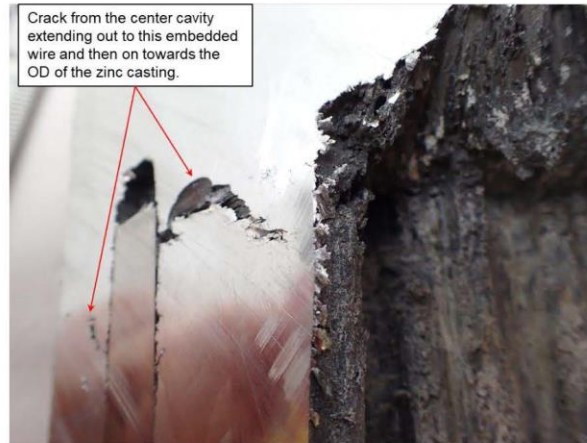
Figure 85. Surface of an additional longitudinal cut made on slice 3a. Cracks from the faceted structure can be seen to extend out from the tops of the wire channels, left from the outer diameter of the cable-end section that pull free of the socket, along the abrasive saw cut surface to an embedded wire. The crack extends past the wire, on a different transverse plane, on towards the outer diameter of the zinc casting.

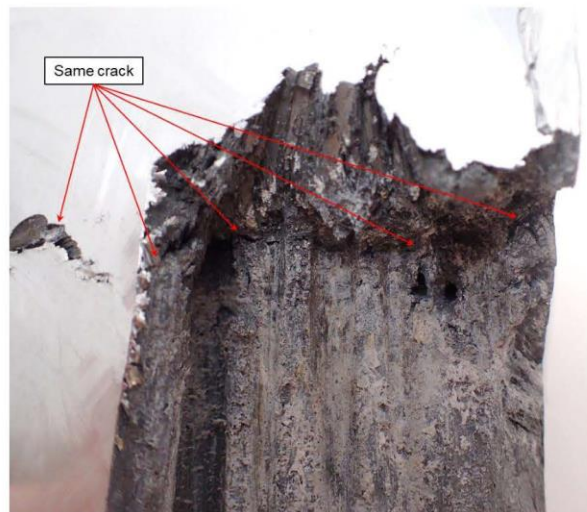
Figure 86. The crack from Figure 85 physically connects with the crack that extends around the cable-end section's interface between the faceted surface and the tops of the wire channels.

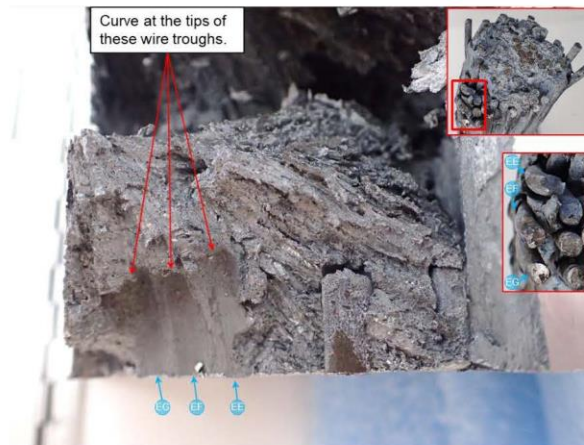
Figure 87. The center lower piece of the socket cavity (the piece closest to the socket base, with one side of the faceted surface feature located on the casting cap side of the piece) has wire channels that bend at where the wire ends were positioned at one time. The wires EE, EF, and EG, that filled those channels are seen in the inset images as-received with the cable-end section.

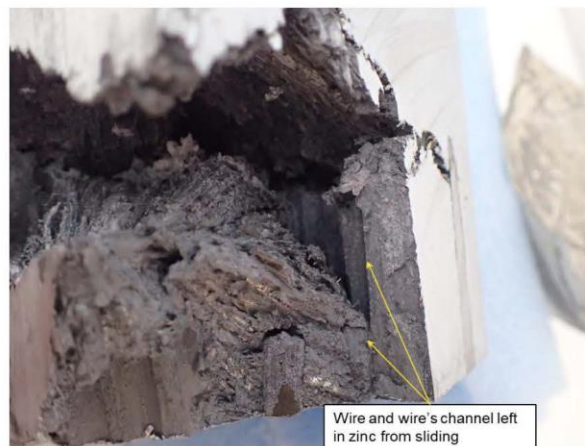
Figure 89. The center lower piece of the socket cavity has still embedded wires, with little to no gap between the top of the wire and the surrounding zinc, that have traveled an inch or more down their original wire channels towards the socket base at some point in time after solidification of the zinc casting. Wire AB and its channel are identified with arrows here.

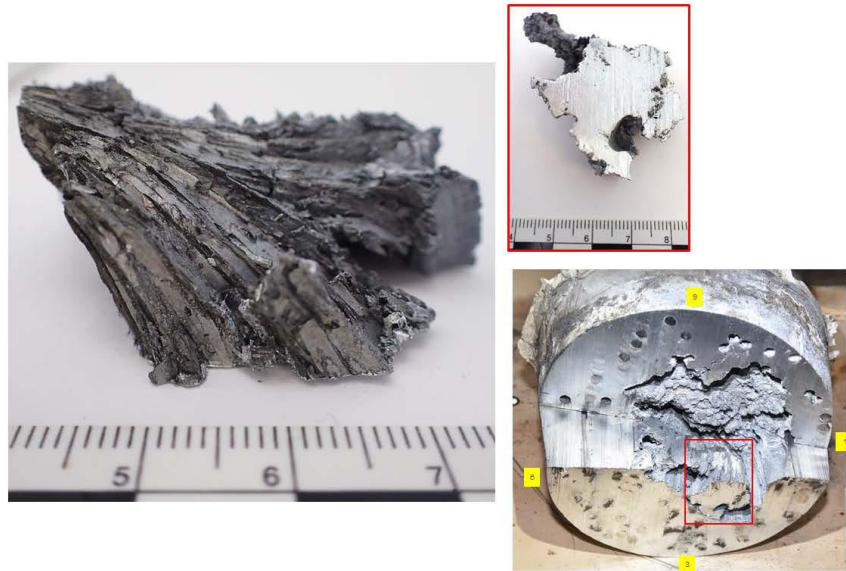
Figure 90. A small piece of the center lower piece of the socket cavity was broken off, labeled piece 3-1, and examined more closely.

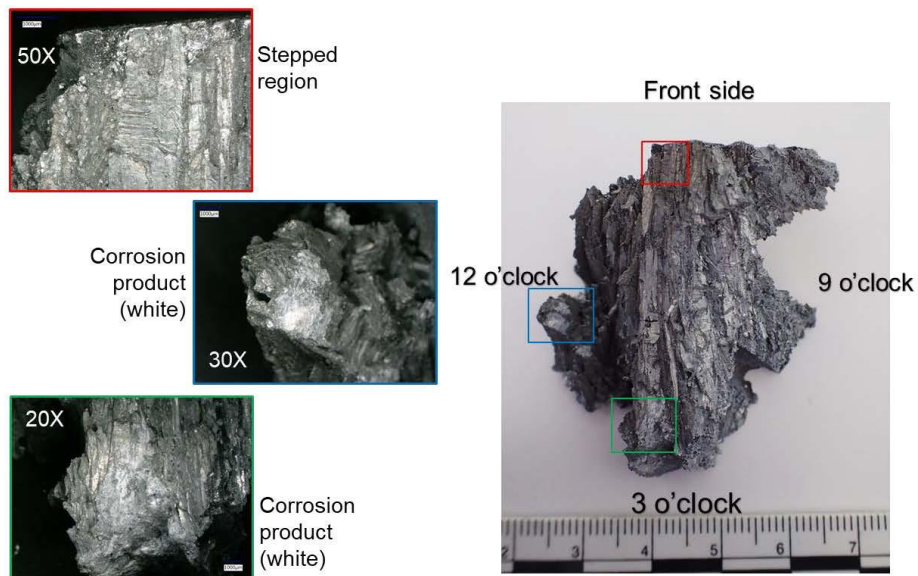
Figure 91. Examining the faceted surface on the casting cap side of Piece 3-1 by stereomicroscopy, revealed a stepped region, characteristic of zinc brittle fracture, along with lots of white corrosion product, most probably zinc oxide.

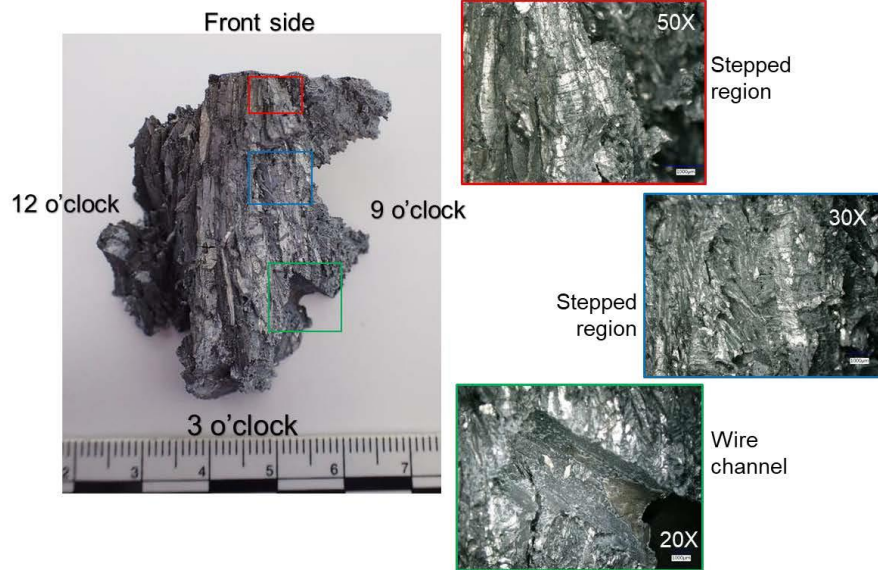
Figure 92. Additional stereomicroscope images of the faceted surface of Piece 3-1, identifying more stepped regions, characteristic of zinc brittle fracture.

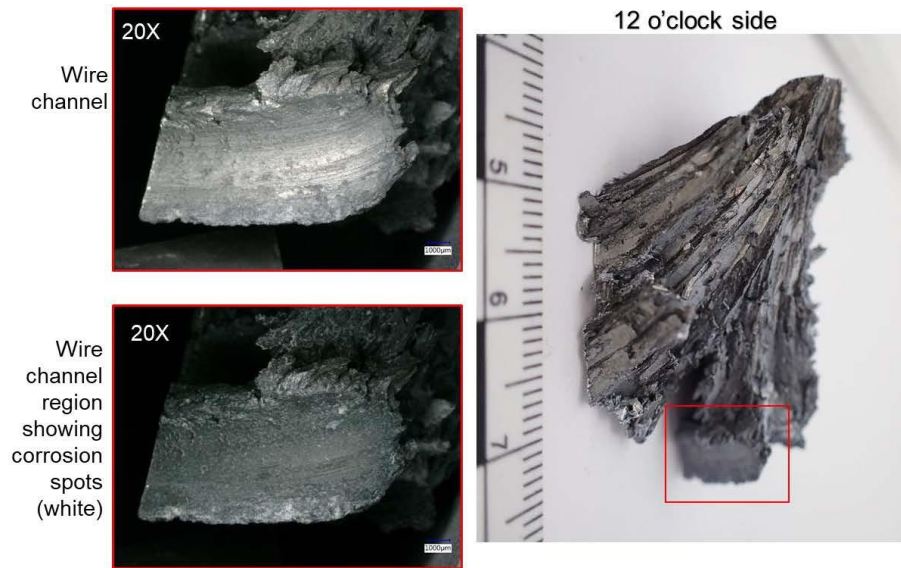
Figure 93. A wire channel located on Piece 3-1 in both bright field and dark field illumination, showing the presence of white corrosion product along the wire channel.

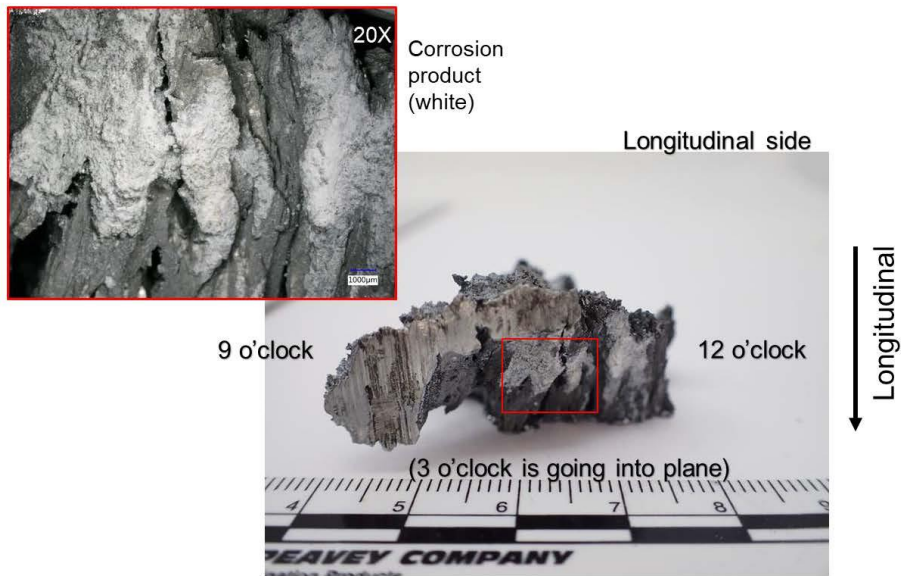
Figure 94. A location on Piece 3-1 with heavy white corrosion, likely zinc oxide. Scale in centimeters.

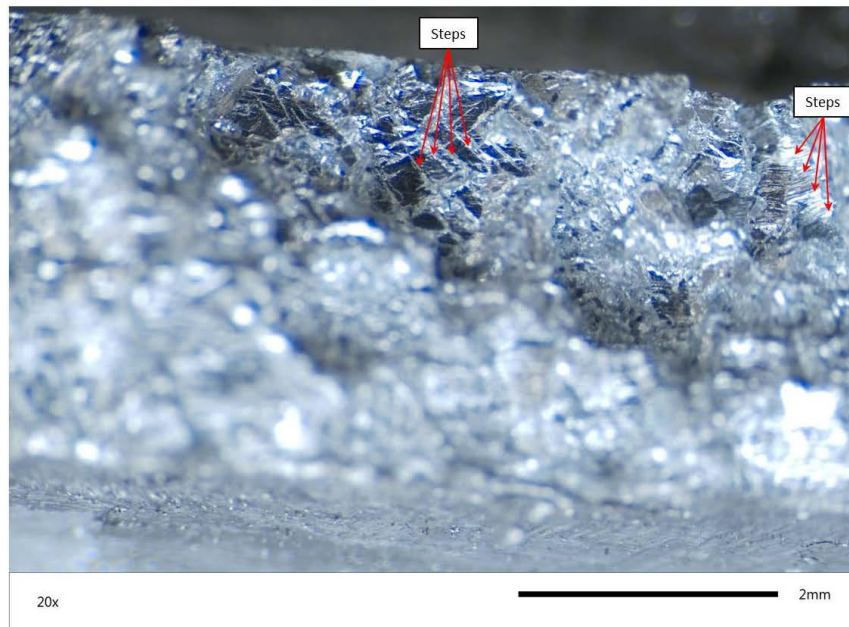
Figure 95. An exemplar that was made by applying a bending force at wire AE. The force was a non-cyclical overload force. The characteristic brittle zinc fracture surface exhibits similar stepped region features as seen on the faceted surface in Figures 91 and 92.

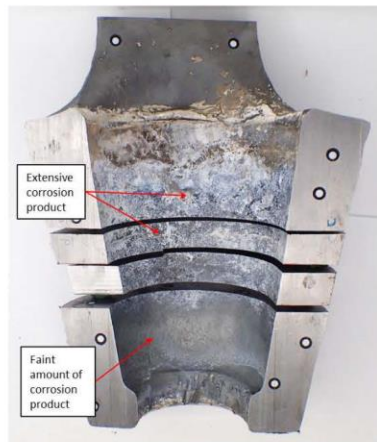
Figure 96. 3 o'clock side of the inner diameter socket wall, showing the surface behind the outer diameter of the zinc casting.

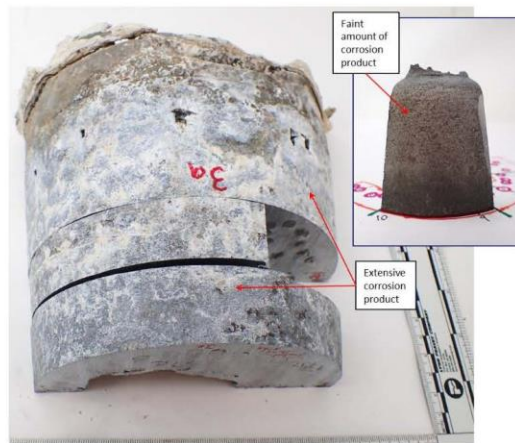
Figure 98. Outer diameter of the 3 o'clock side of the zinc casting (slices 3a, 3c, and 3e). Inset is the outer diameter from a piece of the zinc casting removed from 9g, between 9 and 10 o'clock.

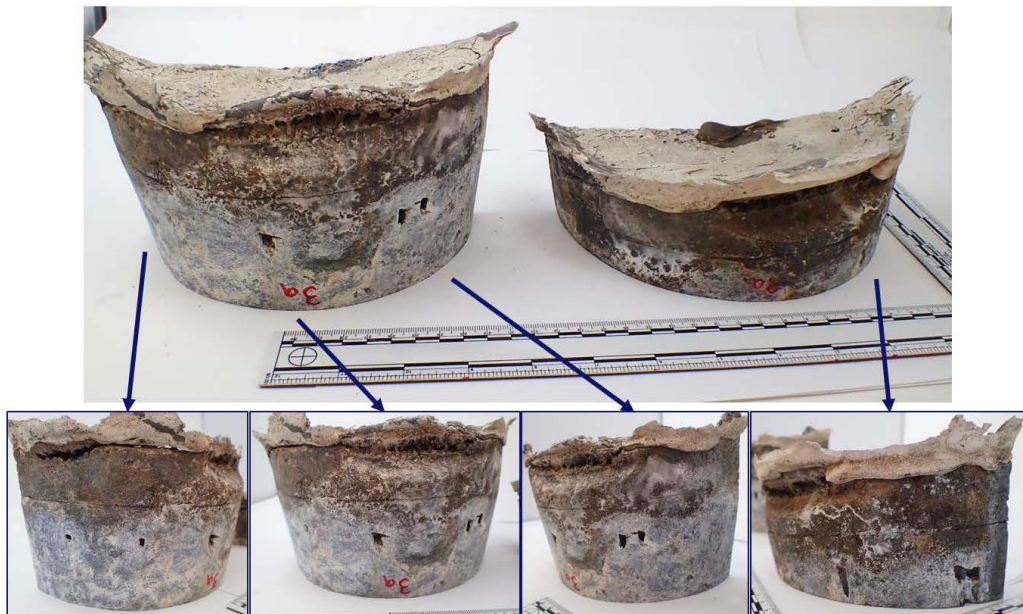
Figure 99. 8 wire holes left by wires that were broomed out and touching the inner socket wall at one time, before being displaced from their original positions towards the socket base. All 8 wires remained embedded in the zinc casting, failing within the socket. Scale in inches and centimeters.

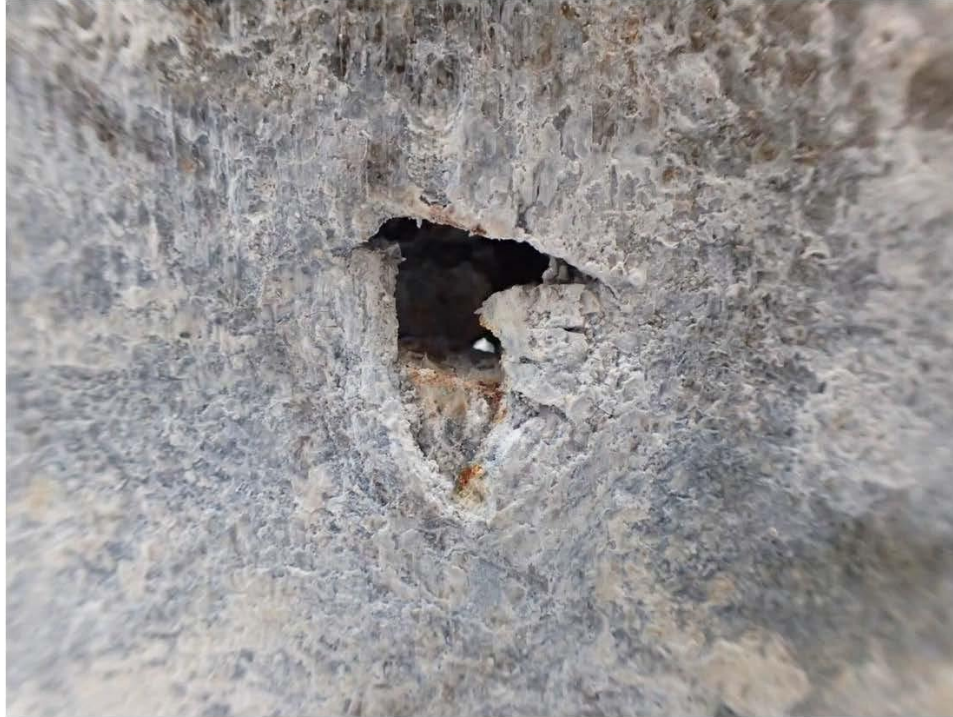
Figure 100. Heavy corrosion around one of the wire holes that breached the zinc casting outer diameter. The bright light in the center of the hole is light coming from the center of the socket cavity.

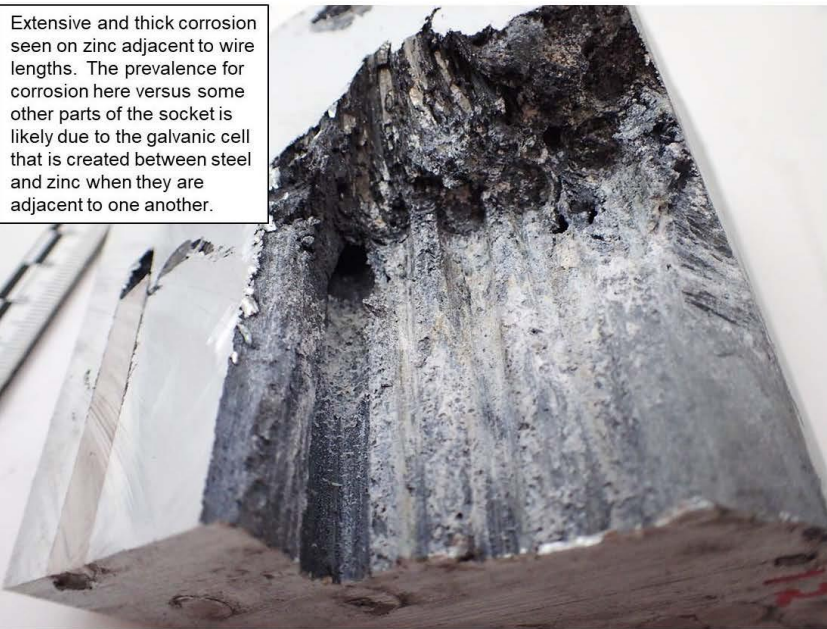
Figure 101. Extensive and relatively thick corrosion on the zinc casting wire channels.

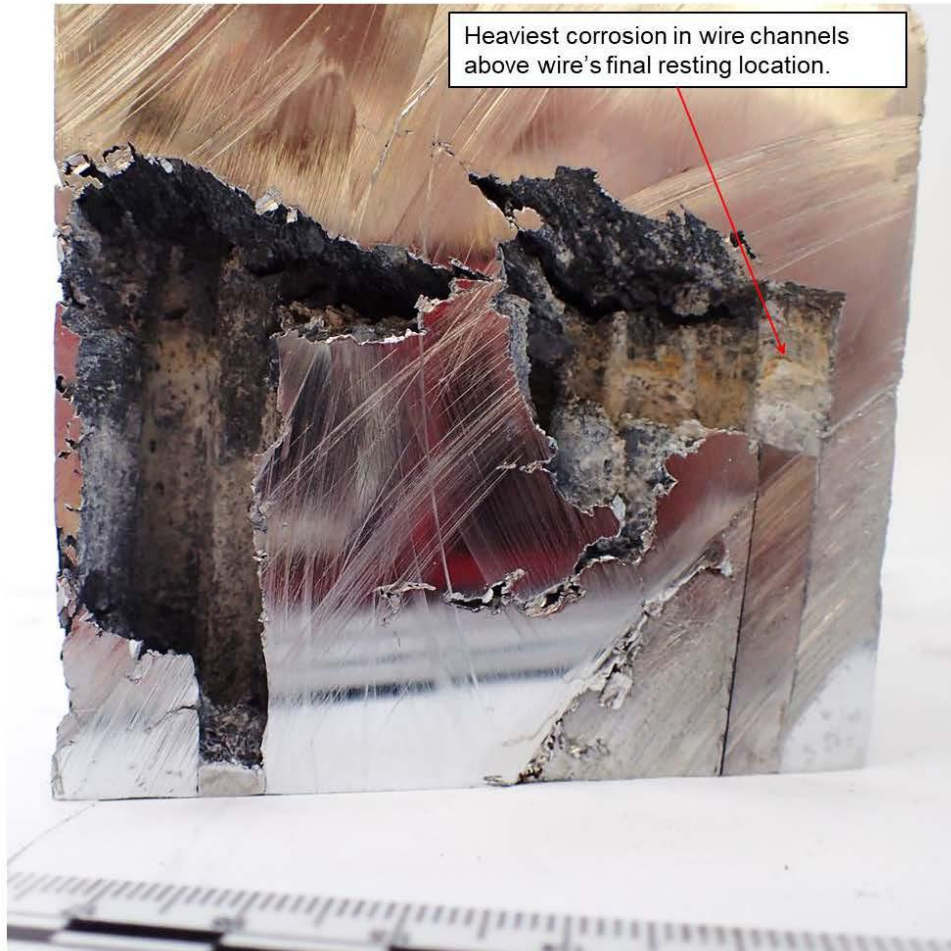
Figure 102. Relatively large volumes of corrosion were visible in the wire channels above the wires (the wire channel for Wire AN is pointed to here).

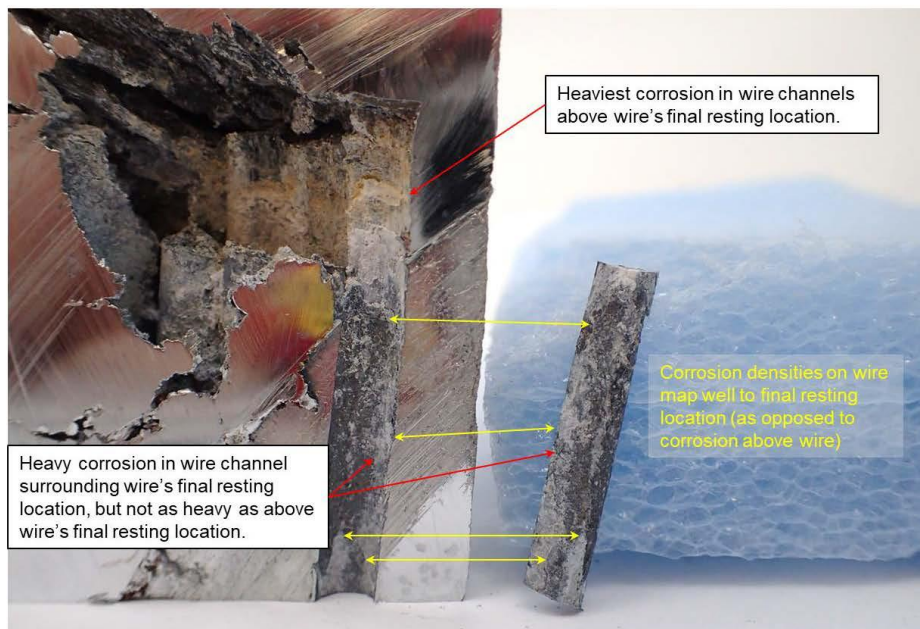
Figure 103. One of the embedded wires (wire AN) was removed from the wire channel. Behind the wire was a heavy amount of corrosion, but not as great as the quantity of corrosion above the wire, along its wire channel. The corrosion densities on the wire surface mapped well to the mating wire channel surfaces.

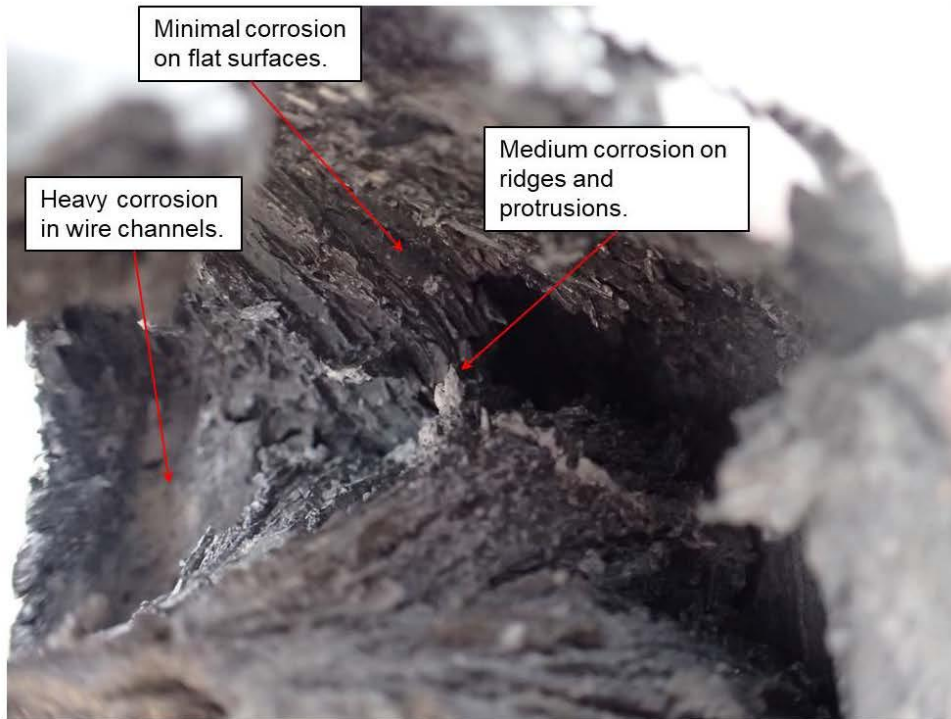
Figure 104. Image of the brittle fracture surface within the socket cavity, showing varying amounts of corrosion build up on different surfaces. The largest amounts of corrosion were seen along the wire channels. Along the faceted surface, the most corrosion build up was on ridges and protrusions, while the flat surfaces exhibited a dull gray appearance, having only a relatively light amount of corrosion.

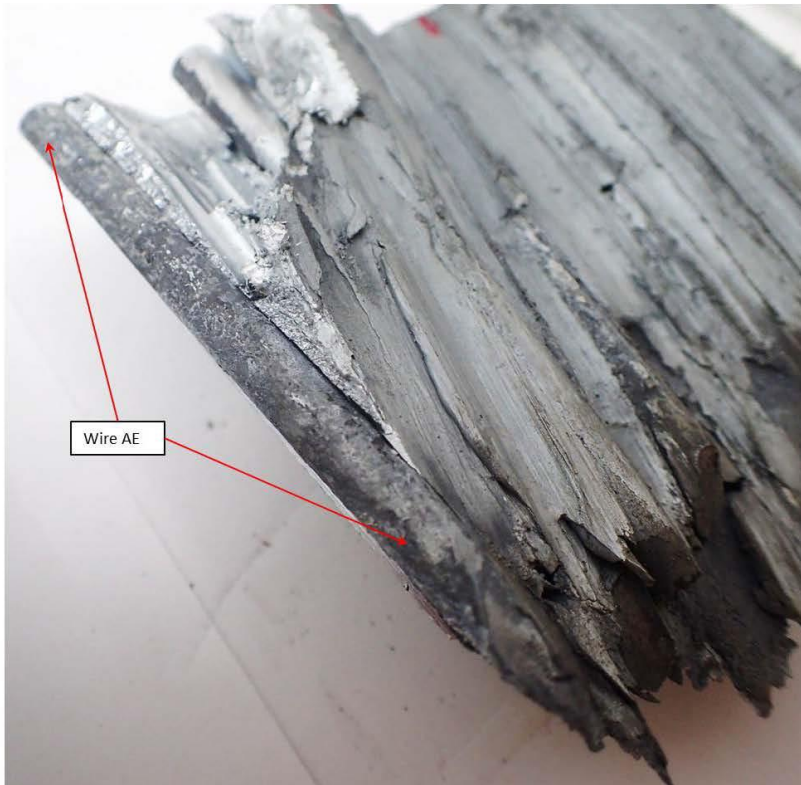
Figure 105. Wire AE, mechanically removed, showed a similar quantity of corrosion along the length of wire embedded in slice 3g as seen on wire AN in Figure 103.

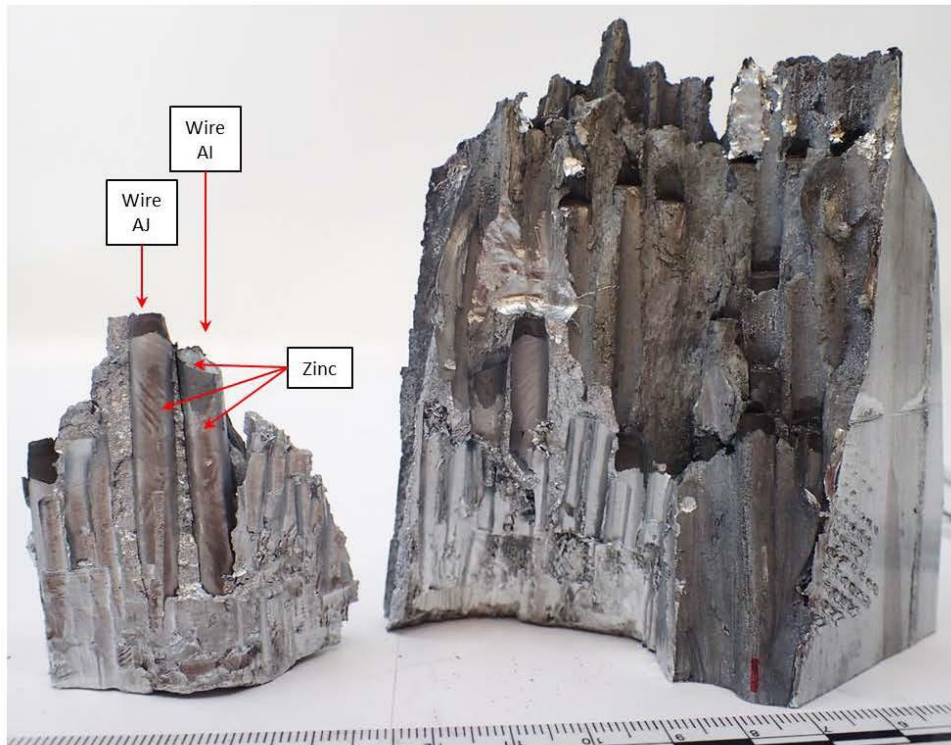
Figure 106. Wires AI and AJ both have visibly good adhesion of zinc along their wire surfaces that were embedded in slice 3g. Note that the thin layer of zinc on wire AI continues from the wire outer diameter surface onto the shear fracture surface. Scale in centimeters.

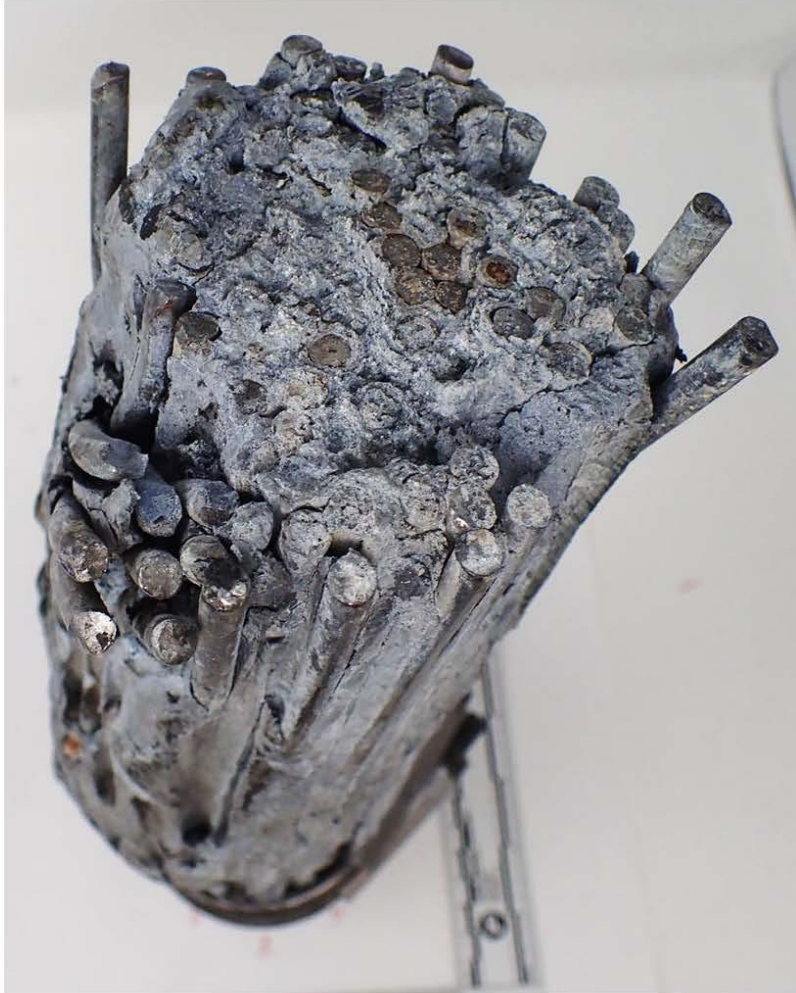
Figure 150. Top of the as-received cable-end section, which would have been the end of the cable embedded in the socket, prior to failure. The top of the image roughly corresponds with 12 o'clock, and 9 o'clock on the right-side of the image.
