NASA/TM-20210017934
NESC-RP-20-01585

Arecibo Observatory Auxiliary M4N Socket Termination Failure Investigation

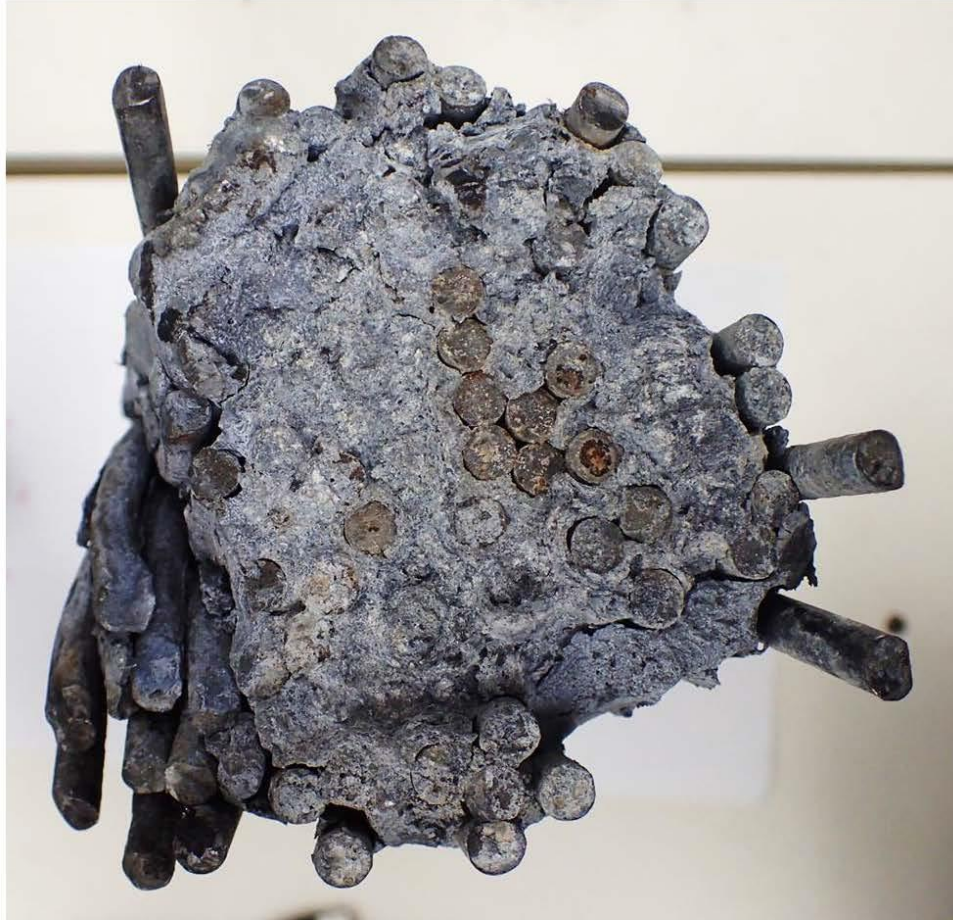
Figure 151. Top of the as-received cable-end section. The top of the image roughly corresponds with 12 o'clock, and 9 o'clock on the right-side of the image.

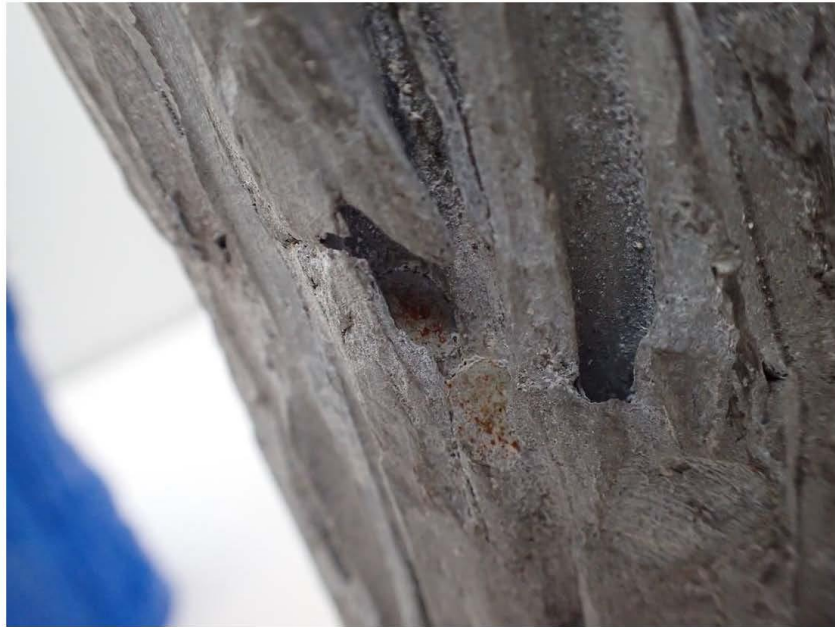
Figure 154. Close up view of a couple wire fractures on the 12 o'clock side of the cable-end section.

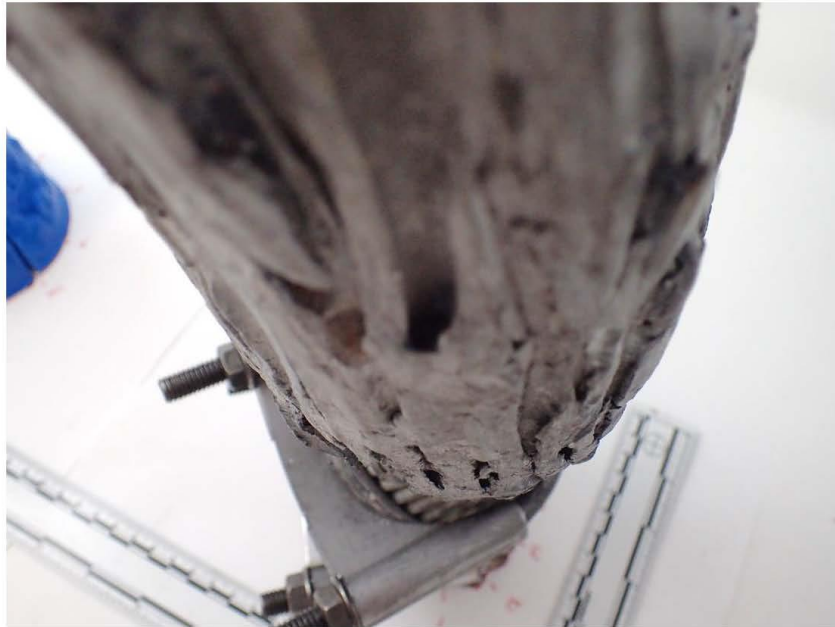
Figure 155. View looking down the 12 o'clock side of the cable-end section, towards the Feed Platform end.
Scale in inches and centimeters.

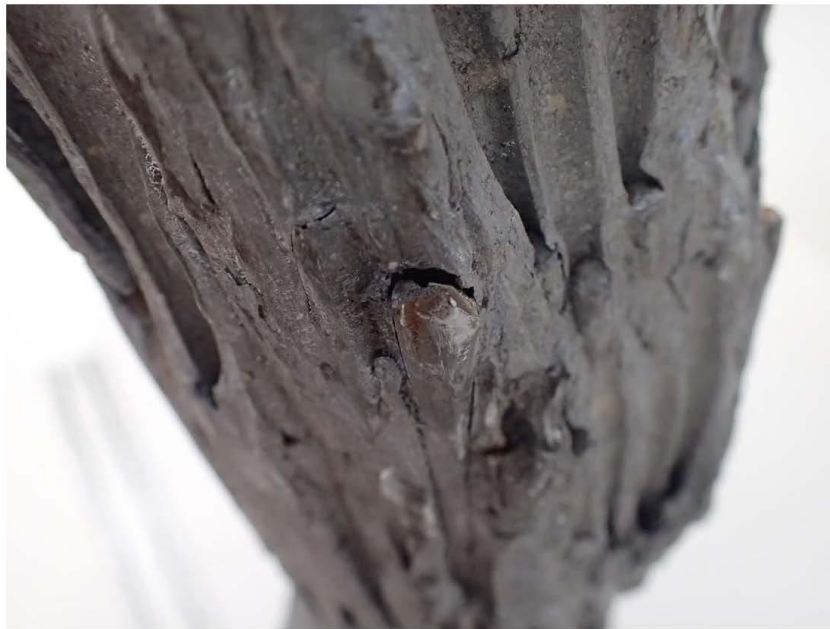
Figure 156. Close up view of a wire fracture on the 2 o'clock side of the cable-end section.

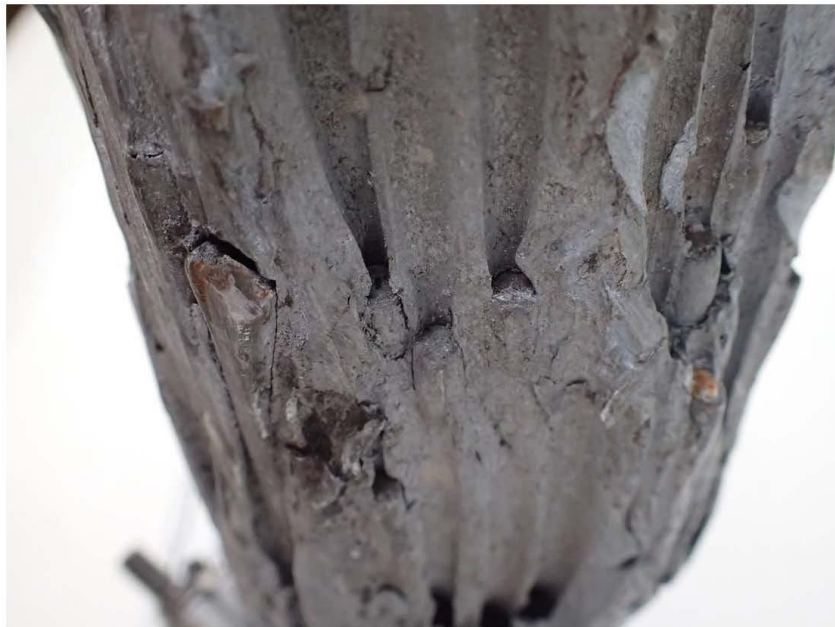
Figure 157. Close up view of wire fractures on the 3 o'clock side of the cable-end section.

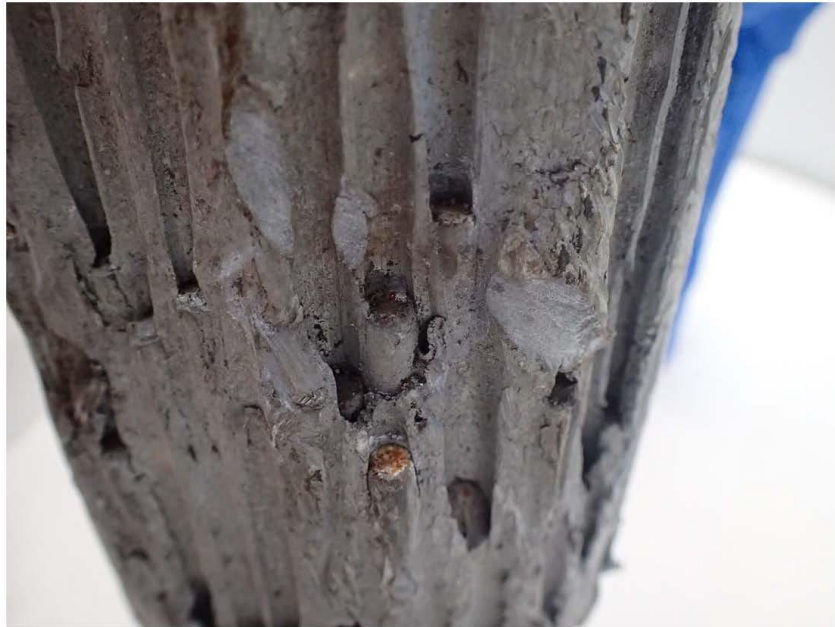
Figure 158. Close up view of wire fractures on the 4 o'clock side of the cable-end section.

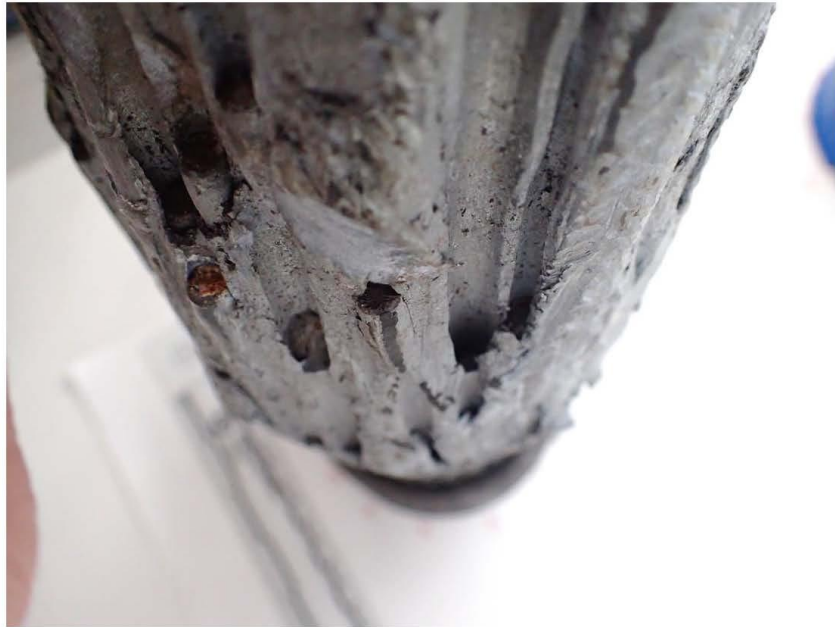
Figure 159. Close up view of wire fractures on the 5 o'clock side of the cable-end section.

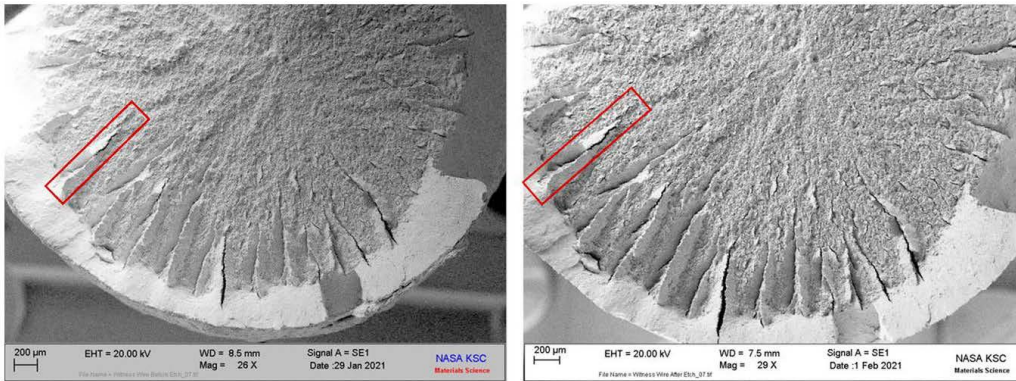
Figure 160. SEM images of the cathodic protection test specimen examined before (left) and after (right) HCl acid immersion. Note the magnifications are slightly different in these two images: 26x on the left and 29x on the right. The red boxes identify a matching feature in both images as an aid for comparing the images.

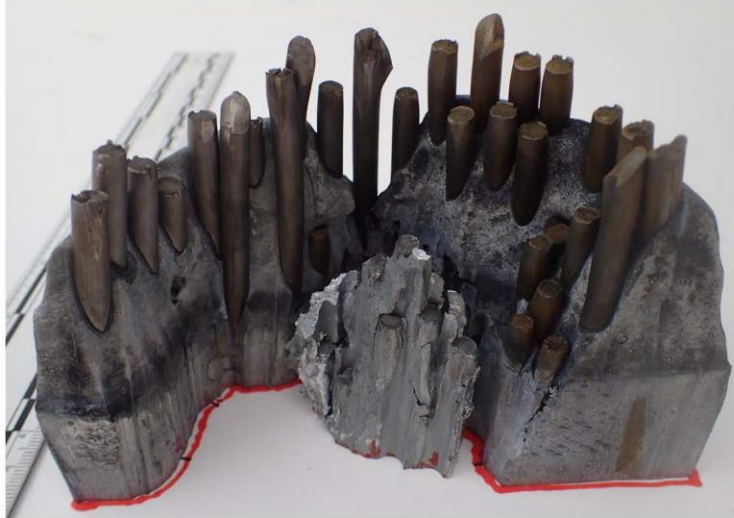
Figure 167. HCl acid wire fracture reveal on slice 3g. Note that the wire oxidation is from flash rusting between removal from the acid bath, cleaning, and then drying. For comparison, the small piece in the center front was mechanically removed, rather than being partially immersed in the acid like the remaining sections.

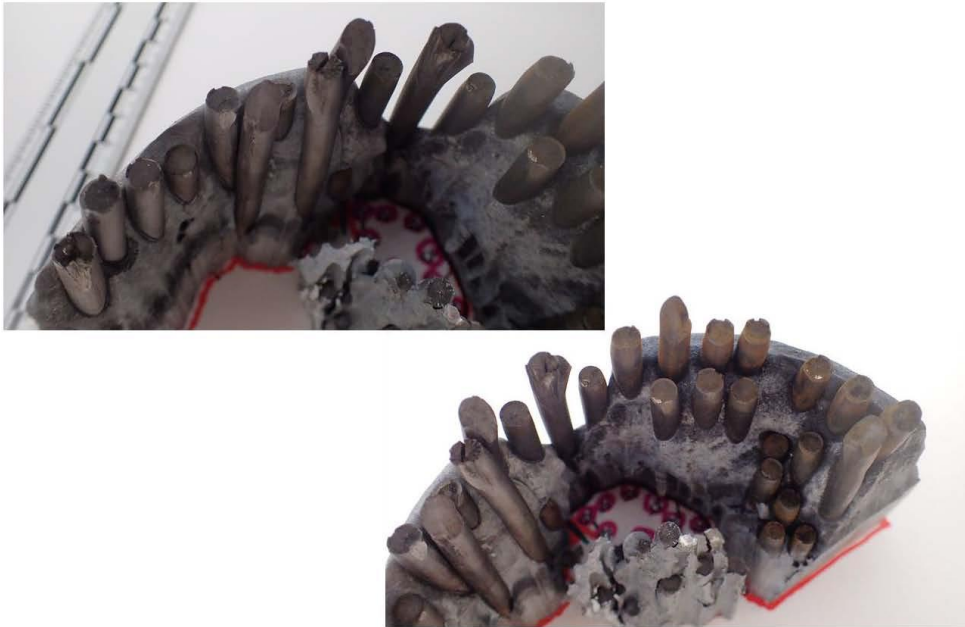
Figure 168. HCl acid wire fracture reveal on slice 3g.

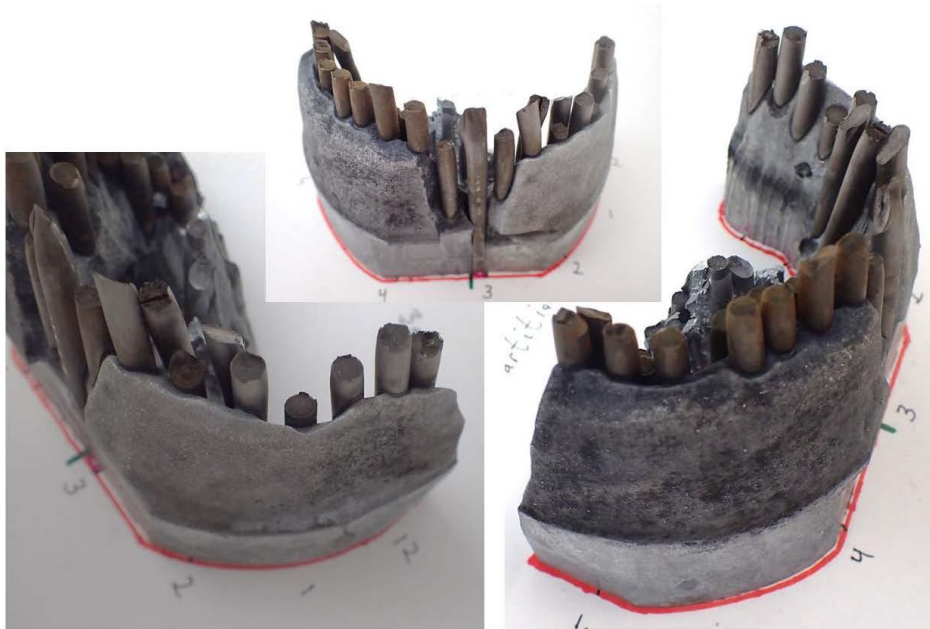
Figure 169. HCl acid wire fracture reveal on slice 3g.

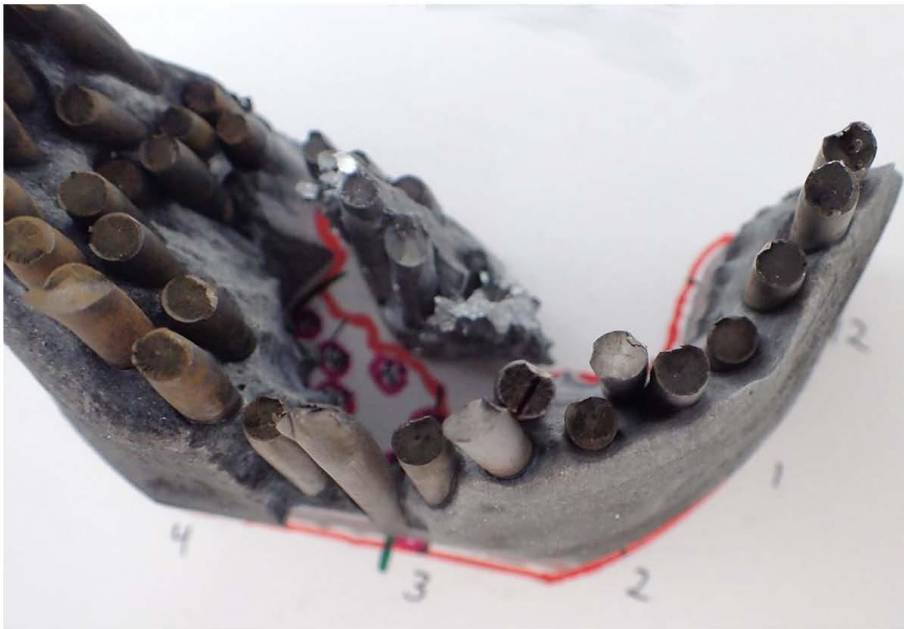
Figure 170. HCl acid wire fracture reveal on slice 3g.

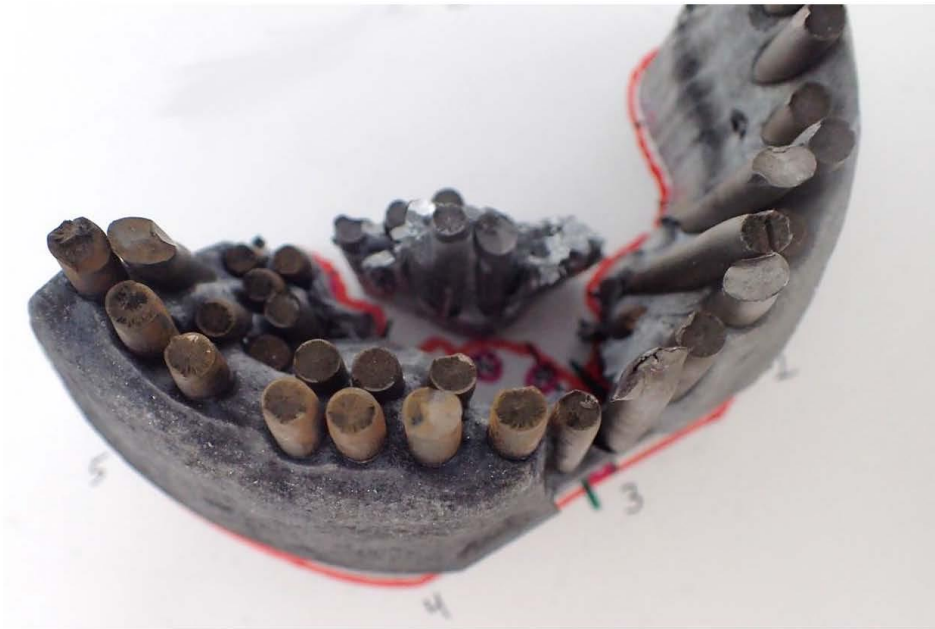
Figure 171. HCl acid wire fracture reveal on slice 3g.

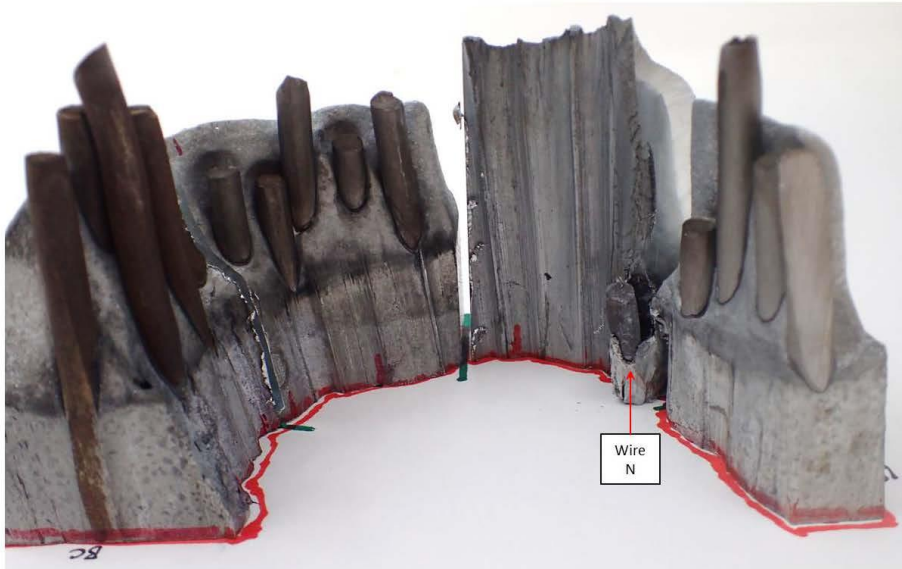
Figure 172. HCl acid wire fracture reveal on slice 9g. Note that the 9-10 o'clock piece was not acid etched and the one wire within that piece, wire N, was mechanically removed.

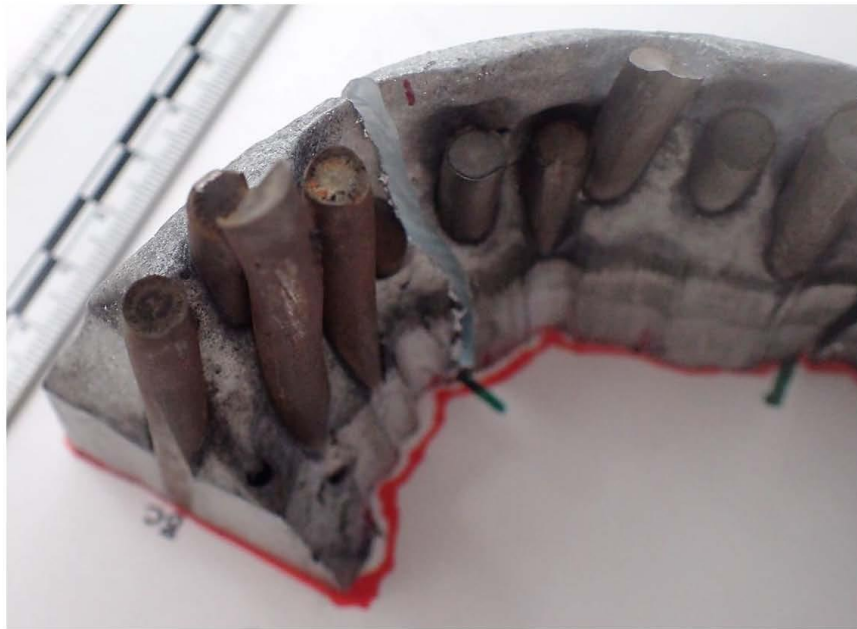
Figure 173. HCl acid wire fracture reveal on slice 9g.

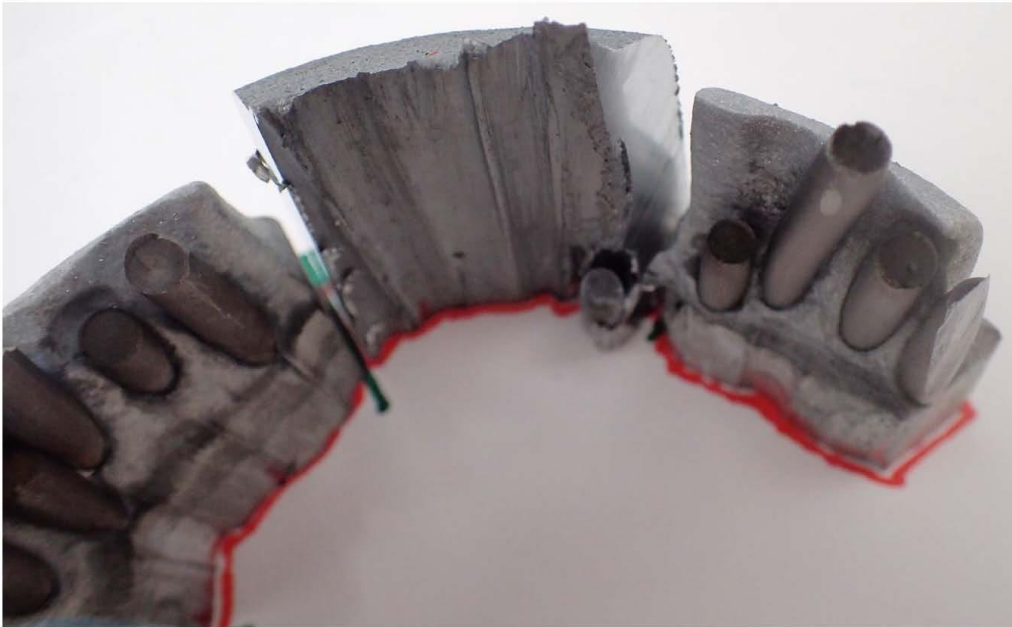
Figure 174. HCl acid wire fracture reveal on slice 9g.

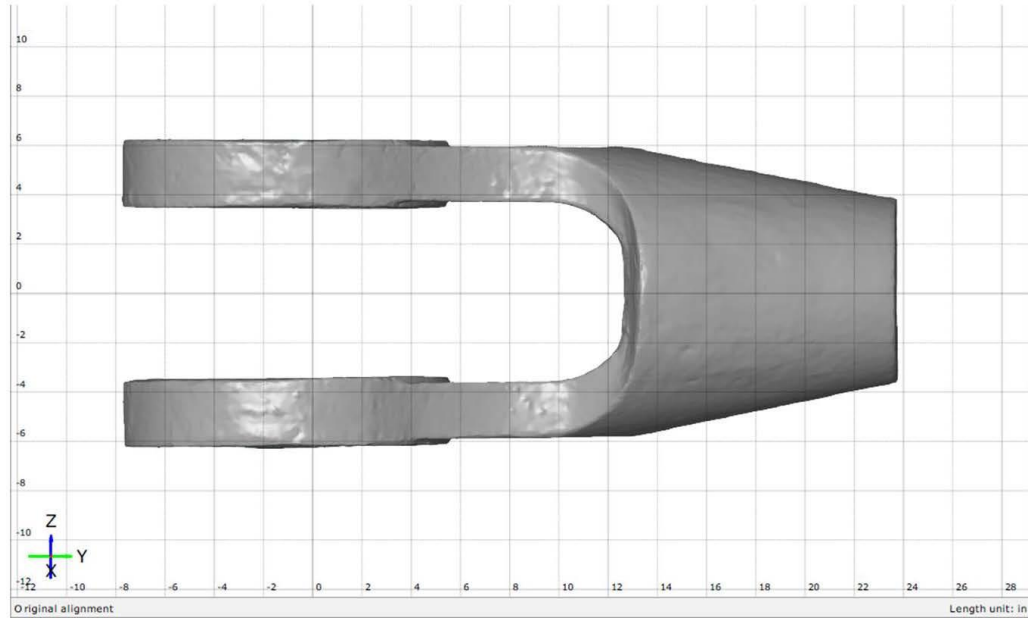
Figure 175. Laser scan of the as-received M4N socket, top view.

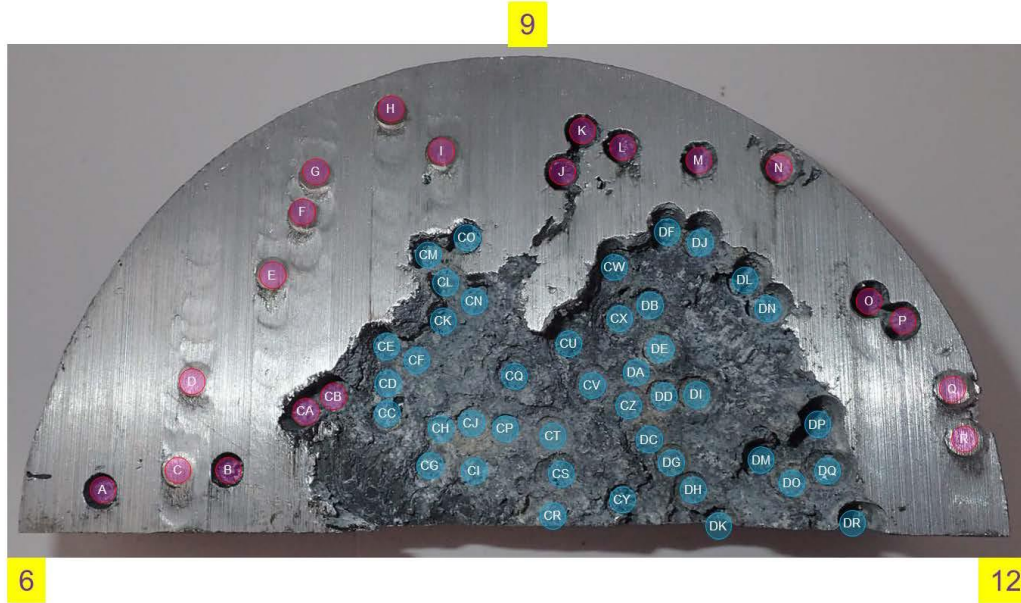
Figure 189. Wire map of the socket base side of slice 9a. Pink wire labels are wires that fractured within the socket and blue wire labels are wires that remained intact.

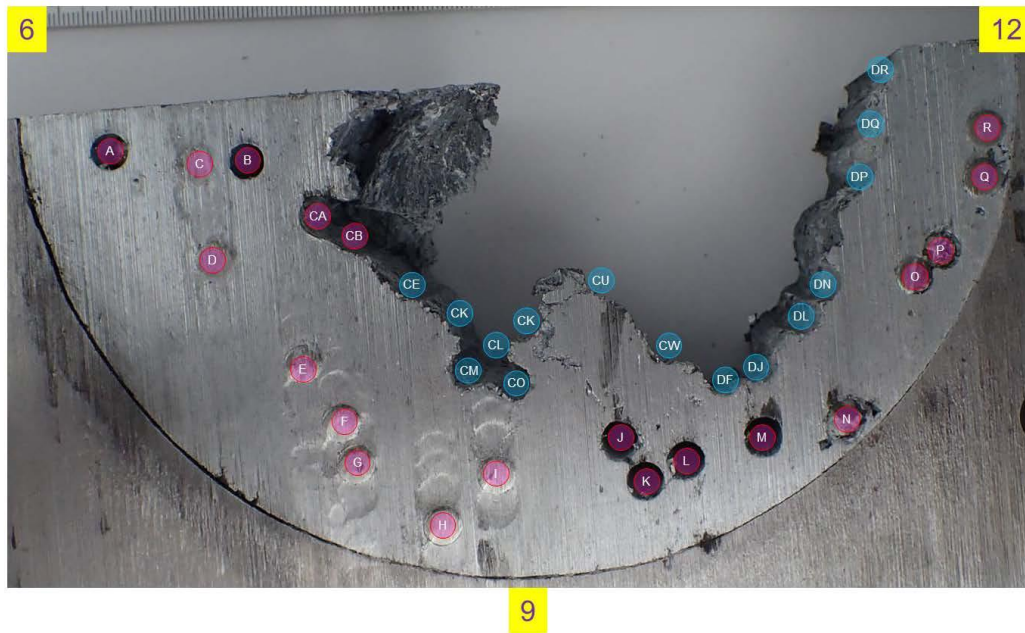
Figure 190. Wire map of the casting cap side of slice 9c. Pink wire labels are wires that fractured within the socket and blue wire labels are wires that remained intact.

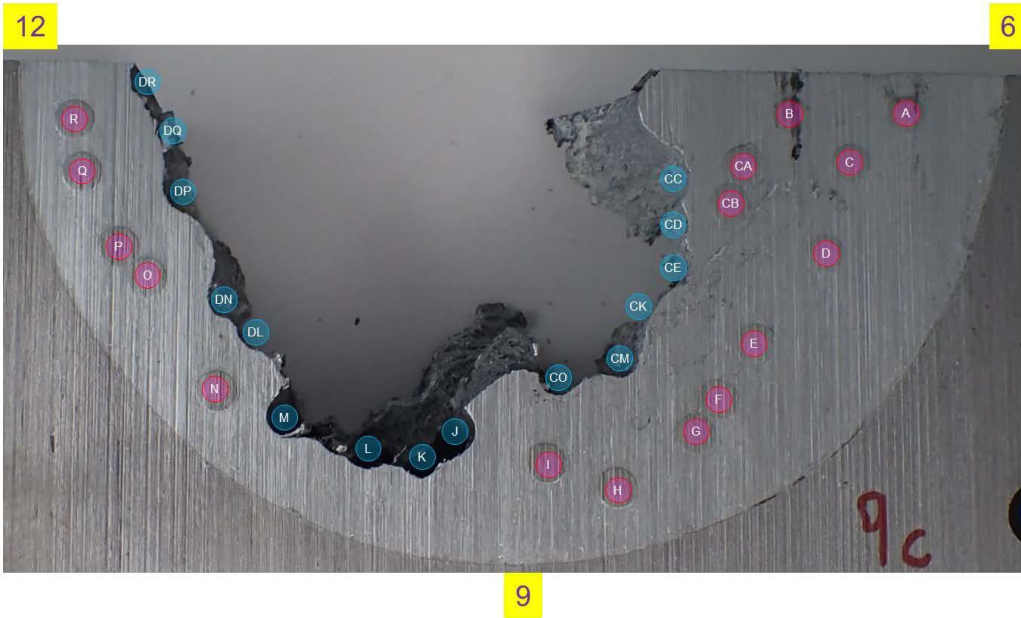
Figure 191. Wire map of the socket base side of slice 9c. Pink wire labels are wires that fractured within the socket and blue wire labels are wires that remained intact.

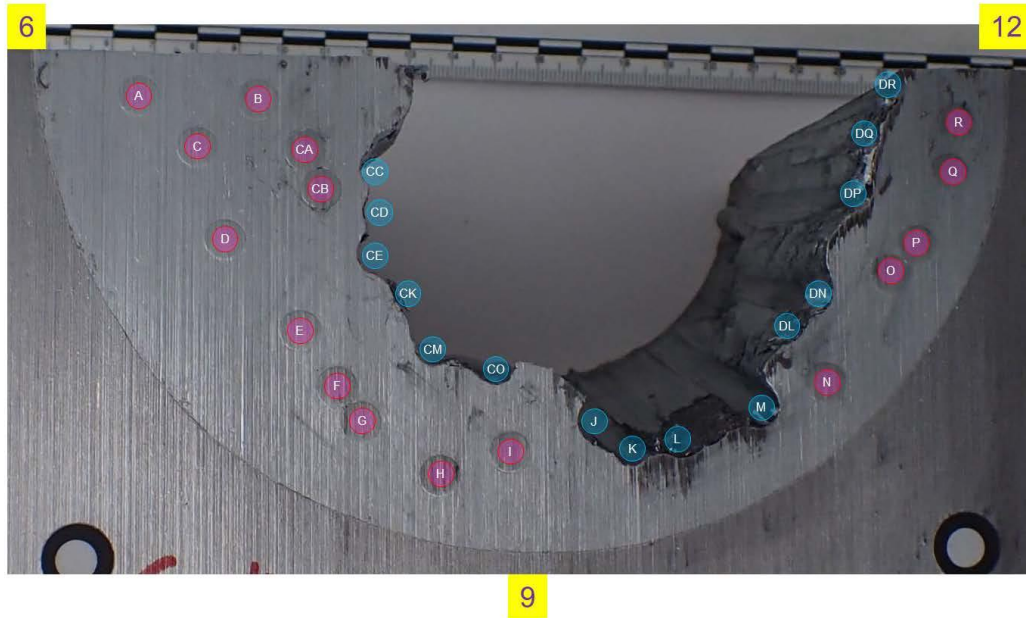
Figure 192. Wire map of the casting cap side of slice 9e. Pink wire labels are wires that fractured within the socket and blue wire labels are wires that remained intact.

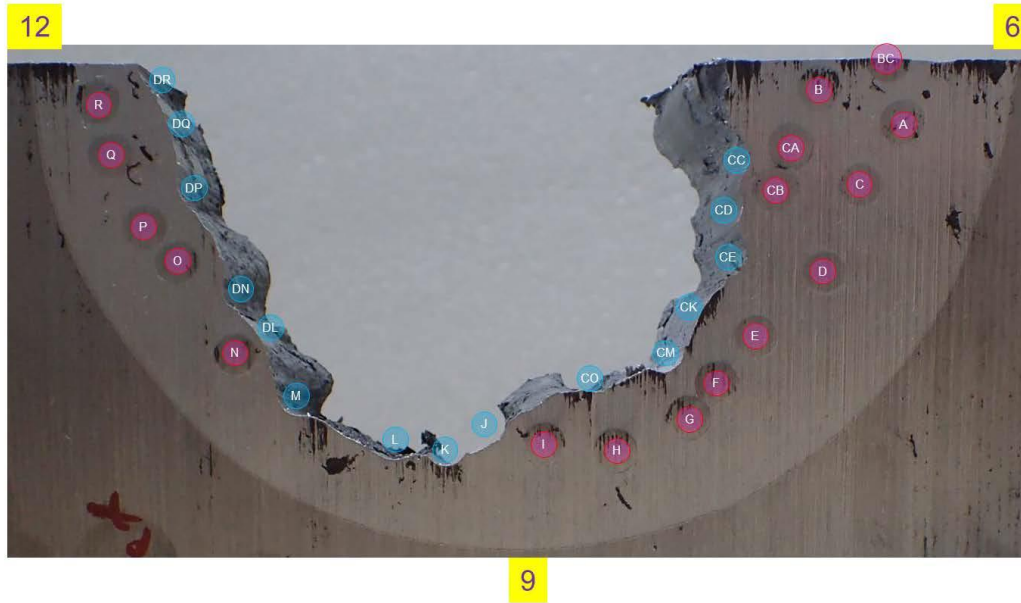
Figure 193. Wire map of the socket base side of slice 9e. Pink wire labels are wires that fractured within the socket and blue wire labels are wires that remained intact.

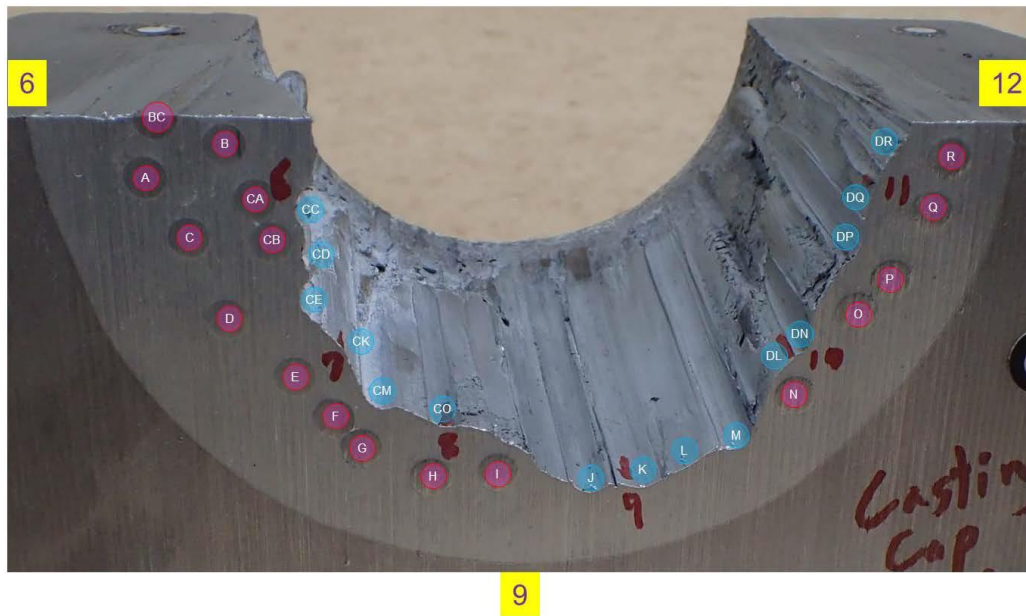
Figure 194. Wire map of the casting cap side of slice 9g. Pink wire labels are wires that fractured within the socket and blue wire labels are wires that remained intact.

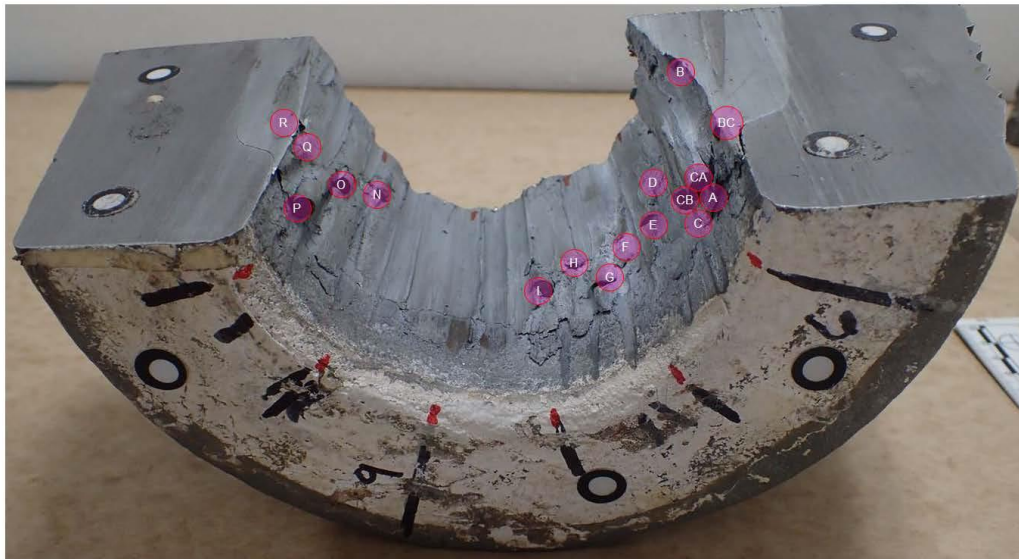
Figure 195. Wire map of the socket base side of slice 9g. Pink wire labels are wires that fractured within the socket.

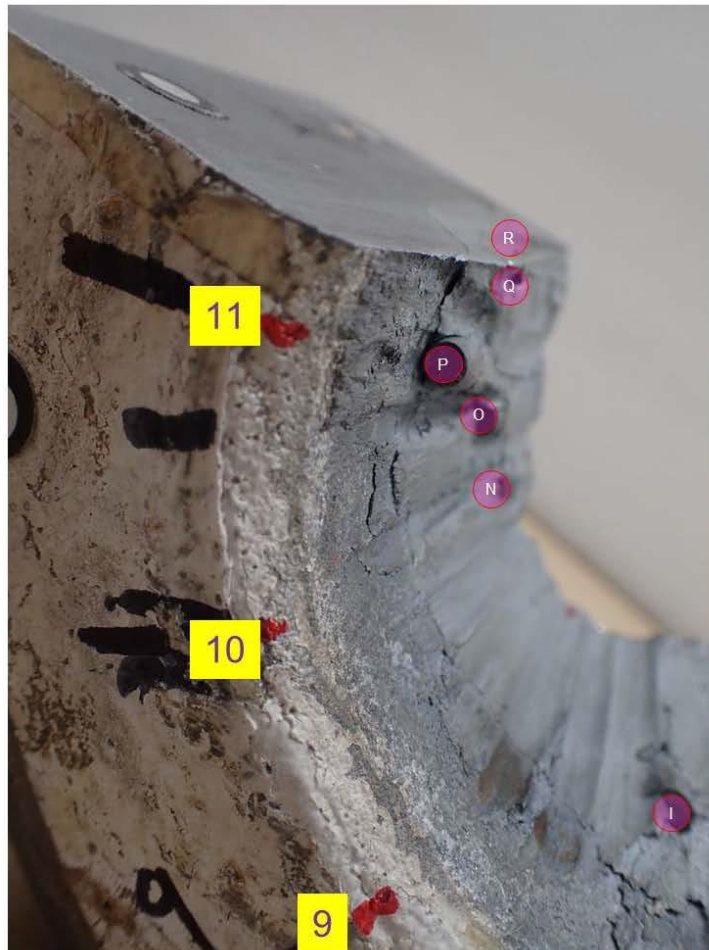
Figure 196. Wire map of the socket base side of slice 9g, from 9 o'clock to 11 o'clock. Pink wire labels are wires that fractured within the socket.

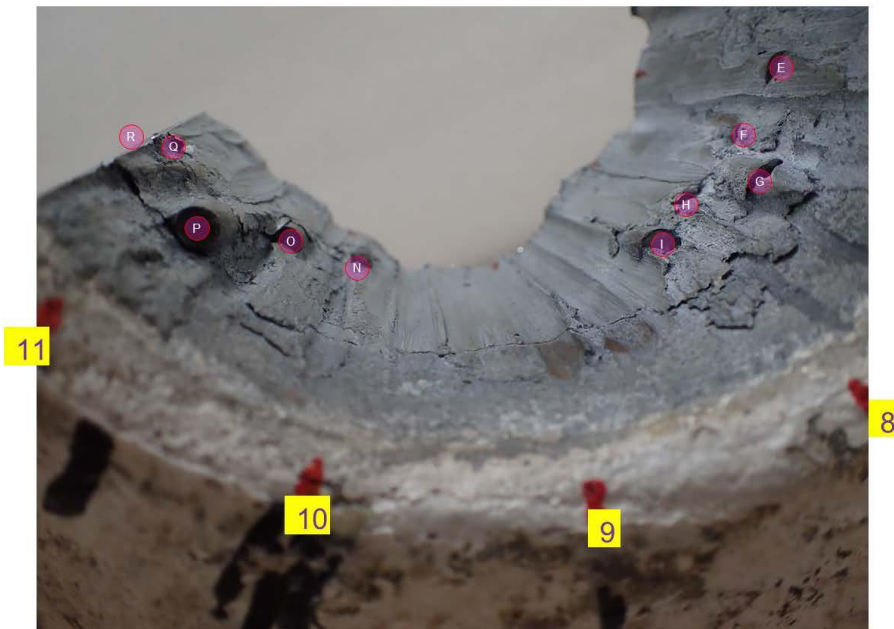
Figure 197. Wire map of the socket base side of slice 9g, from 8 o'clock to 11 o'clock. Pink wire labels are wires that fractured within the socket.

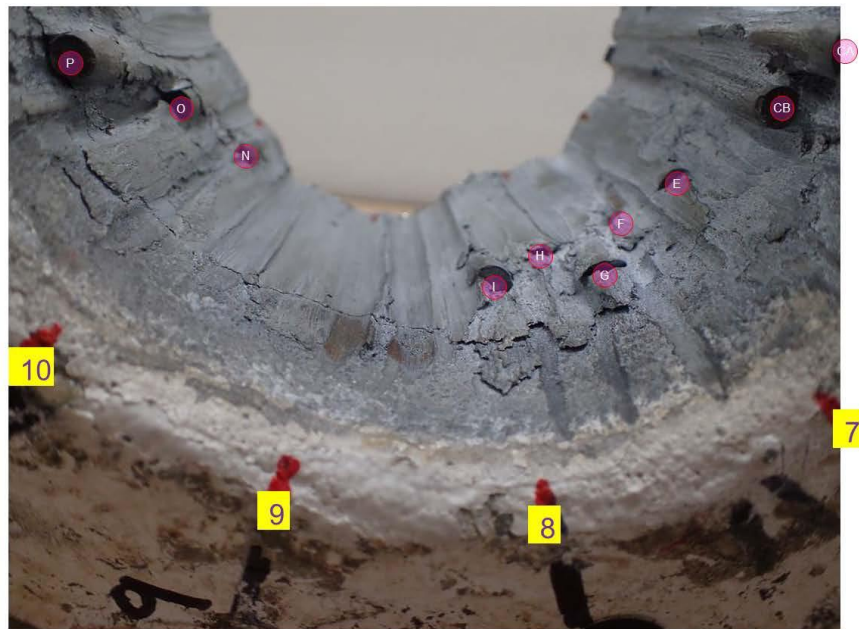
Figure 198. Wire map of the socket base side of slice 9g, from 7 o'clock to 10 o'clock. Pink wire labels are wires that fractured within the socket.

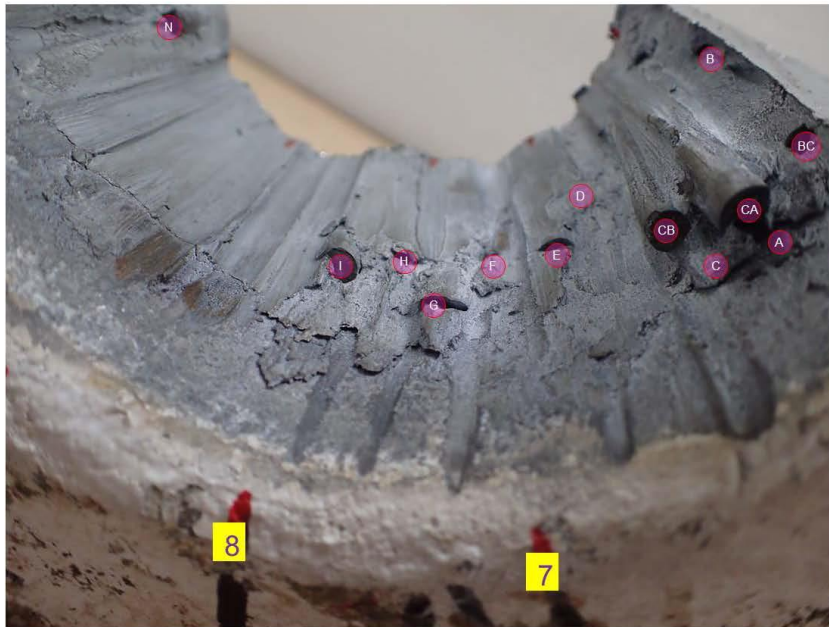
Figure 199. Wire map of the socket base side of slice 9g, from 7 o'clock to 8 o'clock. Pink wire labels are wires that fractured within the socket.

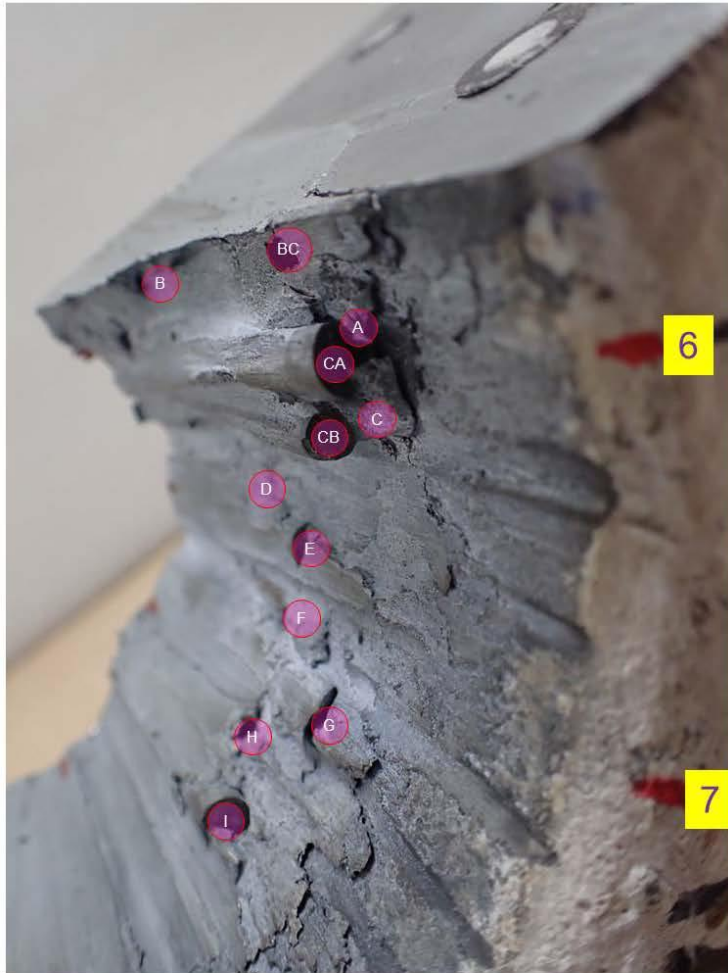
Figure 200. Wire map of the socket base side of slice 9g, from 6 o'clock to 7 o'clock. Pink wire labels are wires that fractured within the socket.

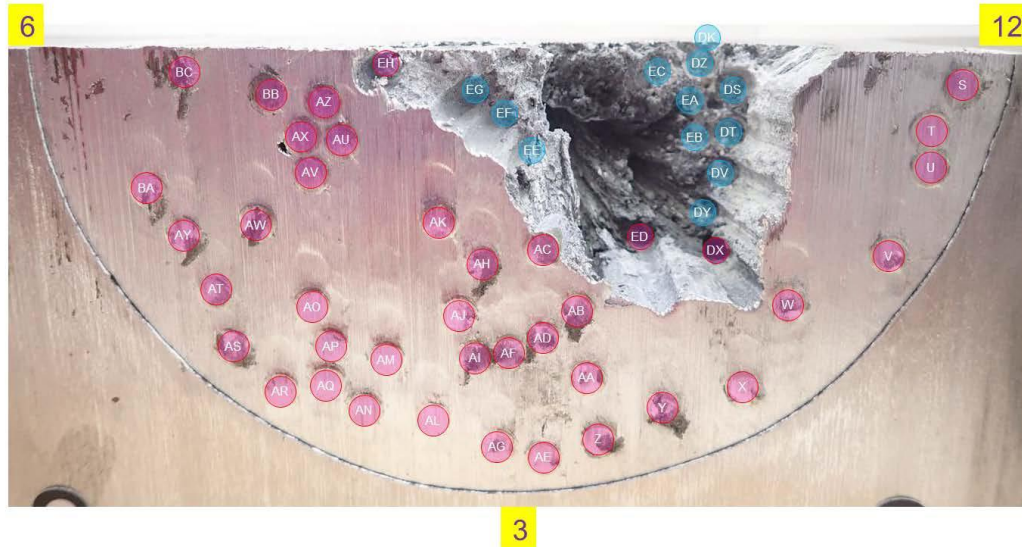
Figure 201. Wire map of the socket base side of slice 3a. Pink wire labels are wires that fractured within the socket and blue wire labels are wires that remained intact.

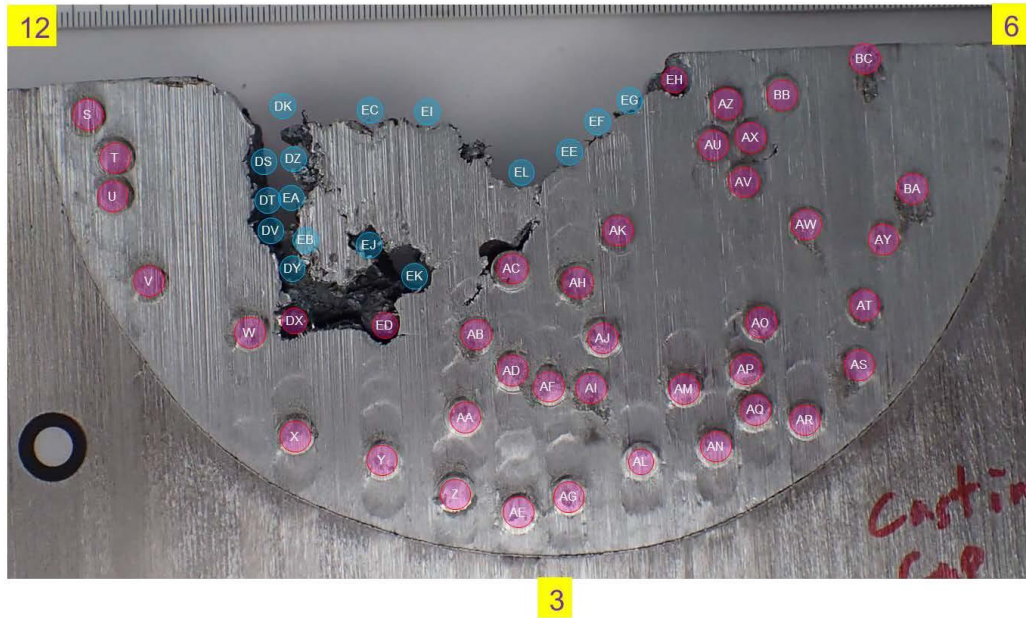
Figure 202. Wire map of the casting cap side of slice 3c. Pink wire labels are wires that fractured within the socket and blue wire labels are wires that remained intact.

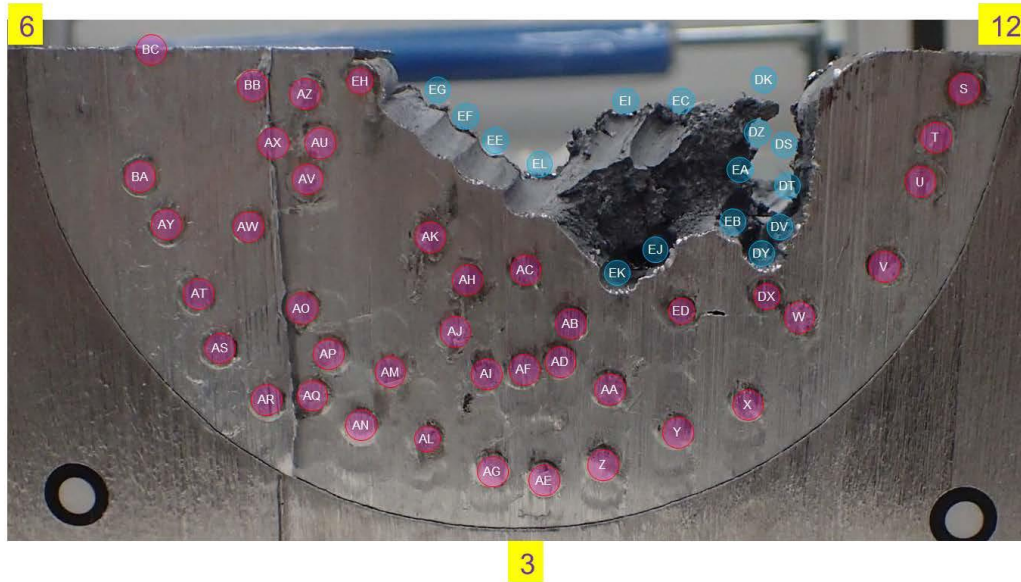
Figure 203. Wire map of the socket base side of slice 3c. Pink wire labels are wires that fractured within the socket and blue wire labels are wires that remained intact.

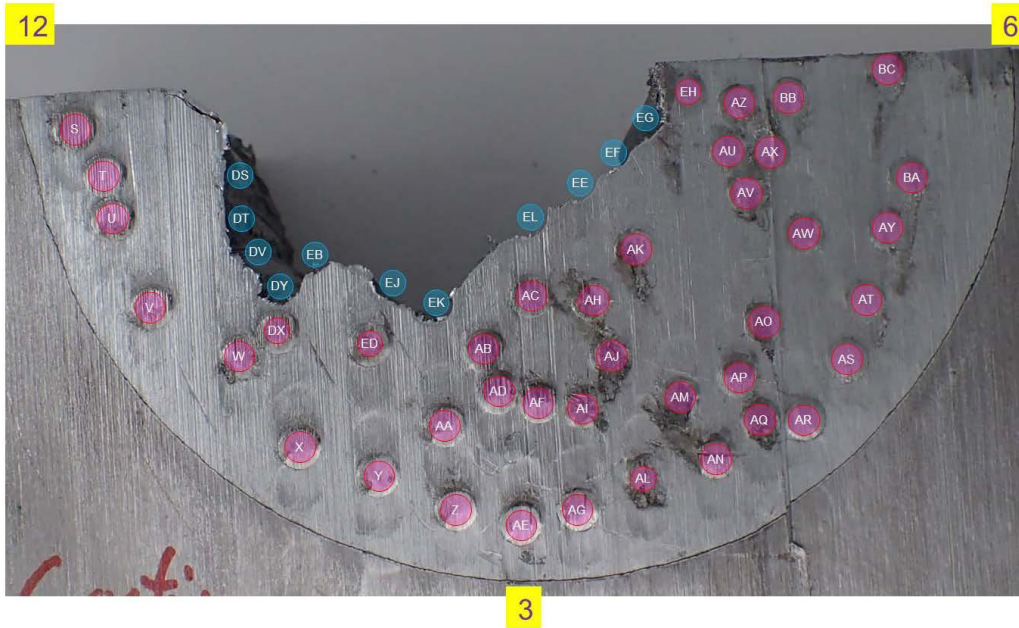
Figure 204. Wire map of the casting cap side of slice 3e. Pink wire labels are wires that fractured within the socket and blue wire labels are wires that remained intact.

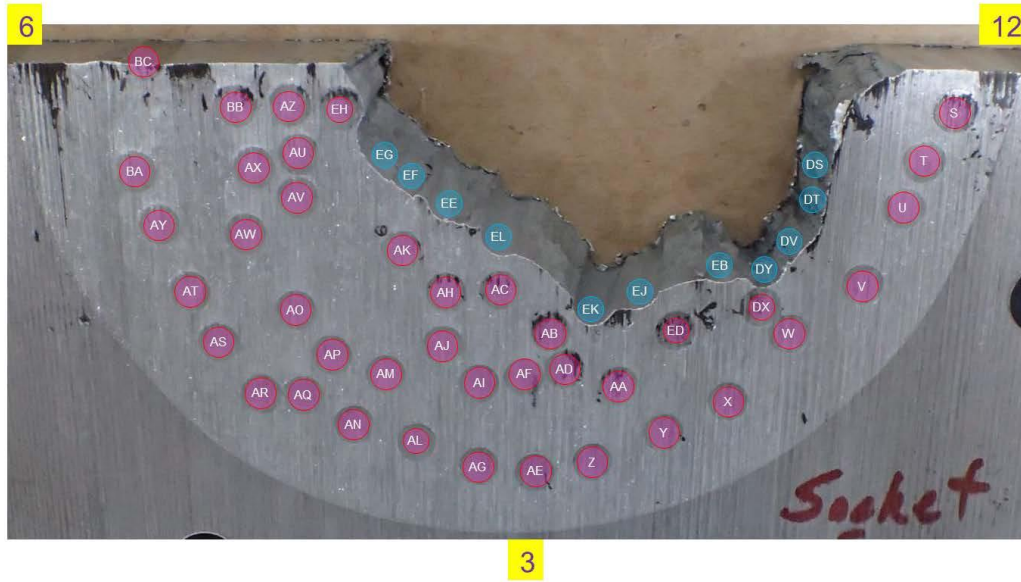
Figure 205 Wire map of the socket base side of slice 3e. Pink wire labels are wires that fractured within the socket and blue wire labels are wires that remained intact.

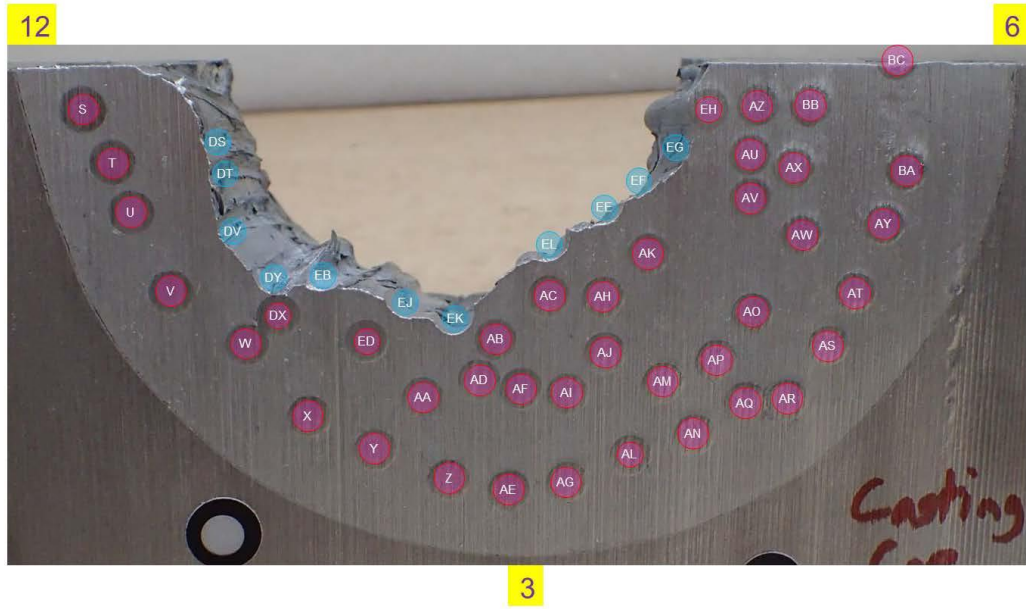
Figure 206. Wire map of the casting cap side of slice 3g. Pink wire labels are wires that fractured within the socket and blue wire labels are wires that remained intact.

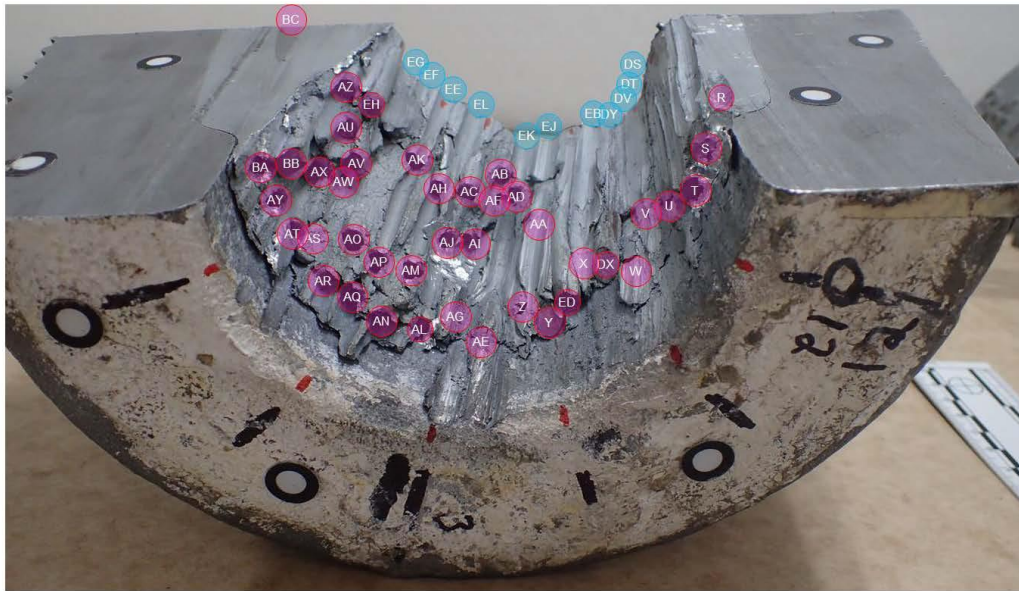
Figure 207. Wire map of the socket base side of slice 3g. Pink wire labels are wires that fractured within the socket and blue wire labels are wires that remained intact.

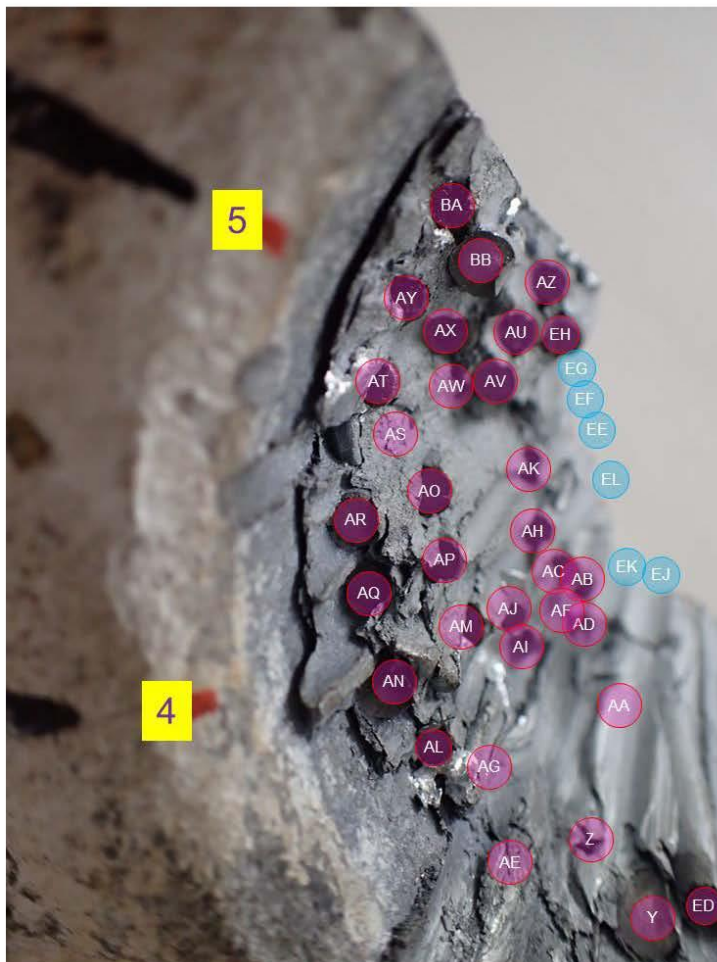
Figure 208. Wire map of the socket base side of slice 3g, from 4 o'clock to 5 o'clock. Pink wire labels are wires that fractured within the socket and blue wire labels are wires that remained intact.
