NASA/TM-20210017934
NESC-RP-20-01585

Arecibo Observatory Auxiliary M4N Socket Termination Failure Investigation

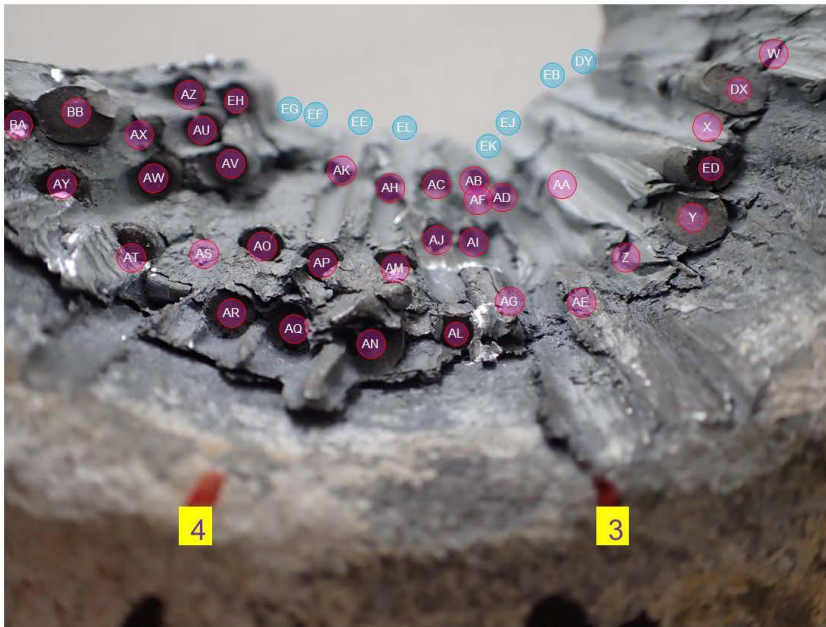
Figure 209. Wire map of the socket base side of slice 3g, from 3 o'clock to 4 o'clock. Pink wire labels are wires that fractured within the socket and blue wire labels are wires that remained intact.

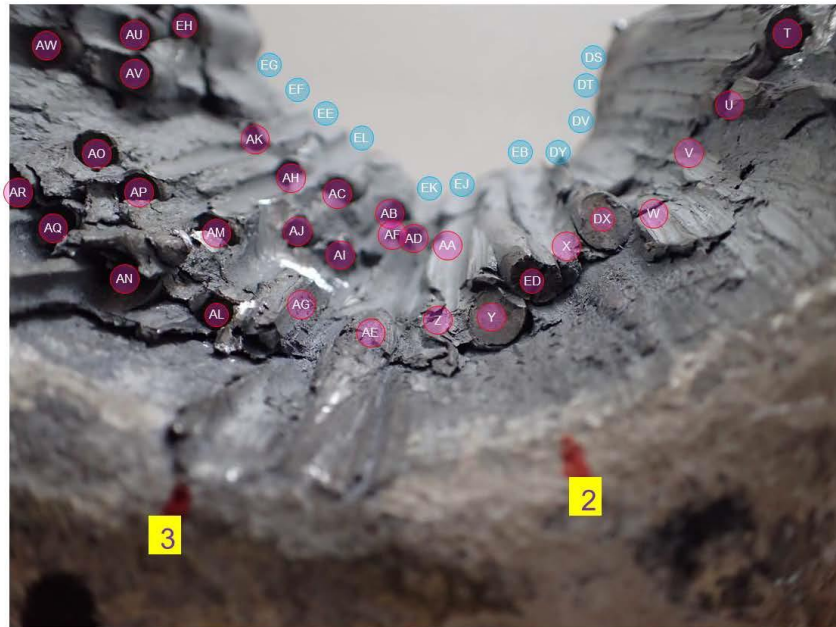
Figure 210. Wire map of the socket base side of slice 3g, from 2 o'clock to 3 o'clock. Pink wire labels are wires that fractured within the socket and blue wire labels are wires that remained intact.

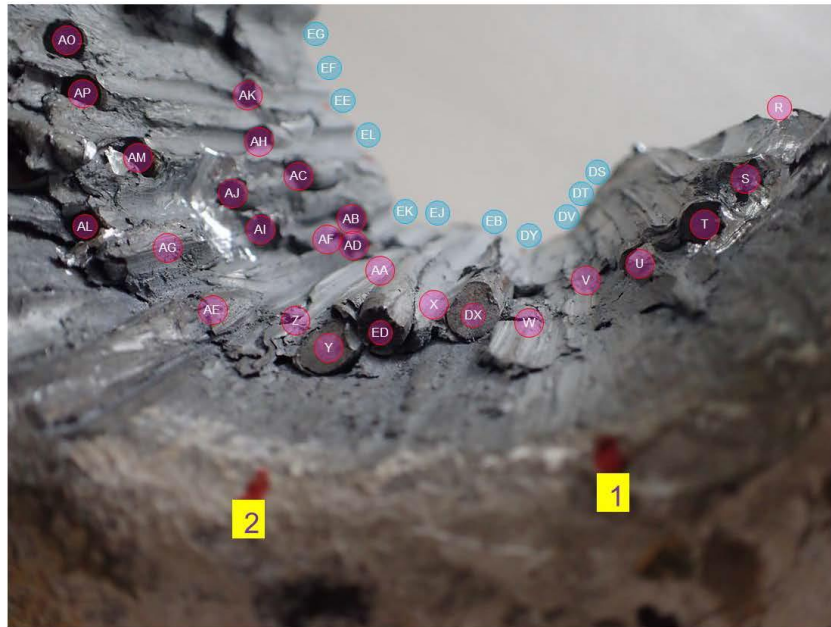
Figure 211. Wire map of the socket base side of slice 3g, from 1 o'clock to 2 o'clock. Pink wire labels are wires that fractured within the socket and blue wire labels are wires that remained intact.

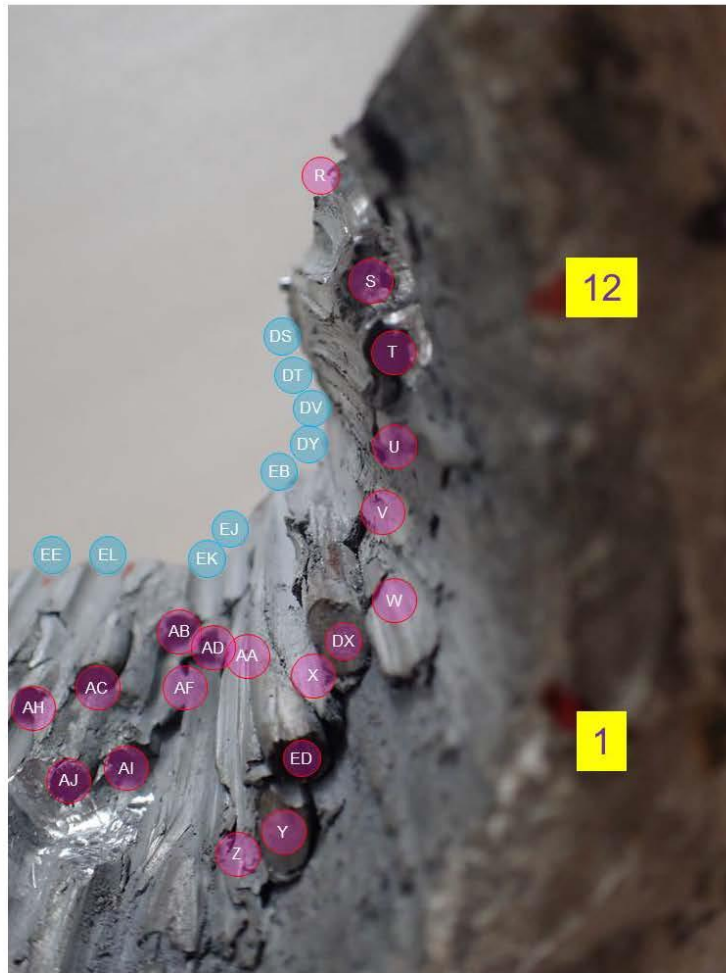
Figure 212. Wire map of the socket base side of slice 3g, from 12 o'clock to 1 o'clock. Pink wire labels are wires that fractured within the socket and blue wire labels are wires that remained intact.

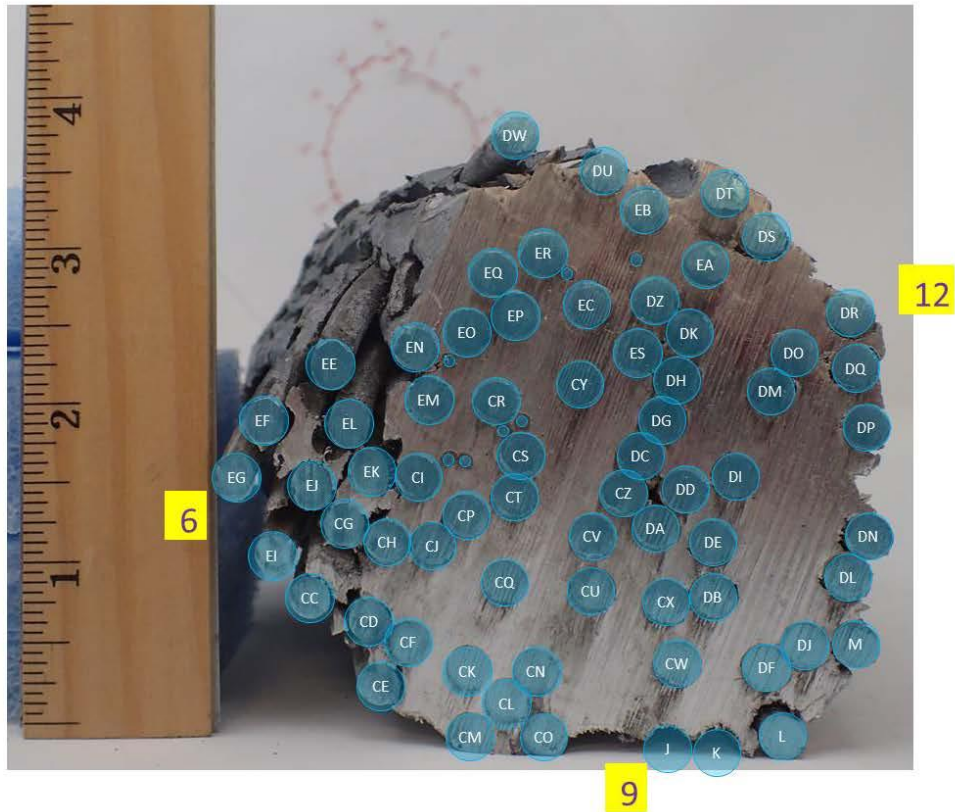
Figure 213. Wire map of the cable-end section transverse slice, 1 inch down from the top. Blue wire labels are wires that remained intact. Scale in inches.

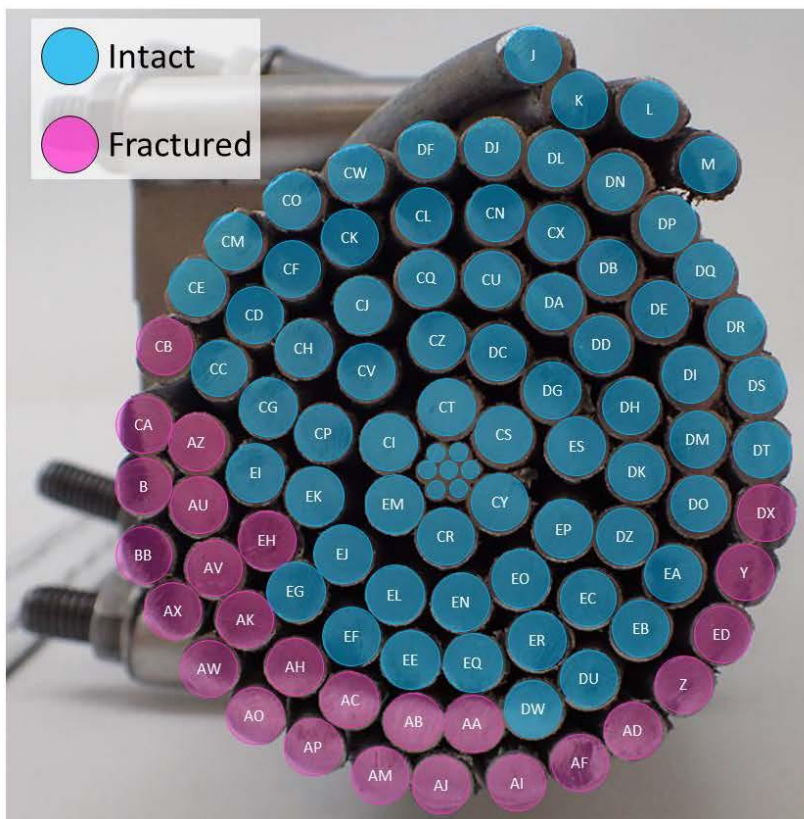
Figure 214. Wire map of the bottom of the cable-end section. Note that this is a representation of the wire configuration at approximately the socket base. The actual wire configuration will vary with distance from the socket base, since each concentric ring of wires rotates in the opposite direction as the adjacent concentric rings of wires. Pink wire labels are wires that fractured within the socket (although these would be the Feed Platform side of those wire fractures) and blue wire labels are wires that remained intact.

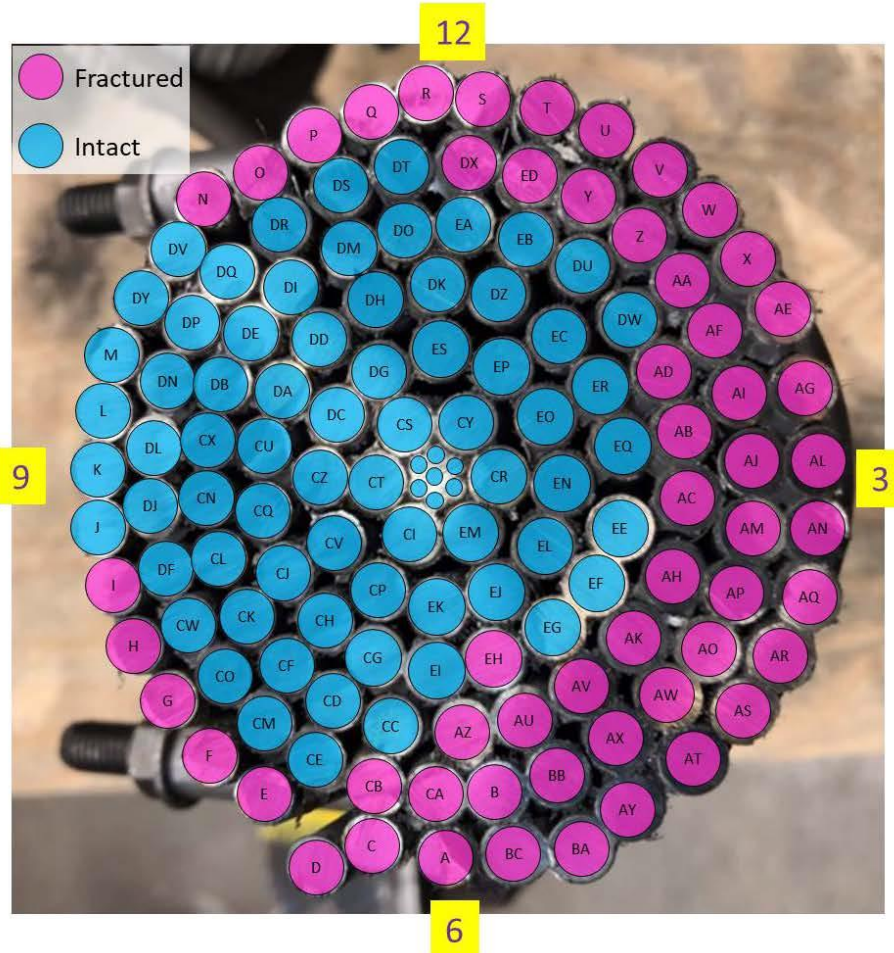
Figure 215. Wire map of the cable. Note that this is a representation of the wire configuration at approximately the socket base. The actual wire configuration will vary with distance from the socket base, since each concentric ring of wires rotates in the opposite direction as the adjacent concentric rings of wires. Pink wire labels are wires that fractured within the socket (although these would be the Feed Platform side of those wire fractures) and blue wire labels are wires that remained intact.

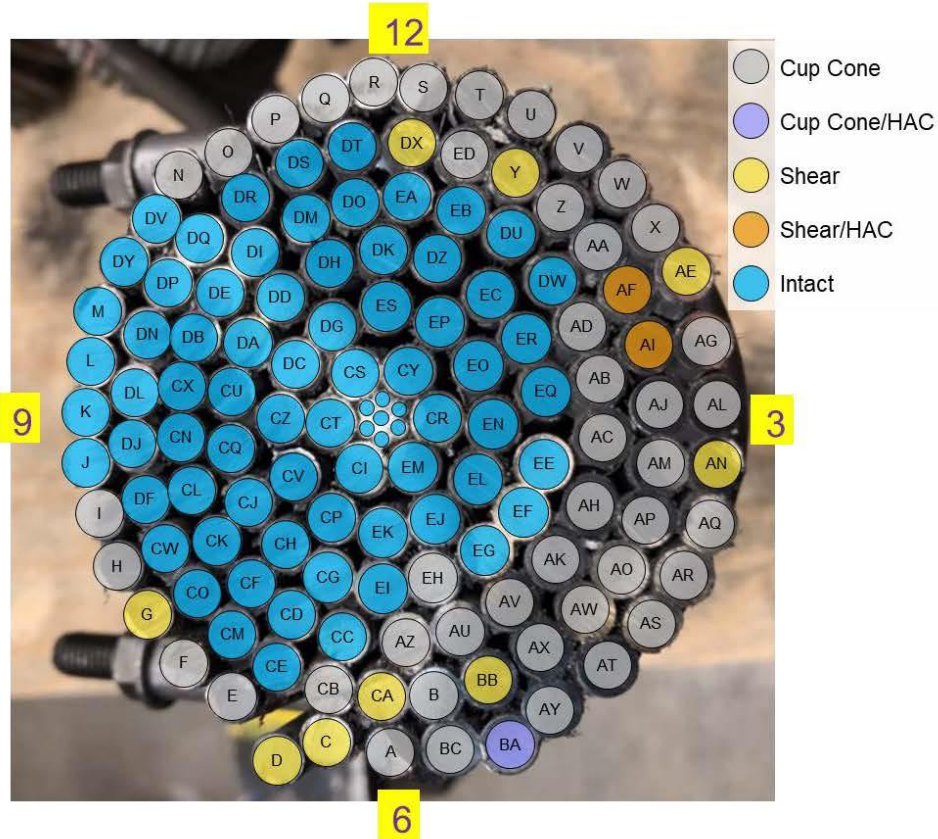
Figure 216. Wire map of the cable by fracture classification. Note that this is a representation of the wire configuration at approximately the socket base. The actual wire configuration will vary with distance from the socket base, since each concentric ring of wires rotates in the opposite direction as the adjacent concentric rings of wires. Gray, purple, yellow, and orange wire labels are wires that fractured in the socket and the color corresponds to the predominant fracture mechanism classified for that wire and blue wire labels are wires that remained intact.

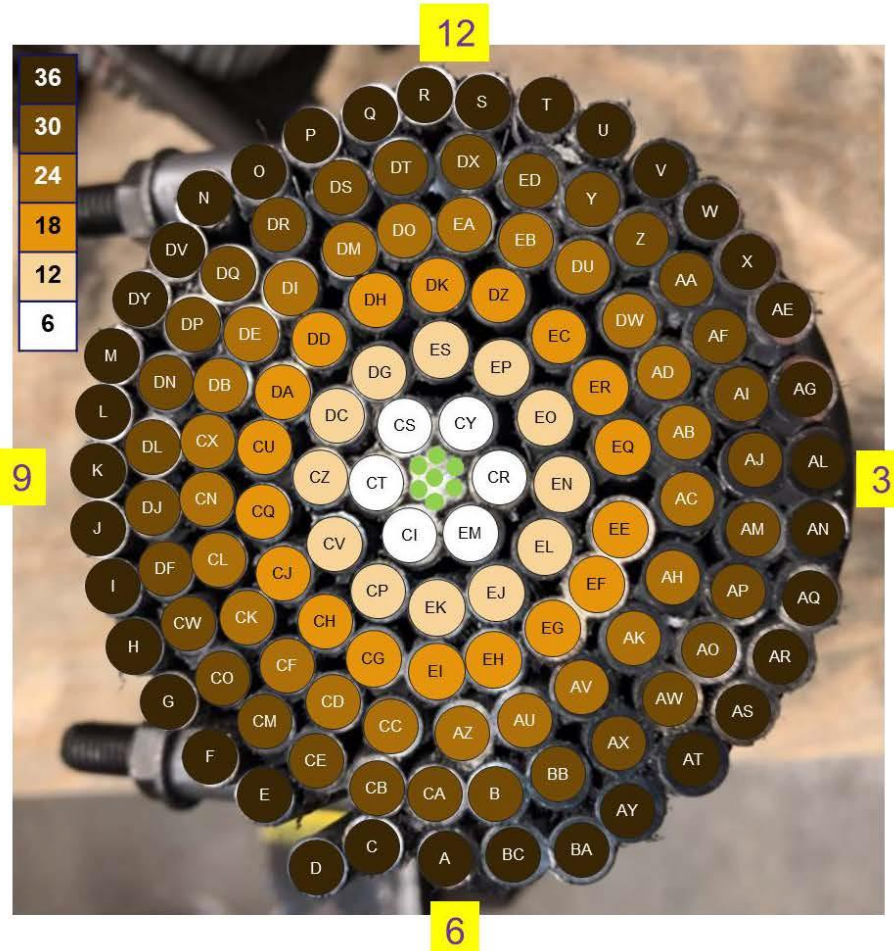
Figure 217. Wire map of the cable by rings. Note that this is a representation of the wire configuration at approximately the socket base. The actual wire configuration will vary with distance from the socket base, since each concentric ring of wires rotates in the opposite direction as the adjacent concentric rings of wires. The color range (white-tan-orange-light brown-brown-dark brown), with the white wires being the inner ring of wires and the dark brown representing the outer diameter wires.

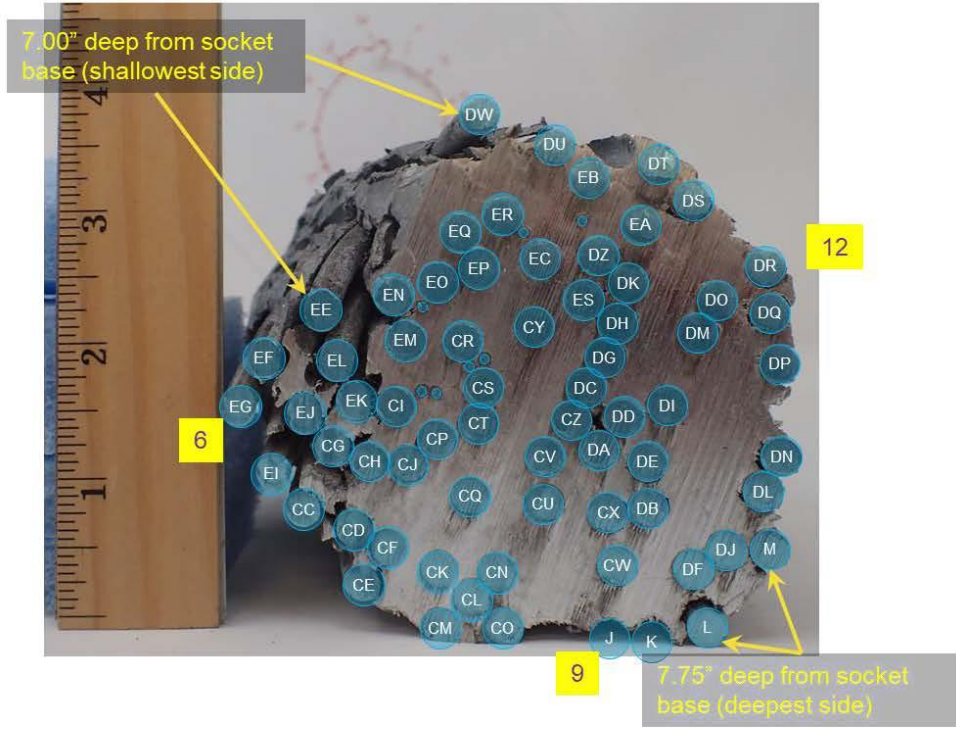
Figure 224. Distance measurements between the expected location of the socket base along the cable-end section and the shown transverse cut, provided for the as-built finite element model. Scale in inches.

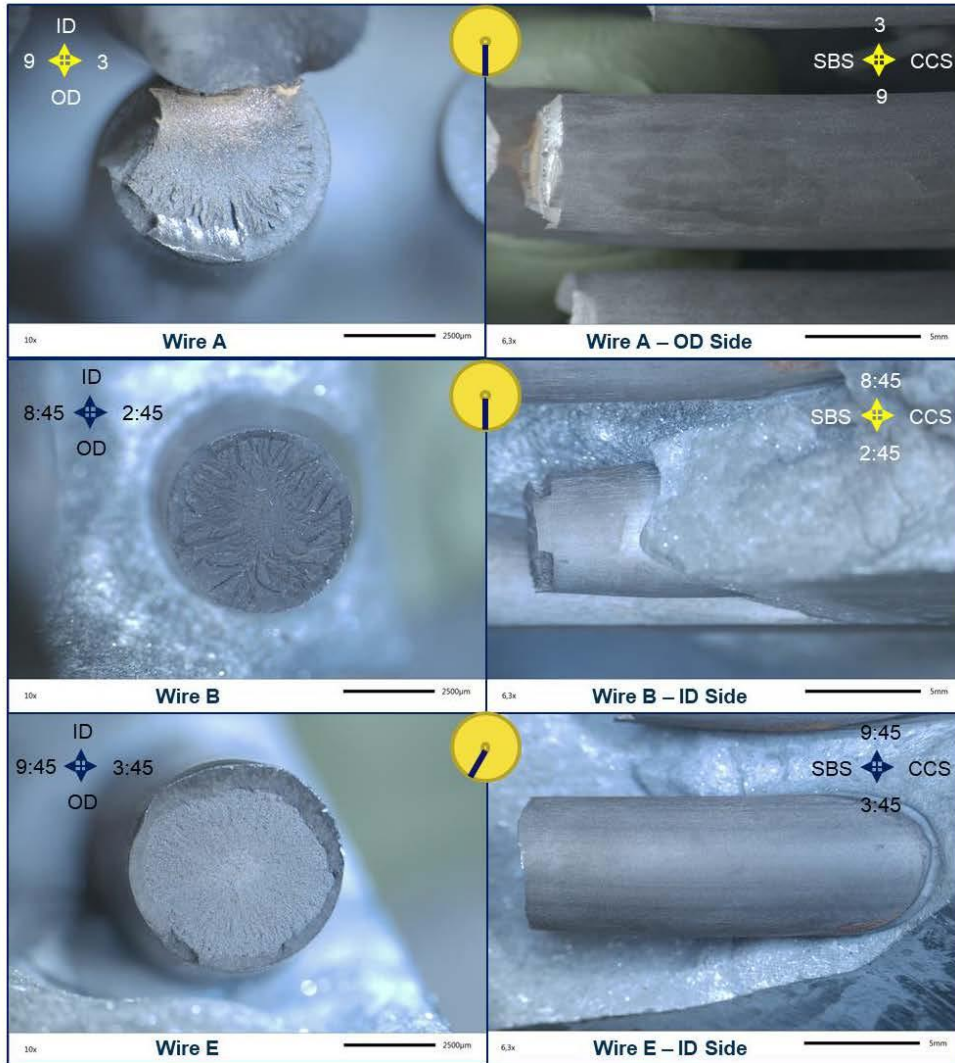
Figure 225. Stereomicroscope images of wire A (6:00), wire B (5:45), and wire E (6:45).

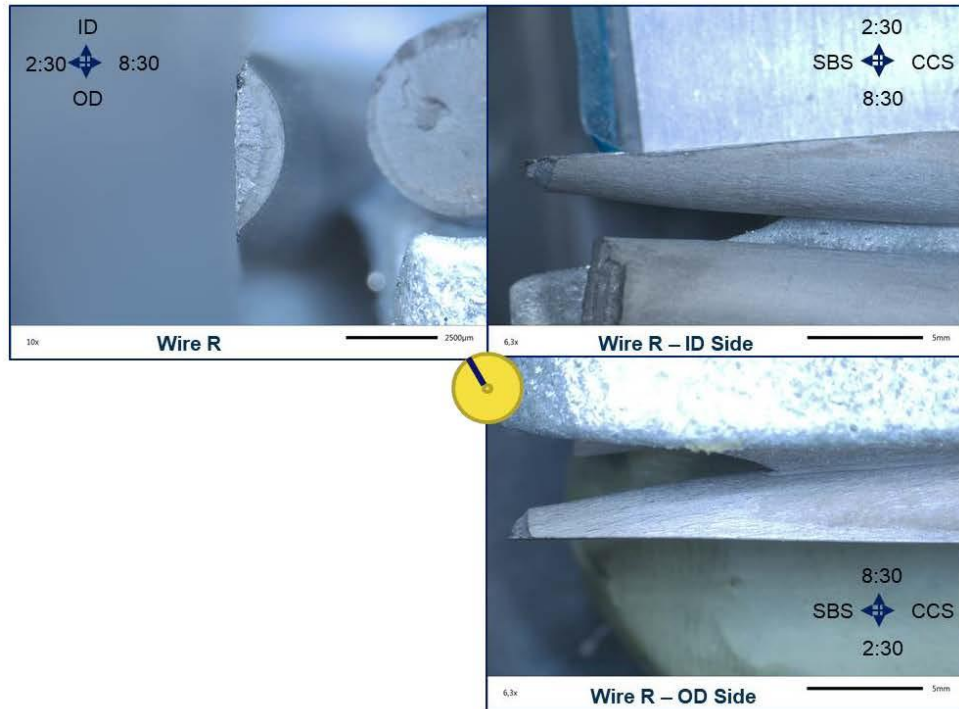
Figure 229. Stereomicroscope images of wire R (11:30). The fracture surface of wire R was cut through during the initial longitudinal cut of the socket cavity.

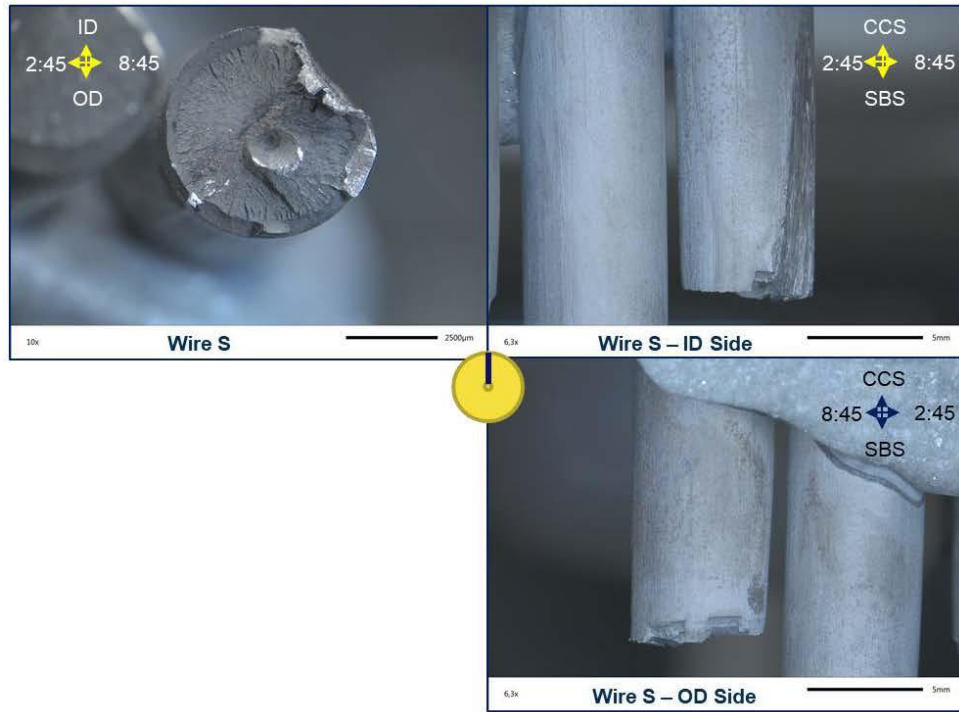
Figure 230. Stereomicroscope images of wire S (11:45).

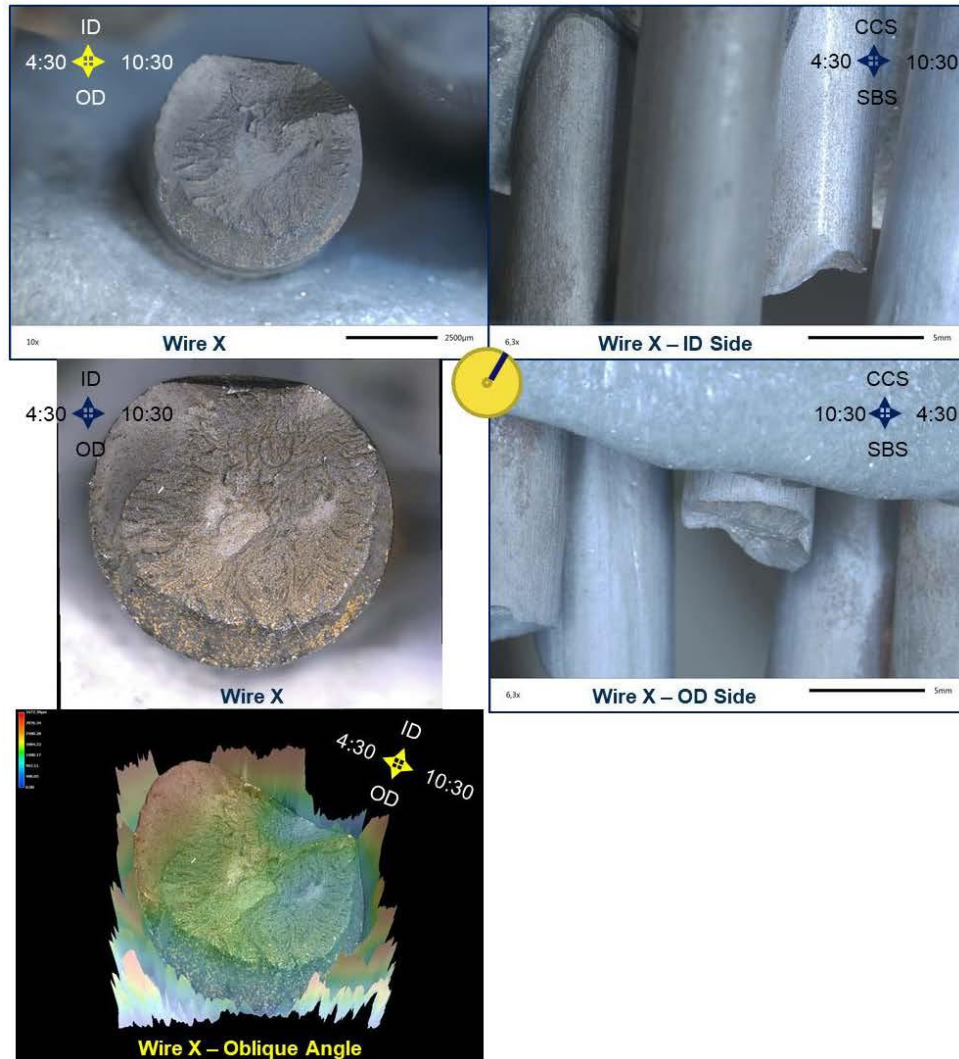
Figure 234. Stereomicroscope images of wire X (1:30). The bottom row left image is a digitally enhanced 3D view of the fracture topography with a color-coded height map.

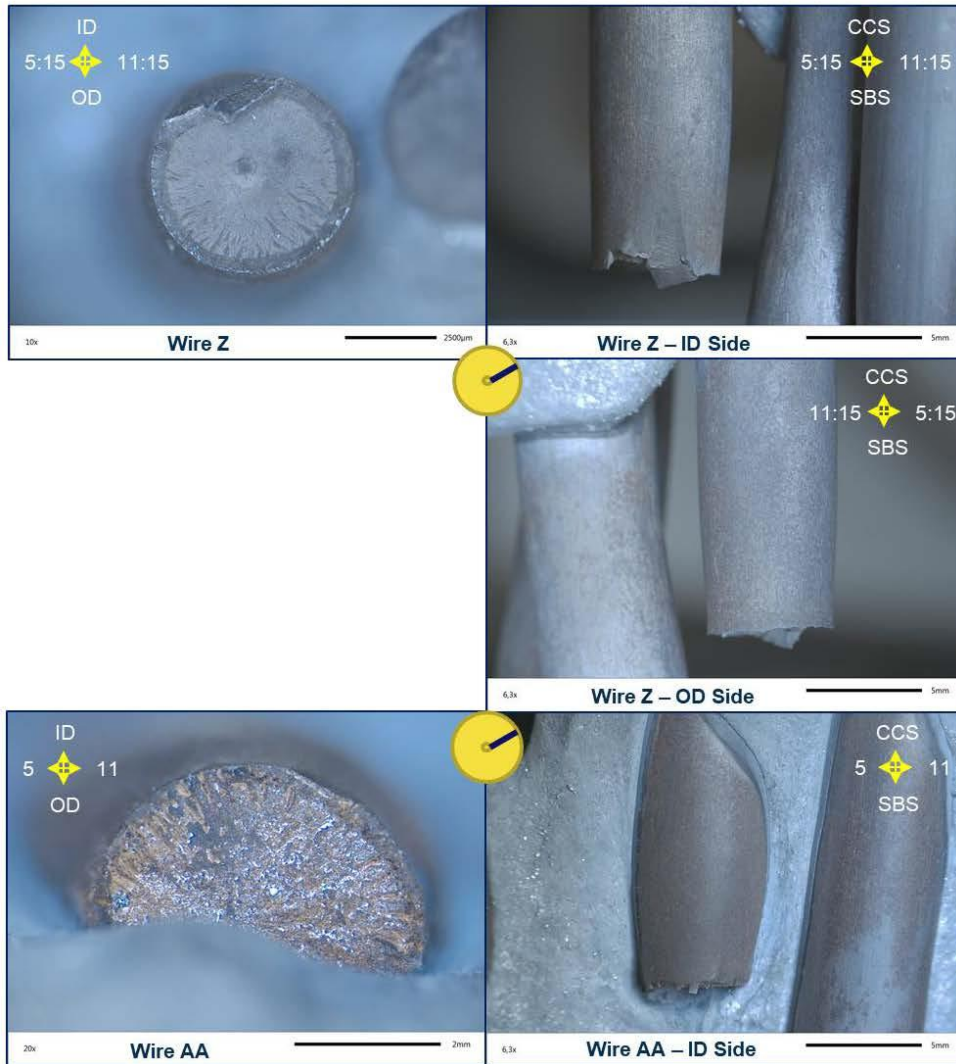
Figure 235. Stereomicroscope images of wire Z (2:15) and wire AA (2:00).

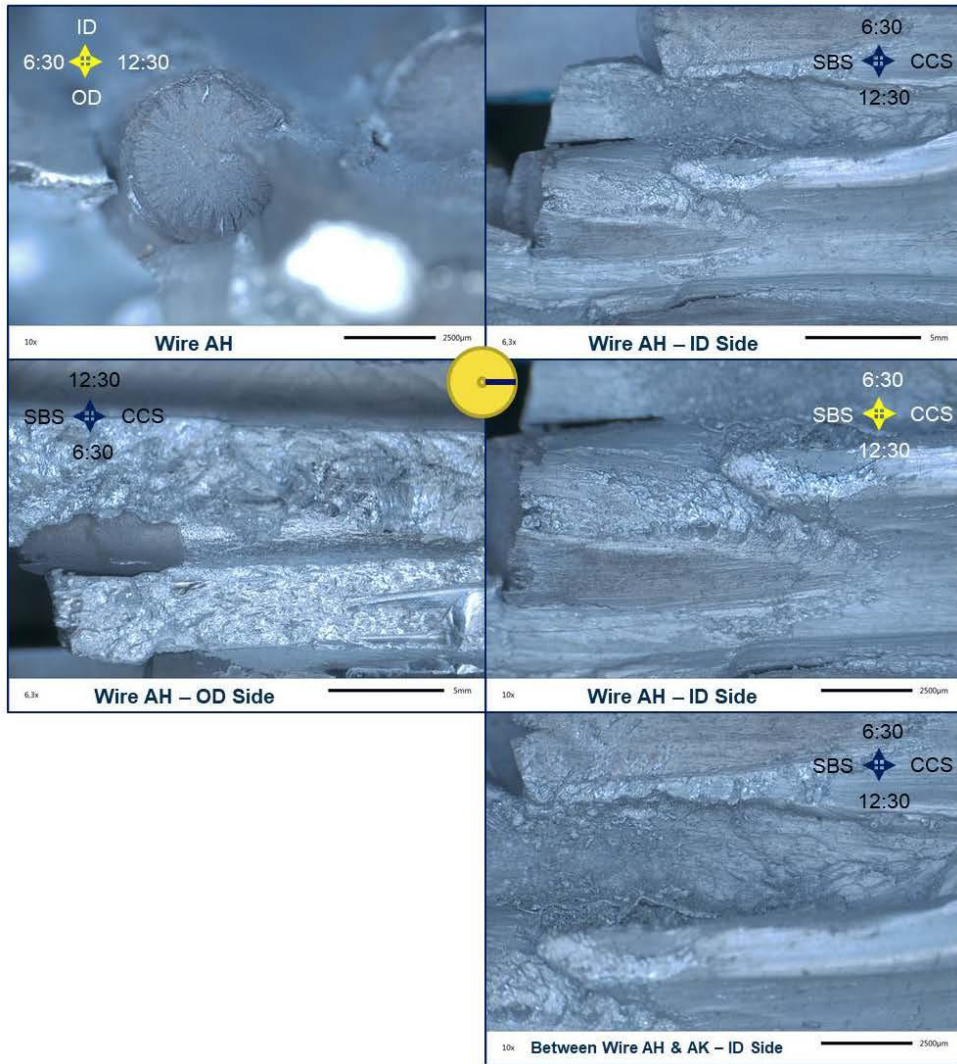
Figure 240. Stereomicroscope images of wire AH (3:30). Close up images of the zinc show a thin layer of molten zinc spatter that occurred when the cable/zinc slug was displaced from the socket during the ultimate failure of the joint.

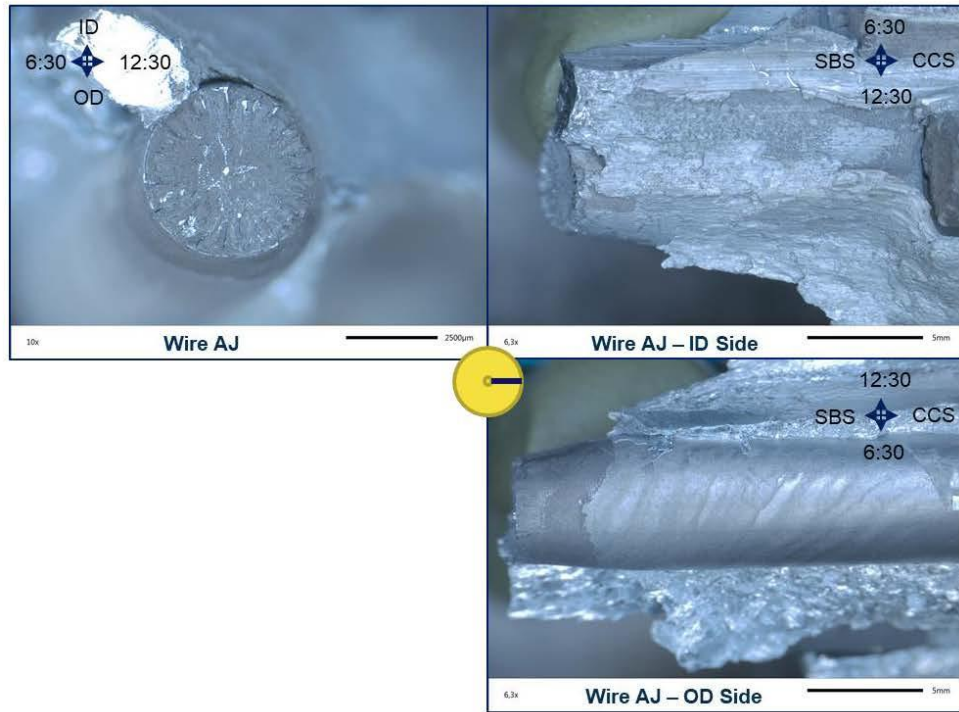
Figure 241. Stereomicroscope images of wire AJ (3:30).

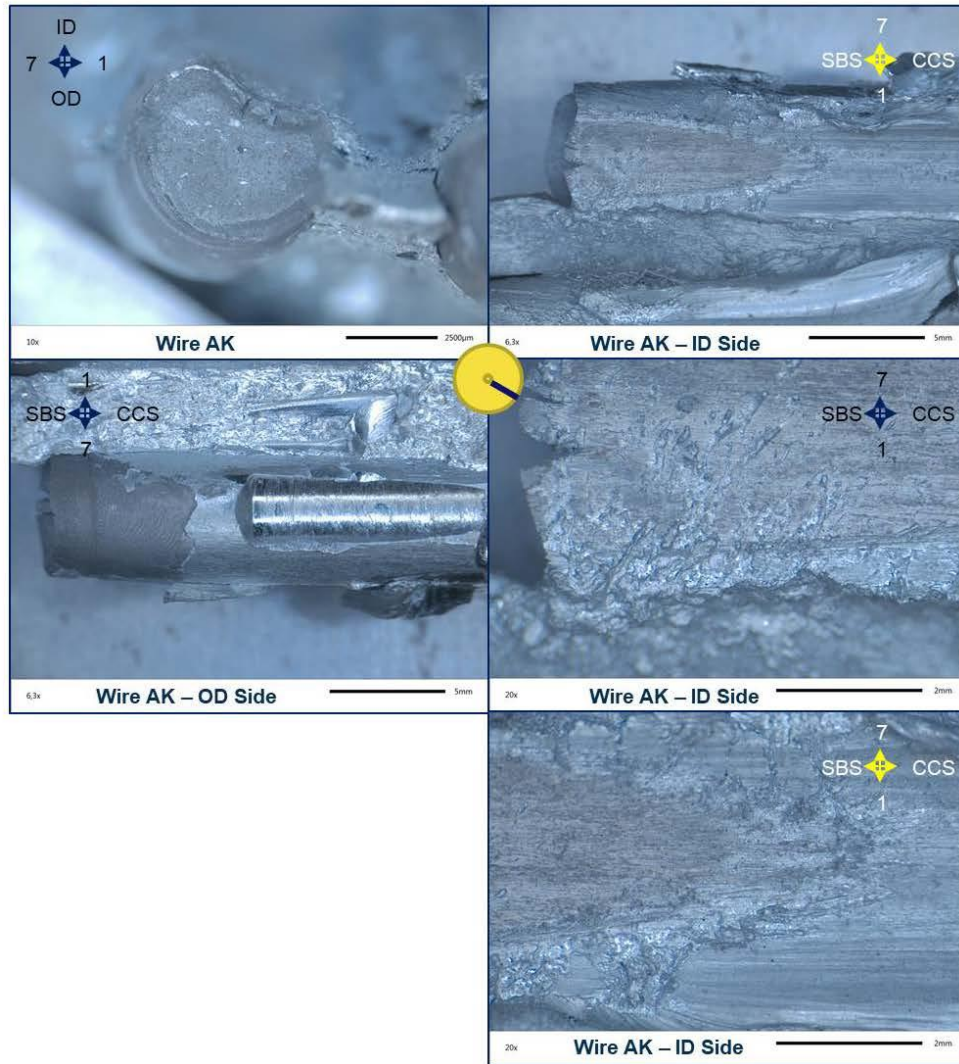
Figure 242. Stereomicroscope images of wire AK (4:00). Close up images of the zinc show a thin layer of molten zinc spatter that occurred when the cable/zinc slug was displaced from the socket during the ultimate failure of the joint.

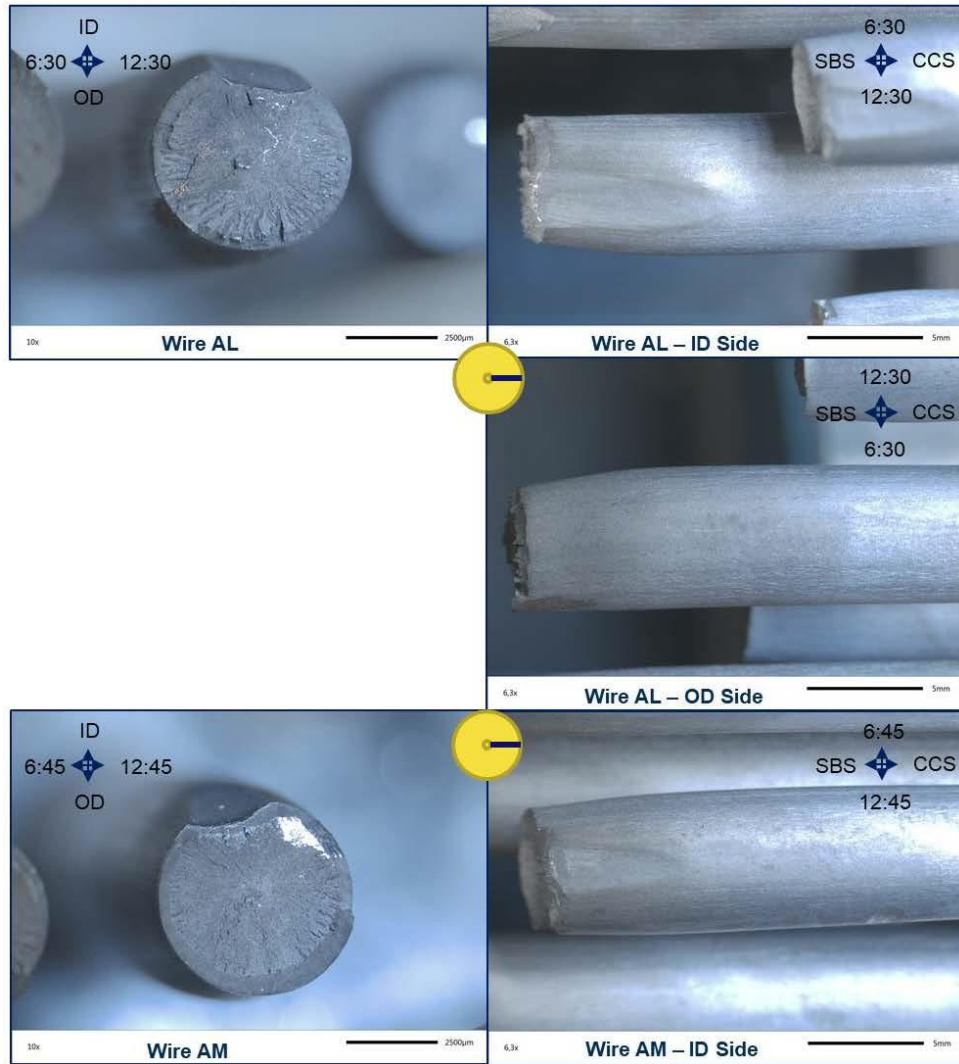
Figure 243. Stereomicroscope images of wire AL (3:30) and wire AM (3:45).

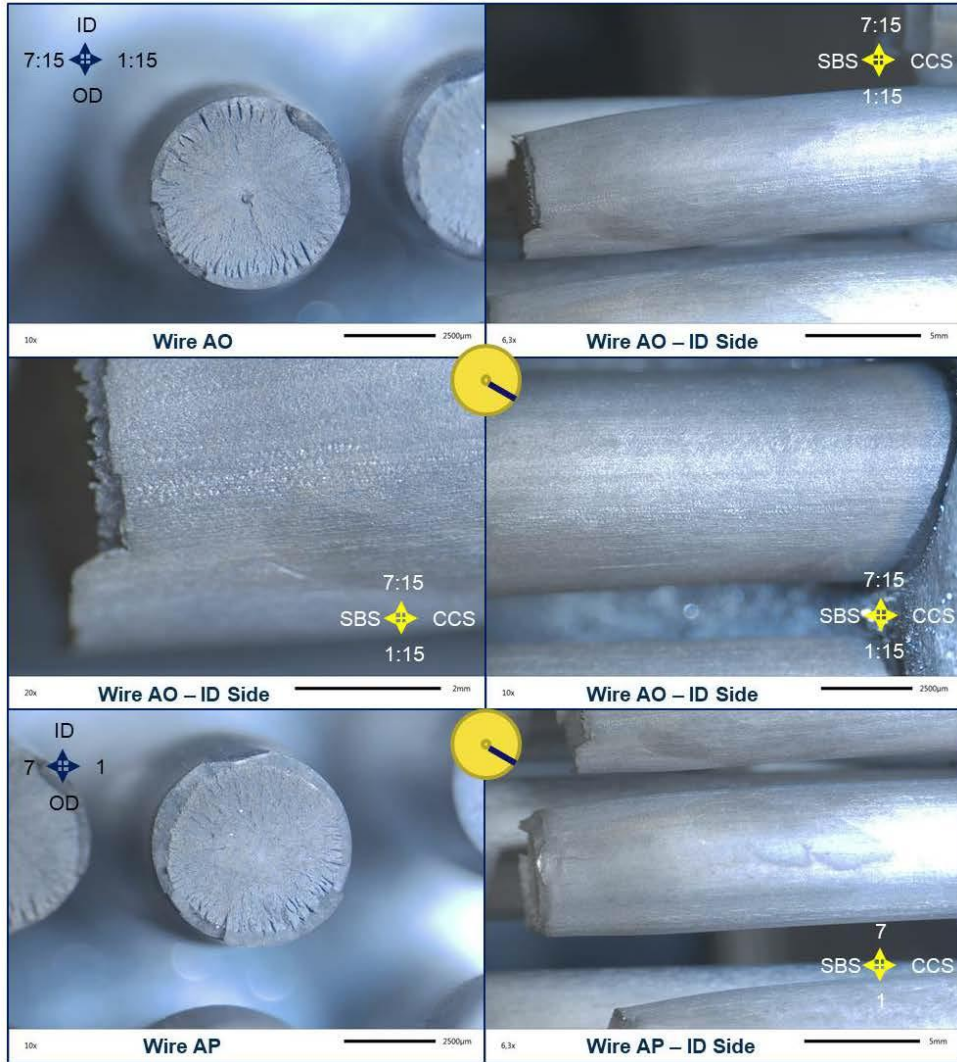
Figure 244. Stereomicroscope images of wire AO (4:15) and wire AP (4:00). Wire AO has a defect running in a line down the length of visible wire, that appears to have been created by a machine or tool.

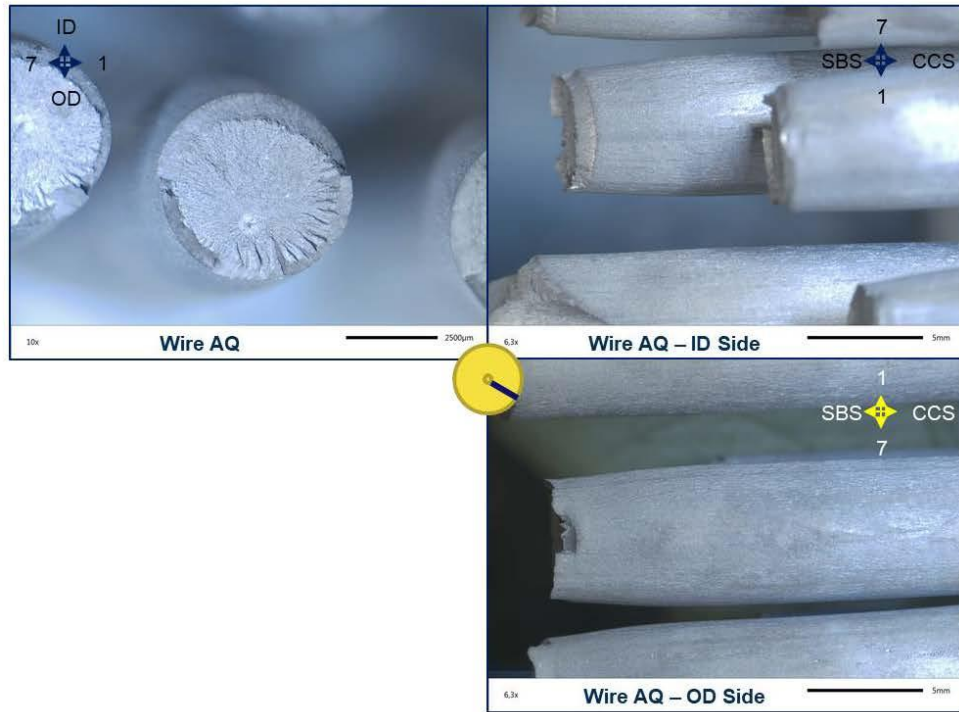
Figure 245. Stereomicroscope images of wire AQ (4:00).

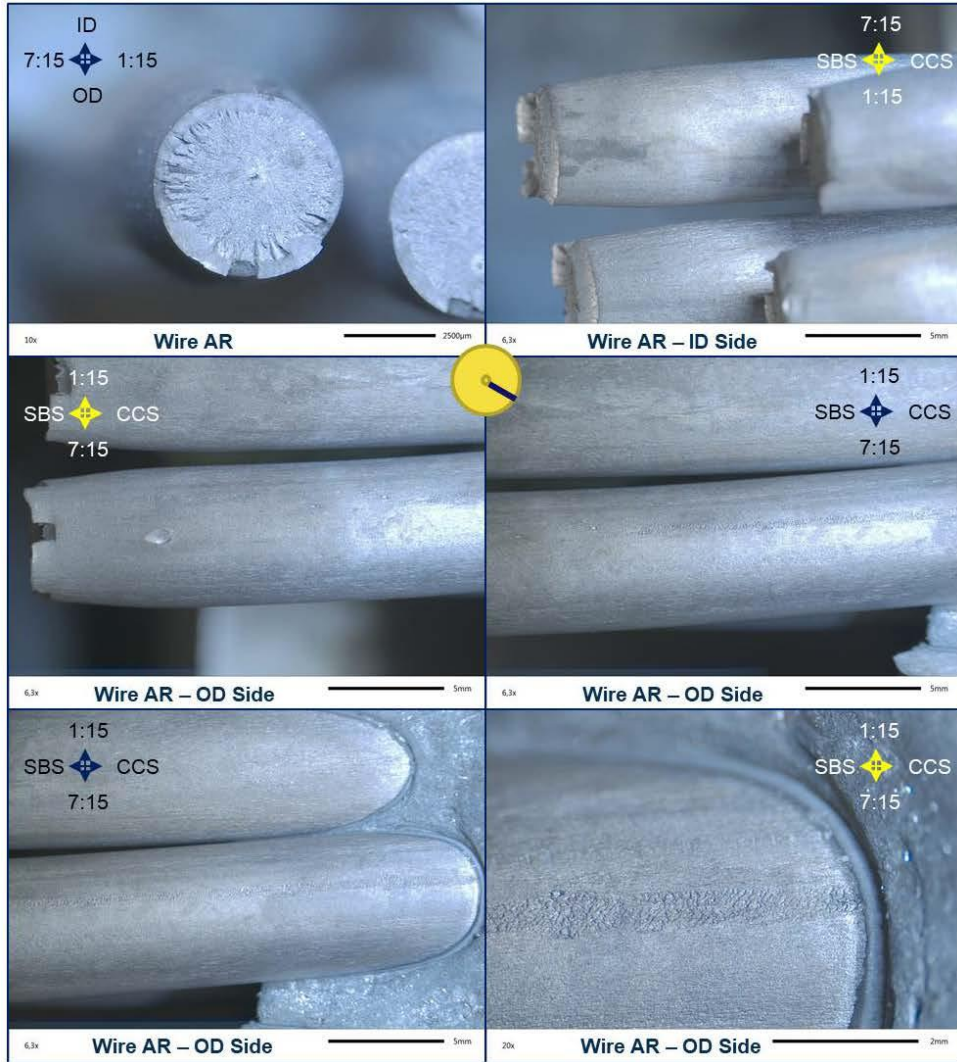
Figure 246. Stereomicroscope images of wire AR (4:15). Wire AR has a defect running in a line down most of the length of visible wire, but not to the fracture surface, that appears to have been created by a machine or tool. The nick seen on the outer diameter side in the middle row left image likely occurred during sectioning.

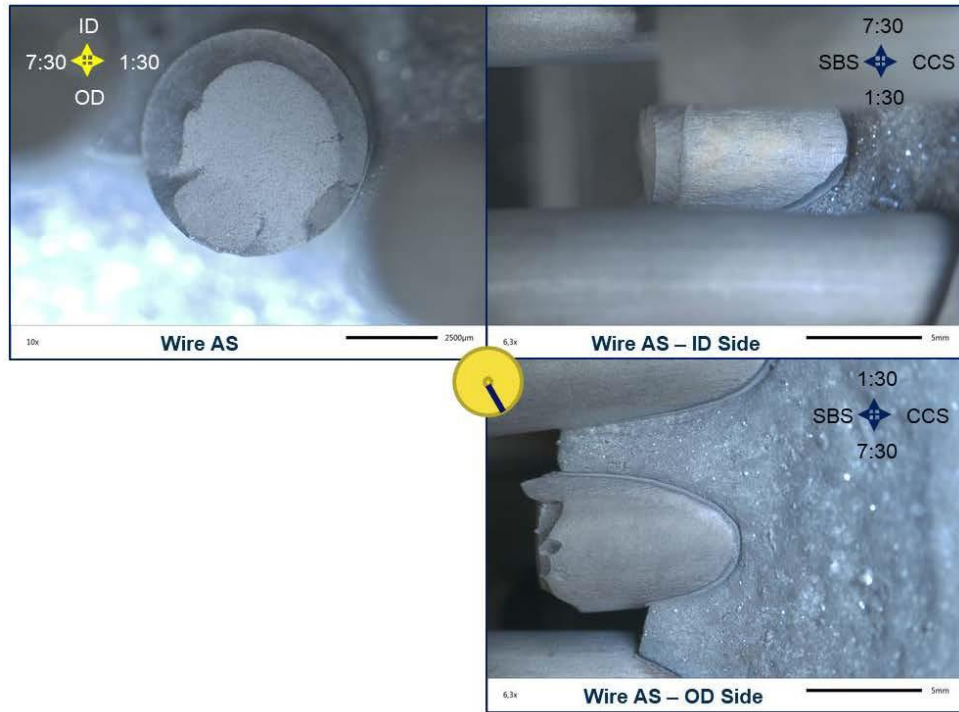
Figure 247. Stereomicroscope images of wire AS (4:30).

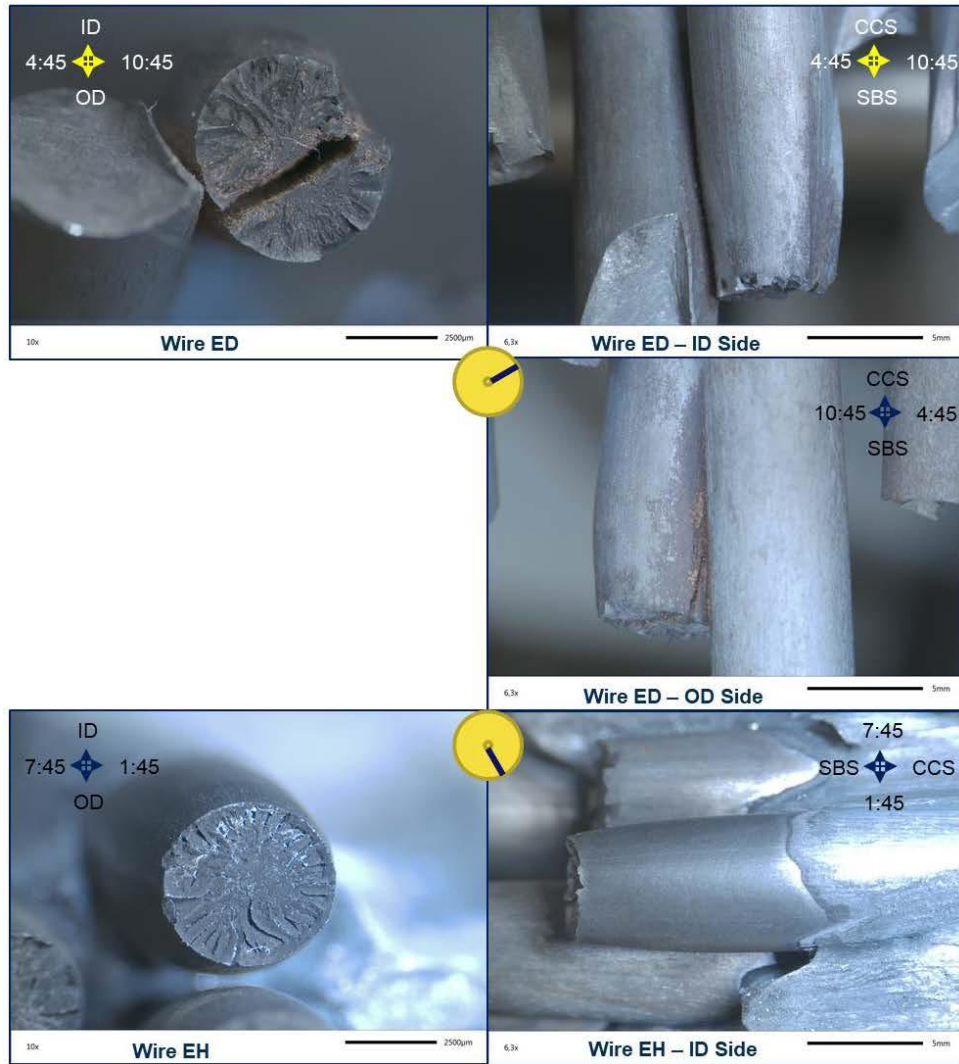
Figure 253. Stereomicroscope images of wire ED (1:45) and wire EH (4:45).

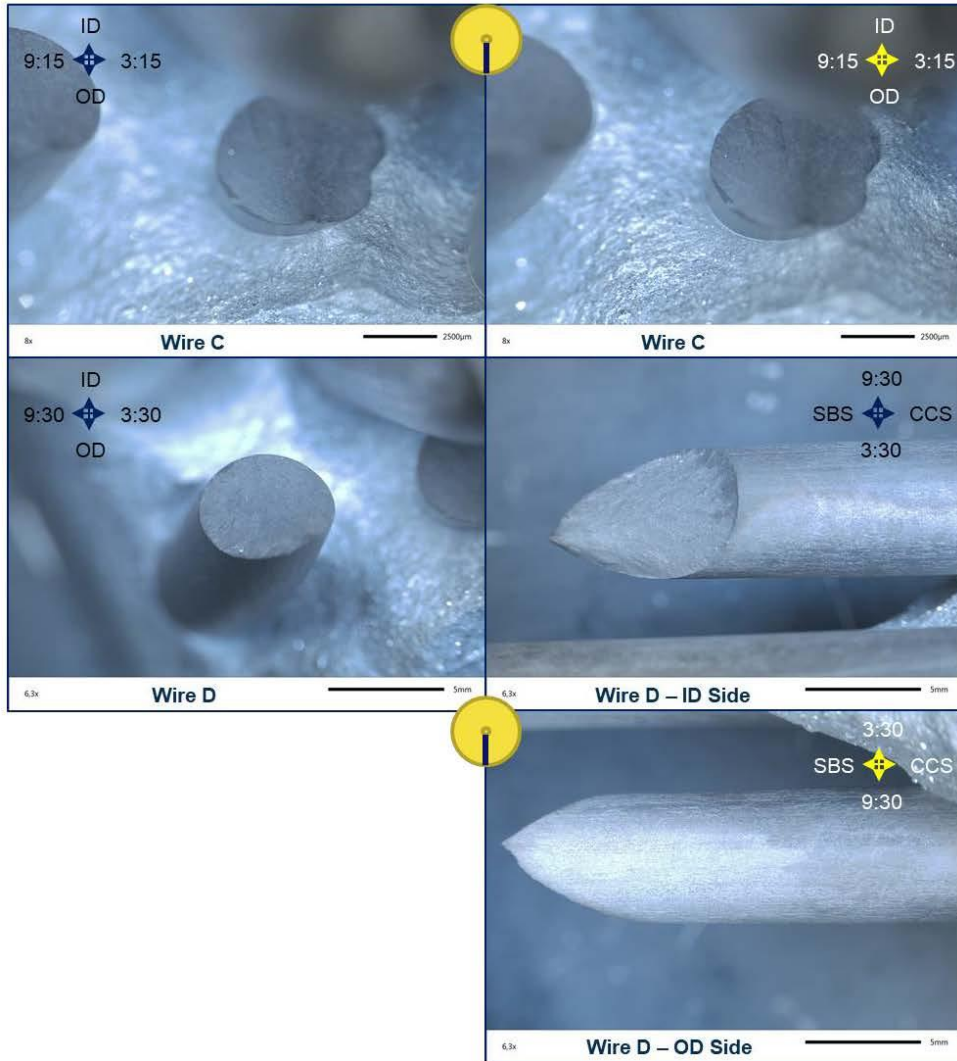
Figure 254. Stereomicroscope images of wire C (6:15) and wire D (6:30).

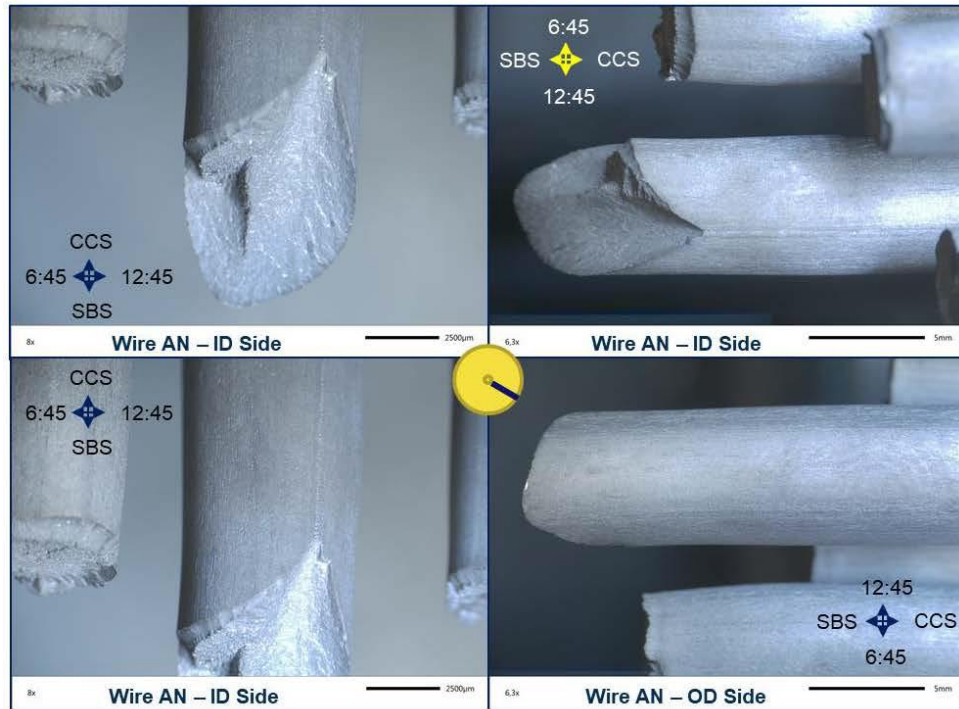
Figure 257. Stereomicroscope images of wire AN (3:45). Wire AN has a defect running in a line down the length of visible wire, that appears to have been created by a machine or tool.
