NASA/TM-20210017934
NESC-RP-20-01585

Arecibo Observatory Auxiliary M4N Socket Termination Failure Investigation

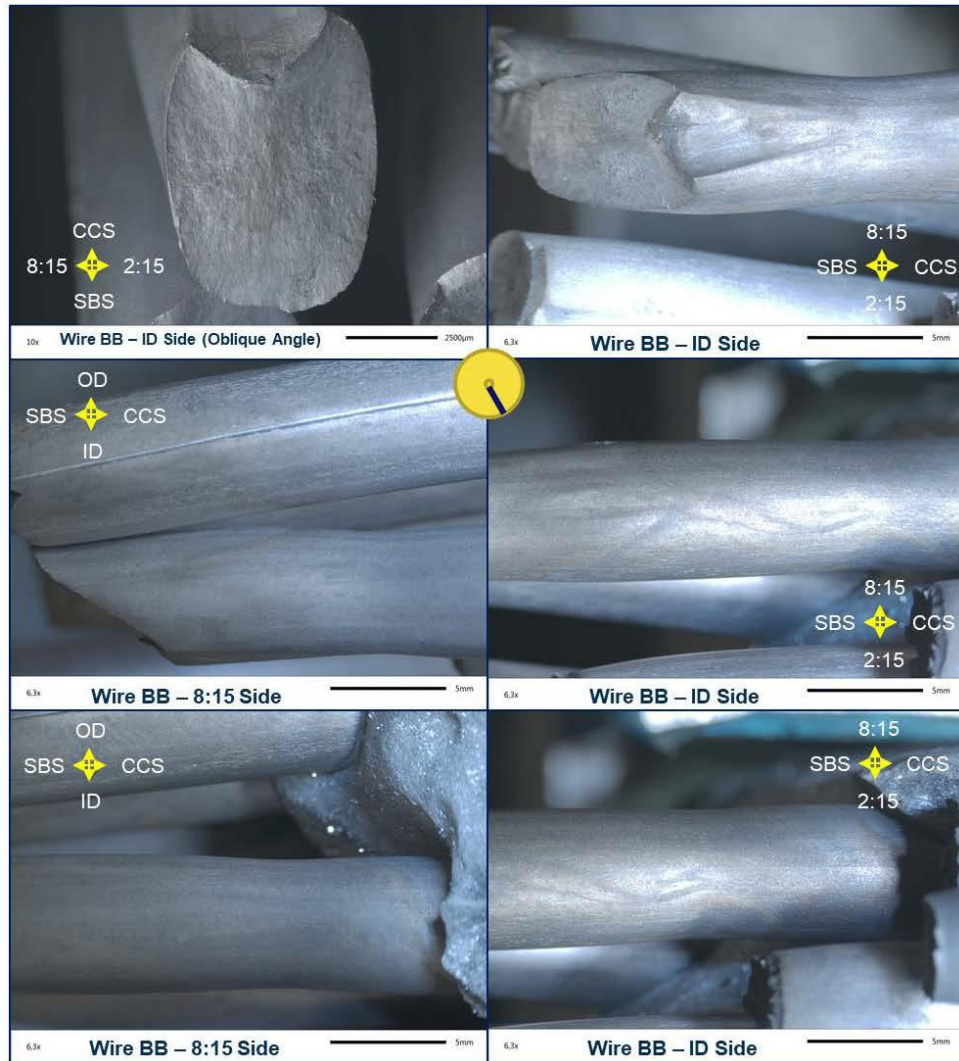
Figure 258. Stereomicroscope images of wire BB (5:15). Wire BB had two necked regions behind the fracture surface.

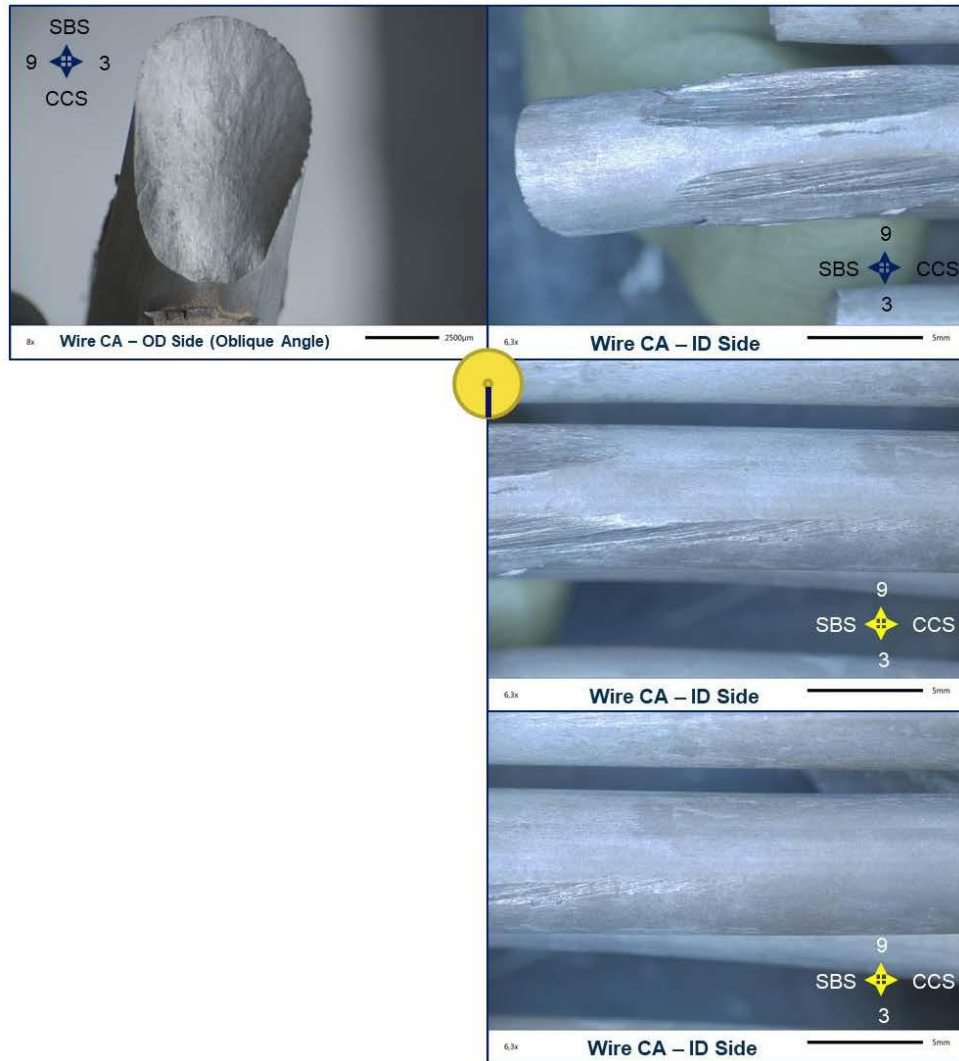
Figure 259. Stereomicroscope images of wire CA (6:00).

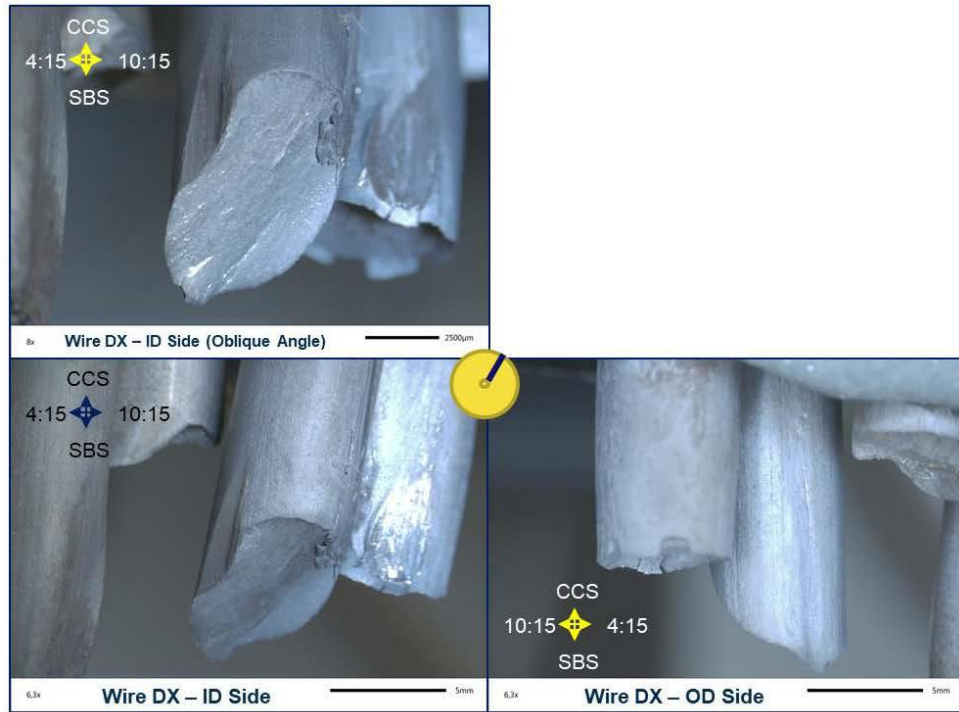
Figure 260. Stereomicroscope images of wire DX (1:15).

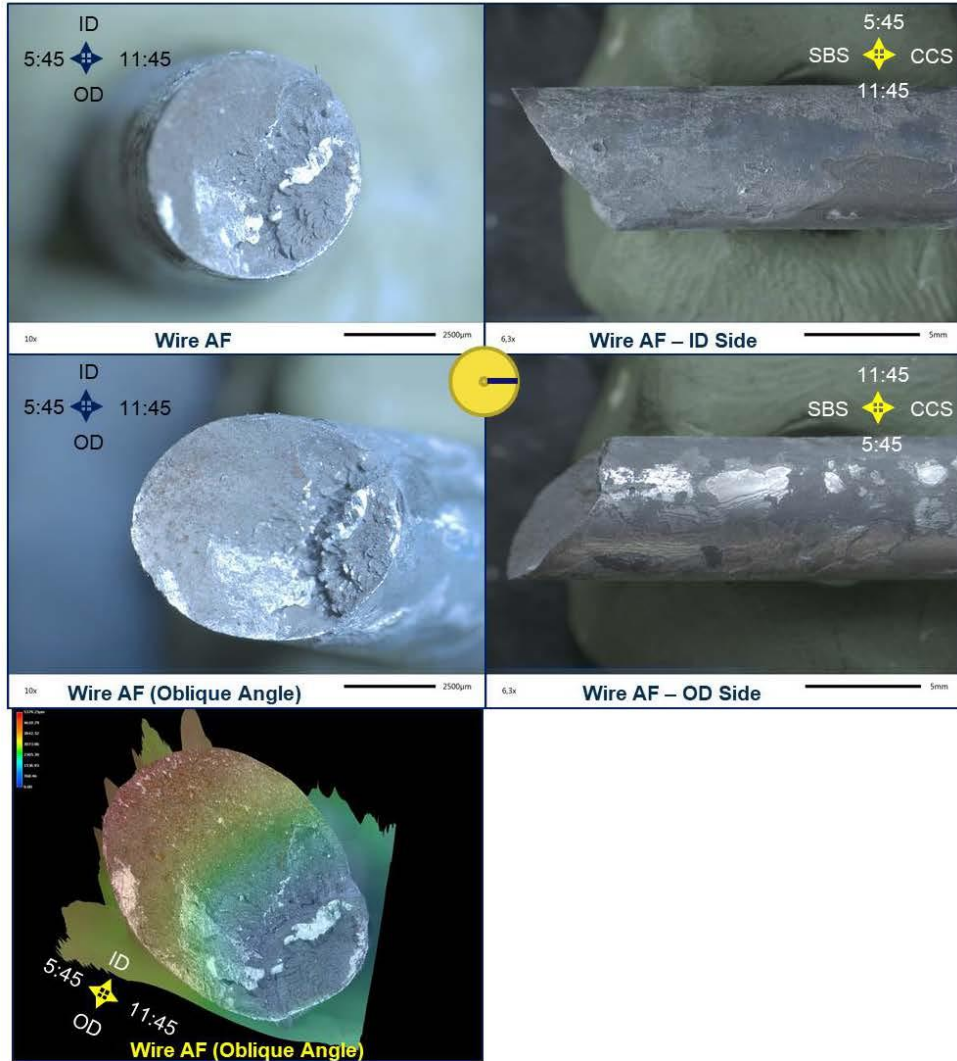
Figure 261. Stereomicroscope images of wire AF (2:45). The bottom row left image is a digitally enhanced 3D view of the fracture topography with a color-coded height map.

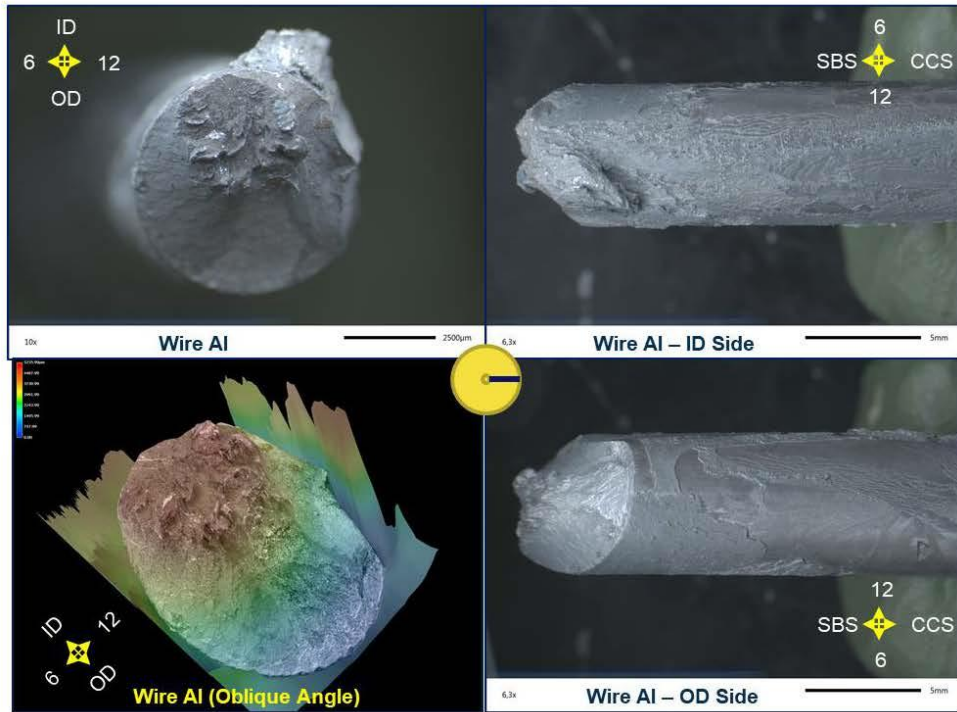
Figure 262. Stereomicroscope images of wire AI (3:00). The bottom row left image is a digitally enhanced 3D view of the fracture topography with a color-coded height map.

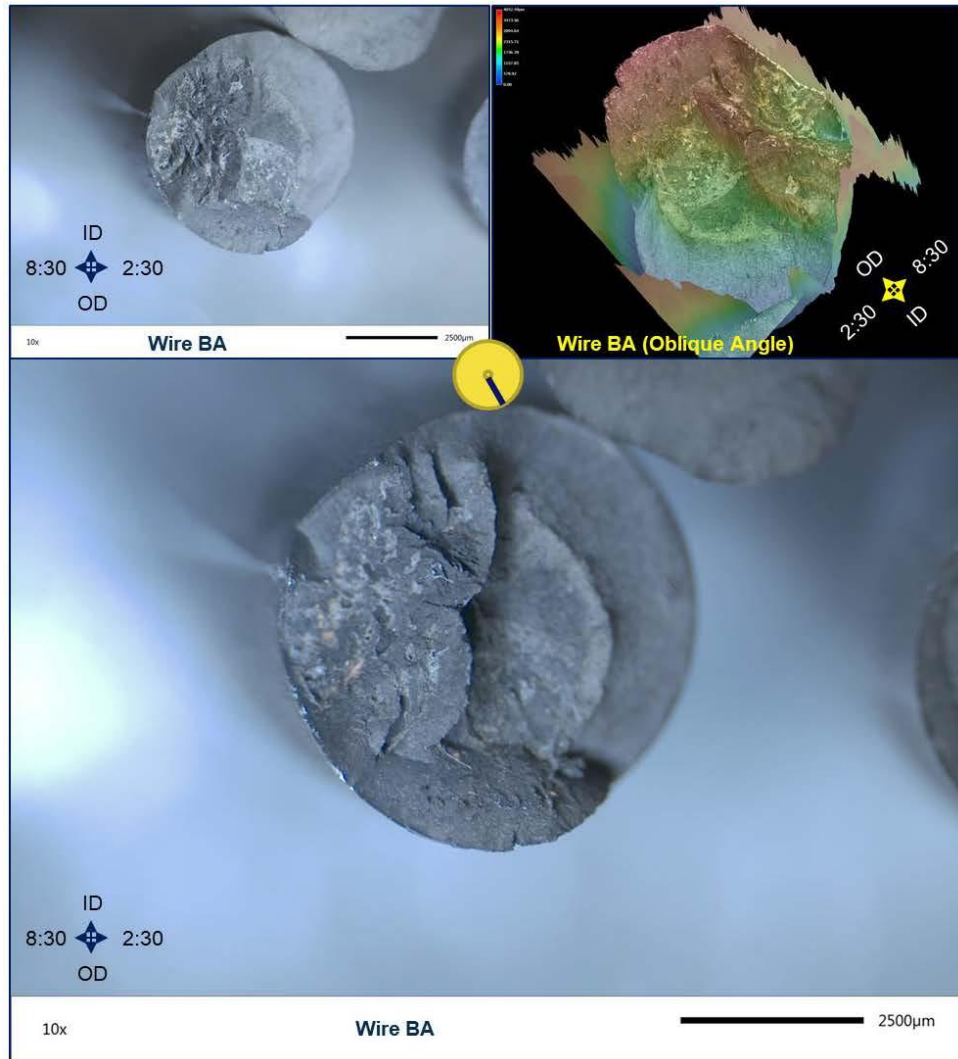
Figure 263. Stereomicroscope images of wire BA (5:30). The top row right image is a digitally enhanced 3D view of the fracture topography with a color-coded height map.

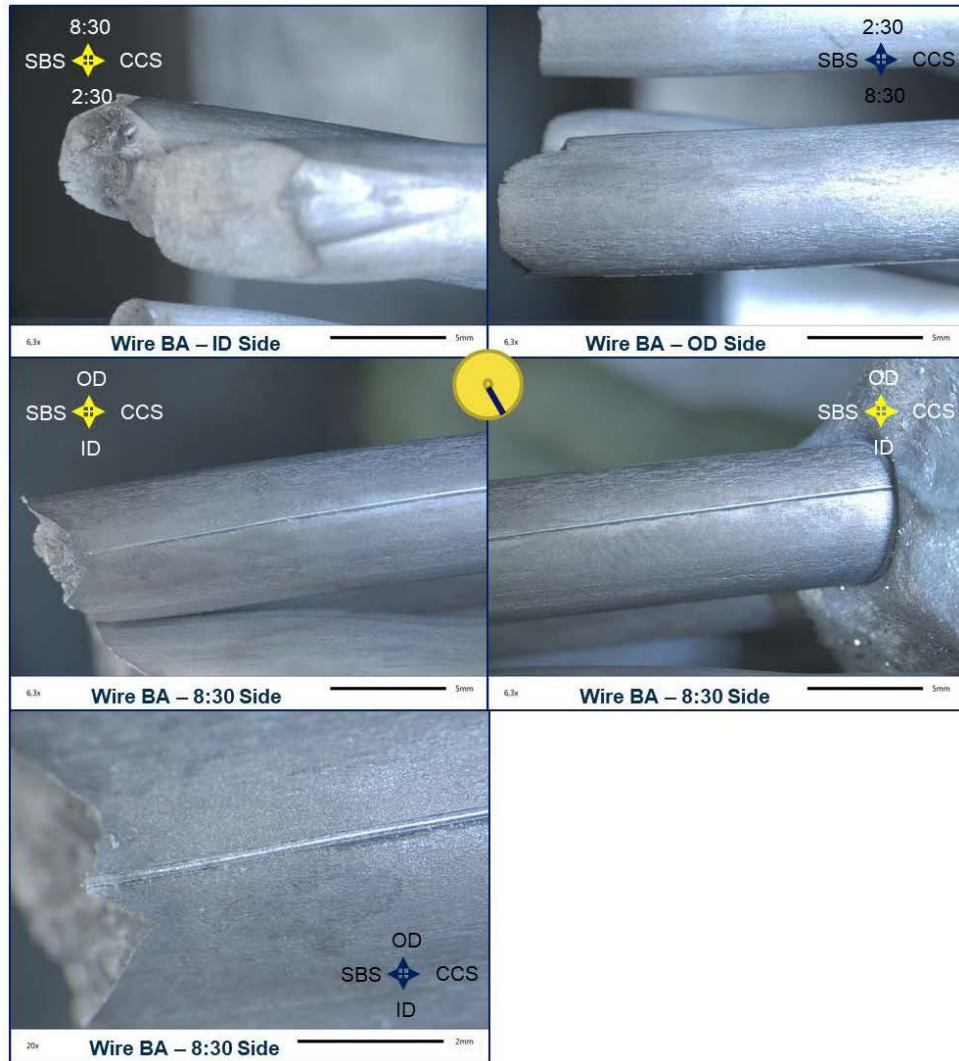
Figure 264. Stereomicroscope images of wire BA (5:30). Wire BA has a defect running in a line down the length of visible wire, that appears like a smooth but deep scribe line.

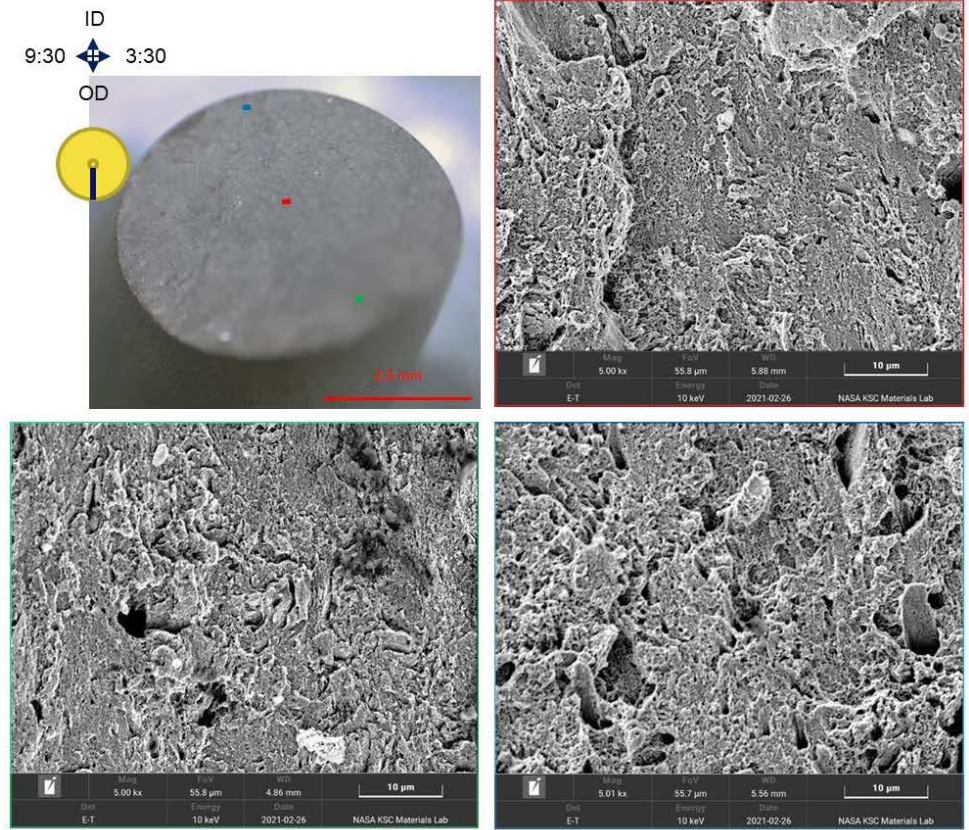
Figure 265. SEM images of wire D.

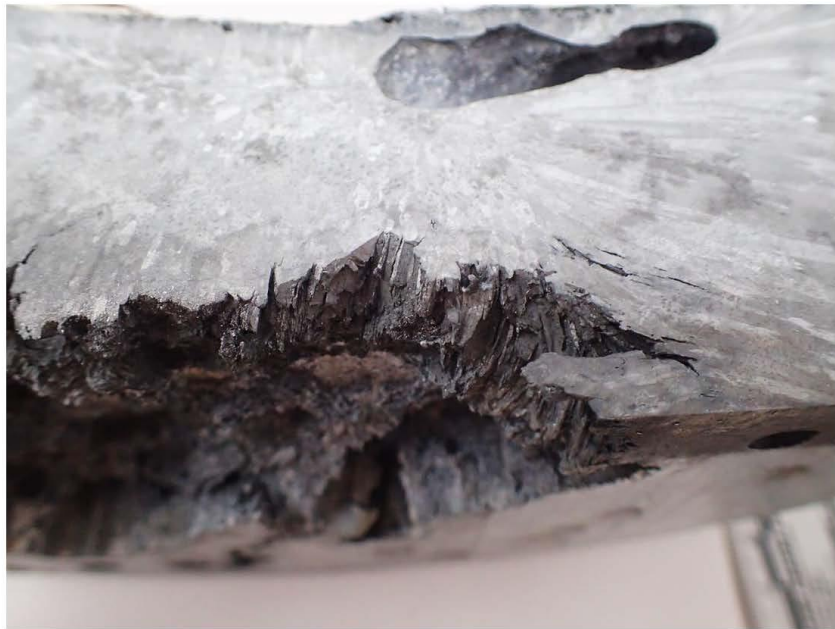
Figure 284. Oblique view of the slice 9a etch, revealing how the brittle fracture region is associated with grains elongated in the direction of the gas bubble near the casting cap.

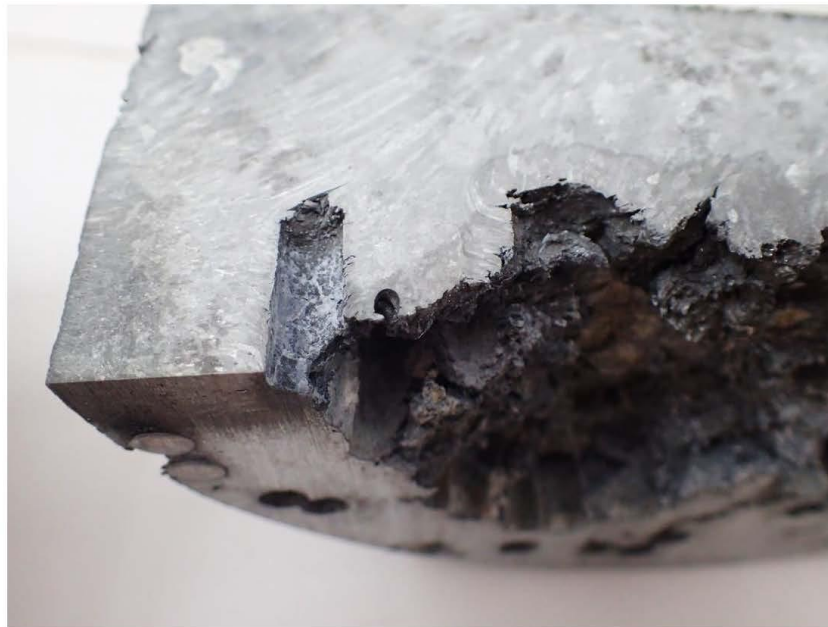
Figure 285. Oblique view of the slice 9a etch, revealing the solidification boundary between the zinc grains that grew out from the wires and the grains that grew inward from the socket inner diameter wall. Note the cone-shape of the zinc surface above where the wire-end was originally within the wire channel.

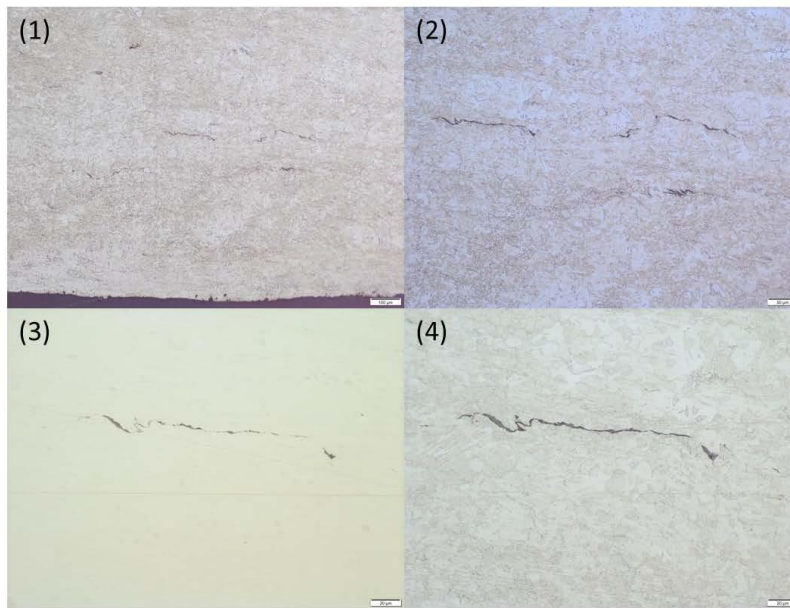
Figure 296. Close up metallograph images of some of the cracks present in Figure 295 adjacent to the cable/zinc slug boundary. (1) Tint etch at 100X. (2) Tint etch at 200X. (3) As polished at 500X. (4) Tint etch at 500X.

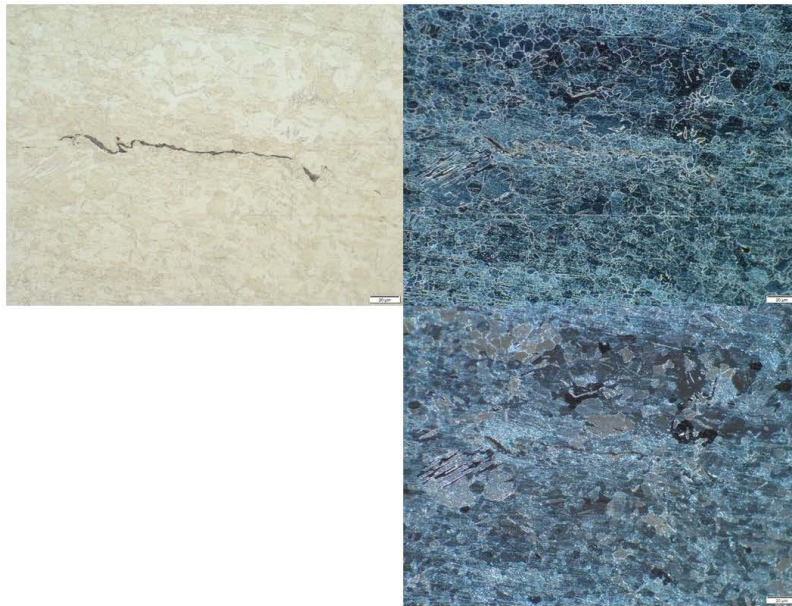
Figure 297. Close up metallograph images of the crack in Figure 296 3) and 4) in brightfield, dark field, and cross-polarized illumination. Tint etch at 500X.

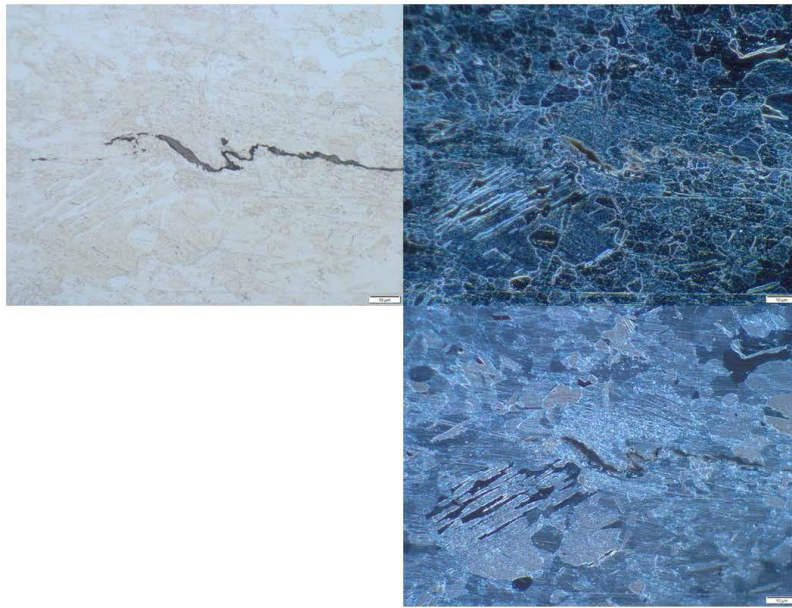
Figure 298. Close up metallograph images of the crack in Figure 297 in brightfield, dark field, and cross-polarized illumination. Tint etch at 1000X.

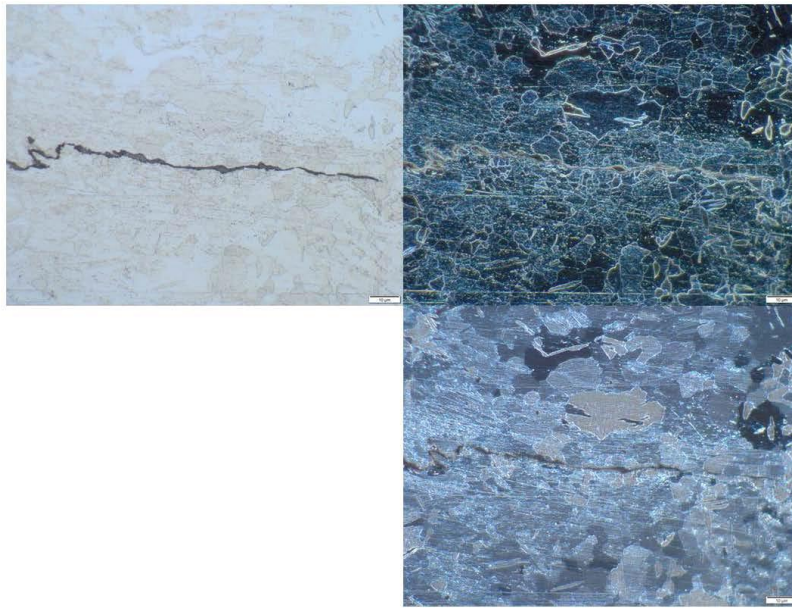
Figure 299. Close up metallograph images of the crack in Figure 297 in brightfield, dark field, and cross-polarized illumination. Tint etch at 1000X.

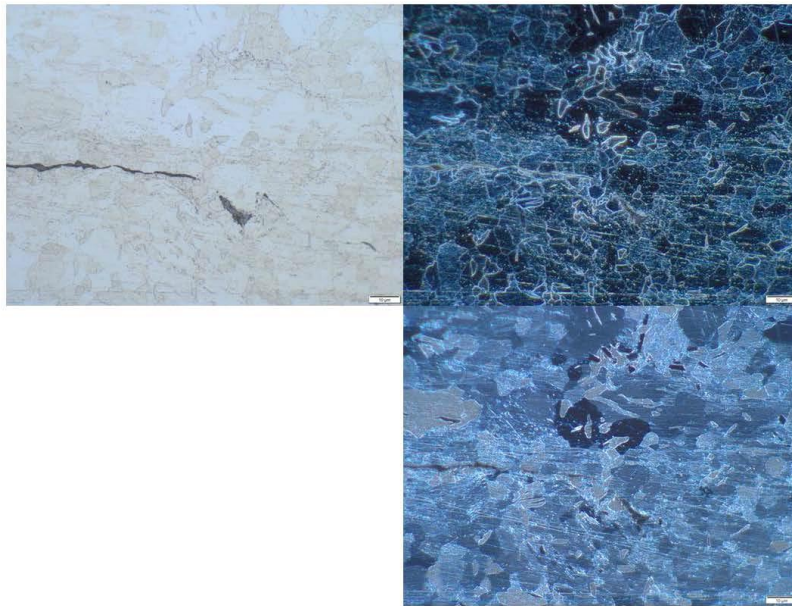
Figure 300. Close up metallograph images of the crack in Figure 297 in brightfield, dark field, and cross-polarized illumination. Tint etch at 1000X.

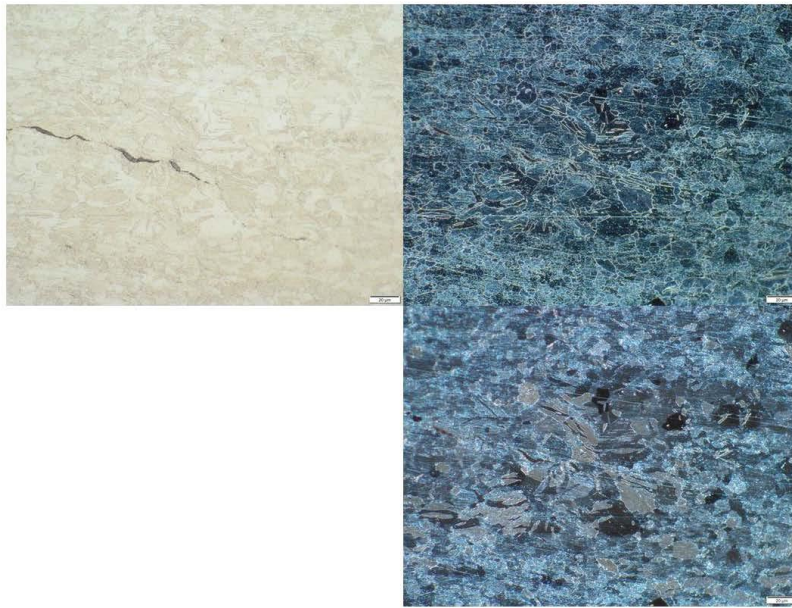
Figure 301. Close up metallograph images of a crack present in Figure 295 adjacent to the cable/zinc slug boundary. Tint etch at 500X.

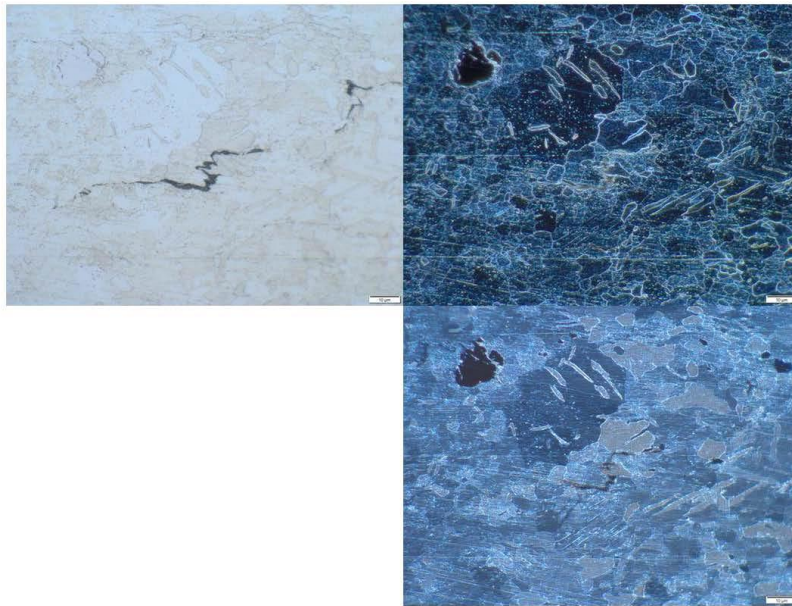
Figure 302. Close up metallograph images of a crack present in Figure 295 adjacent to the cable/zinc slug boundary. Tint etch at 1000X.

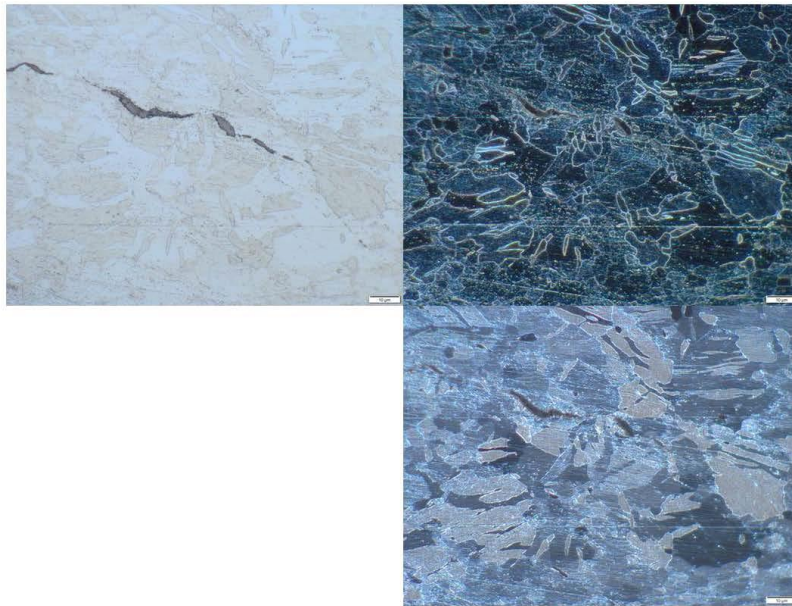
Figure 303. Close up metallograph images of a crack present in Figure 295 adjacent to the cable/zinc slug boundary. Tint etch at 1000X.

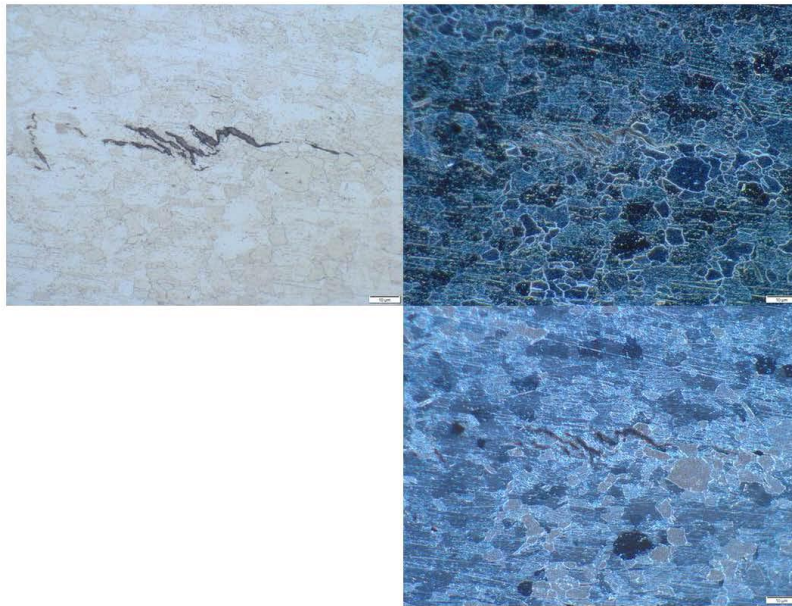
Figure 304. Close up metallograph images of a crack present in Figure 295 adjacent to the cable/zinc slug boundary. Tint etch at 1000X.

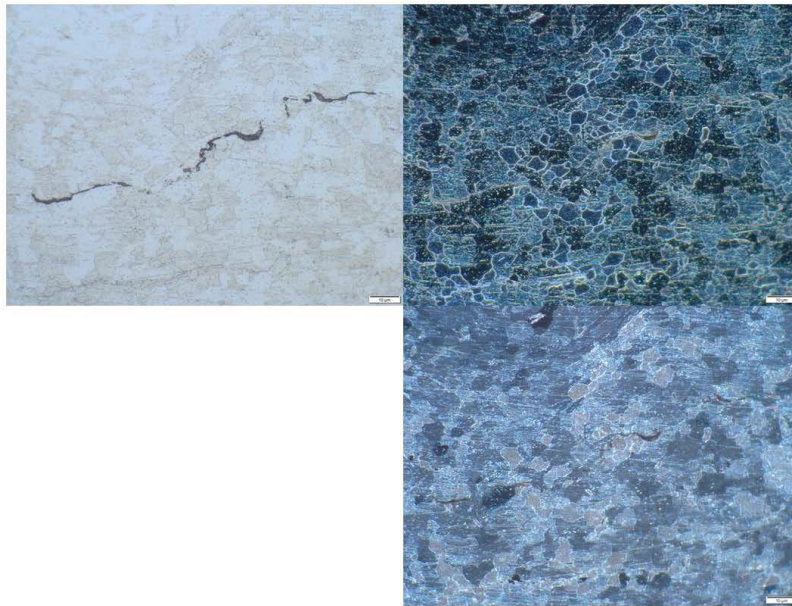
Figure 305. Close up metallograph images of a crack present in Figure 295 adjacent to the cable/zinc slug boundary. Tint etch at 1000X.

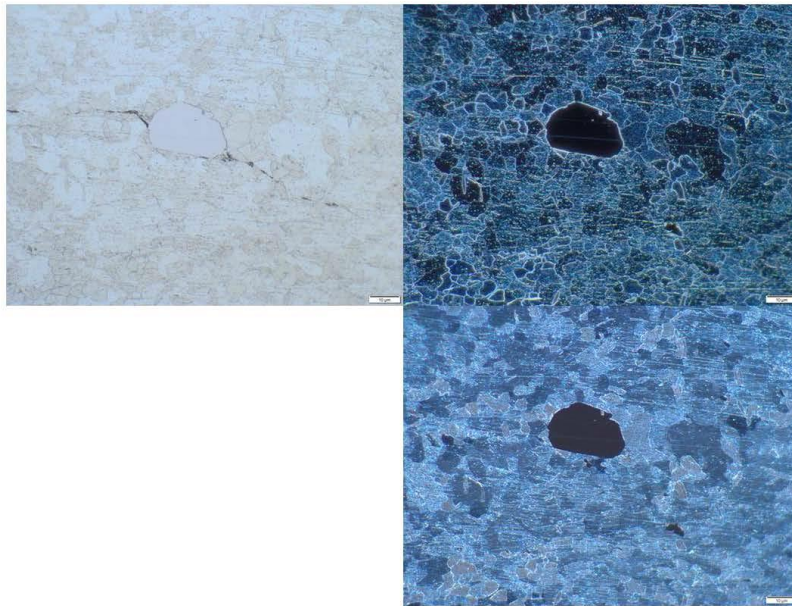
Figure 306. Close up metallograph images of a crack present in Figure 295 adjacent to the cable/zinc slug boundary. Tint etch at 1000X.

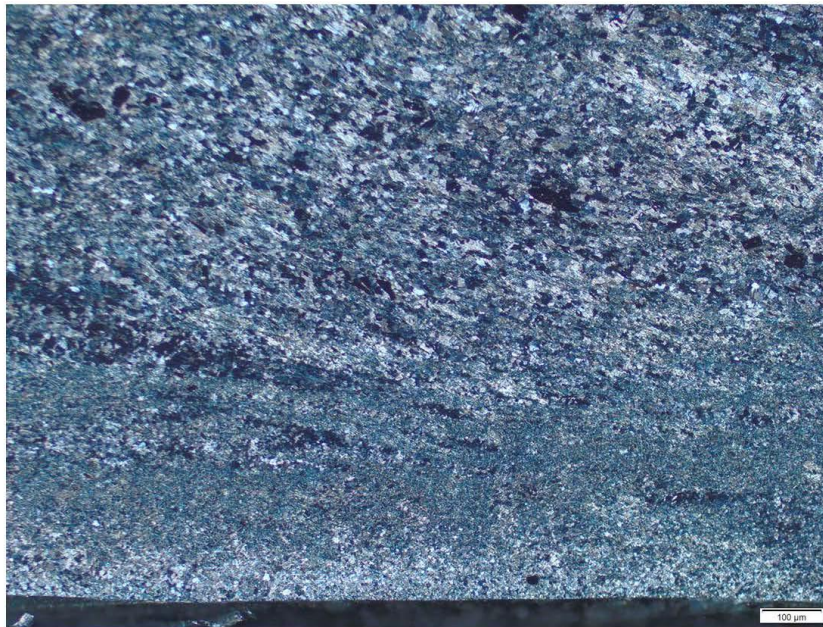
Figure 307. Metallograph image of the small grains present in Figure 295 adjacent to the cable/zinc slug boundary. Tint etch at 100X.

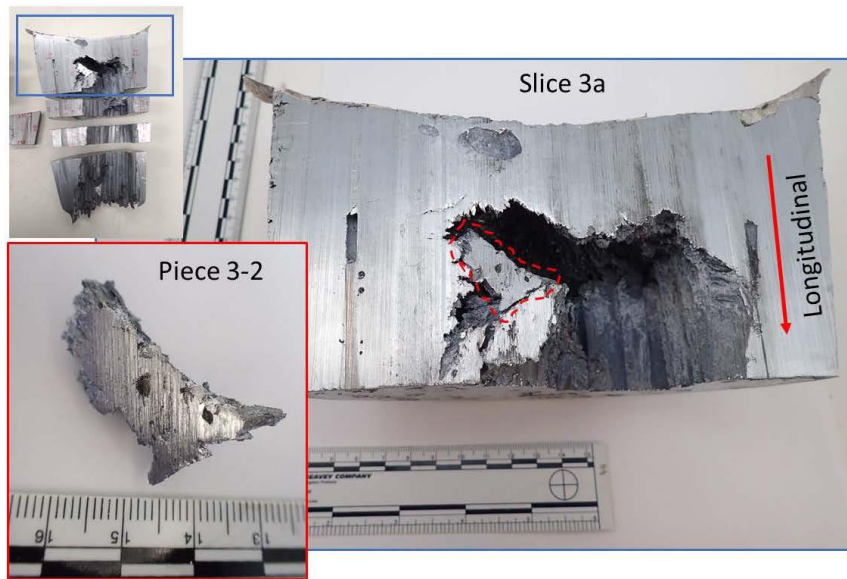
Figure 330. Piece 3-2 was taken from slice 3a and used for the accelerated corrosion test. Scale in inches and centimeters.

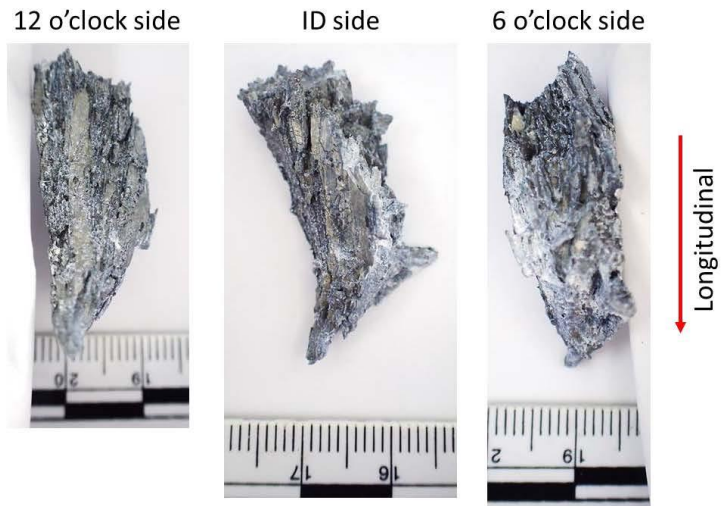
Figure 331. Piece 3-2 as-received, after removal from the socket. White areas are corrosion product. Scale in centimeters.

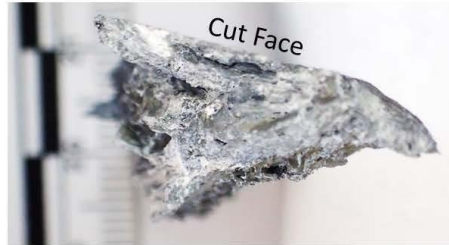
Figure 332. Piece 3-2 as-received, after removal from the socket. White areas are corrosion product. Scale in centimeters.

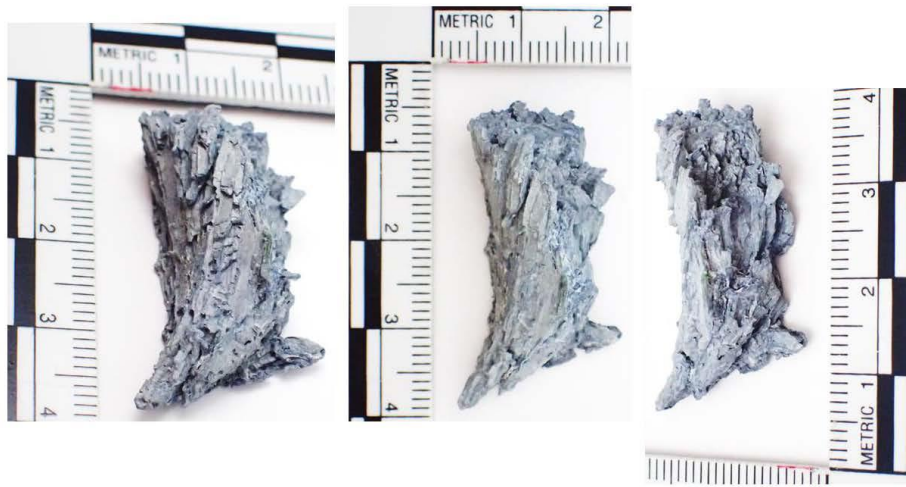
Figure 333. Piece 3-2 after two weeks of exposure to the coastal marine environment at KSC. Scale in centimeters.

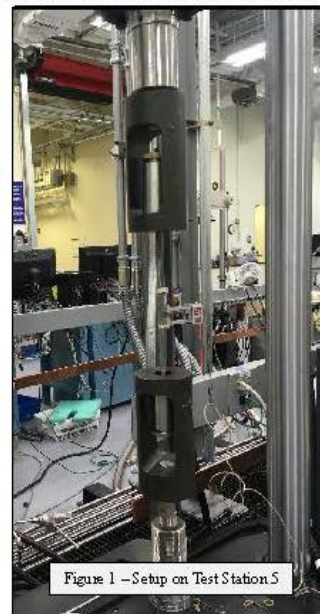
Figure 1 - Setup on Test Station 5

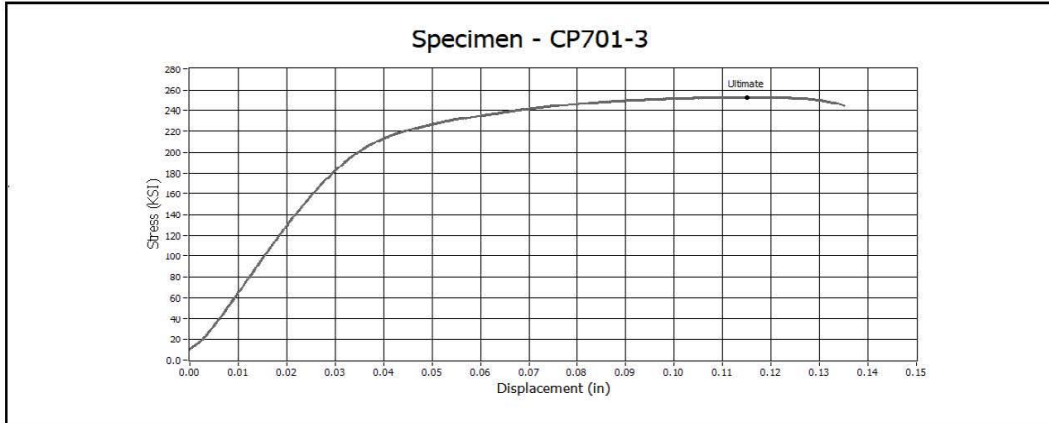
Method File:
 EM22 Tensile Test Template_v5

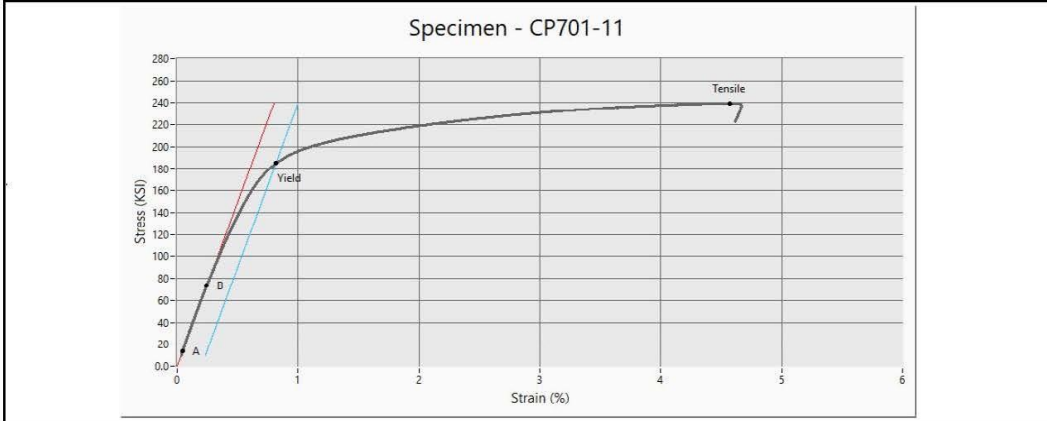
Method File:
EM22 Tensile Test Template_v5

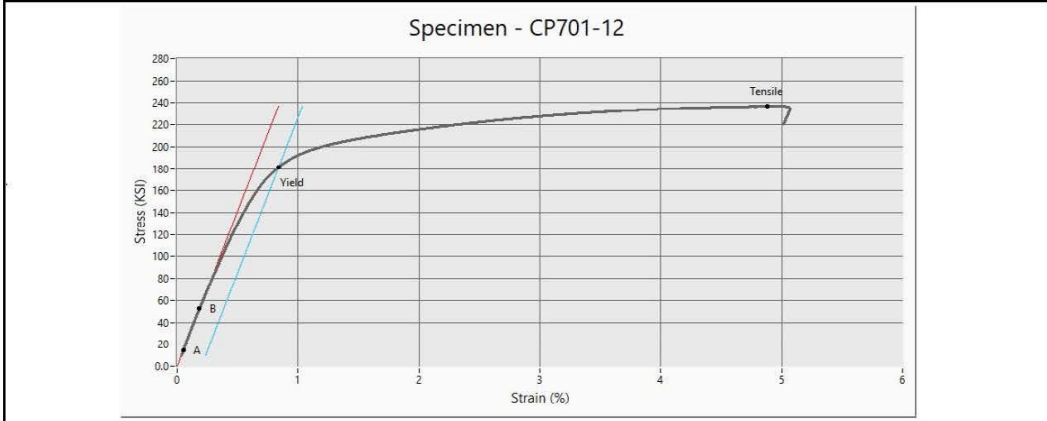
Method File:
EM22 Tensile Test Template_v5

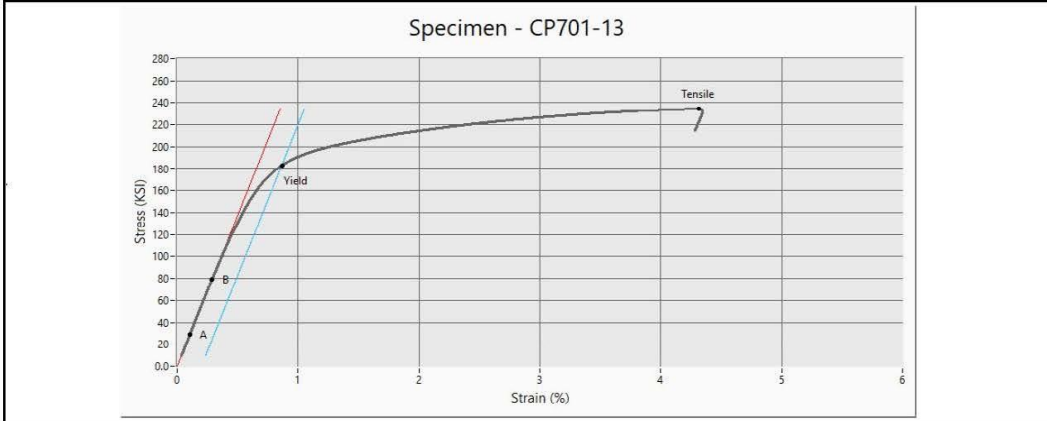
Method File:
EM22 Tensile Test Template_v5

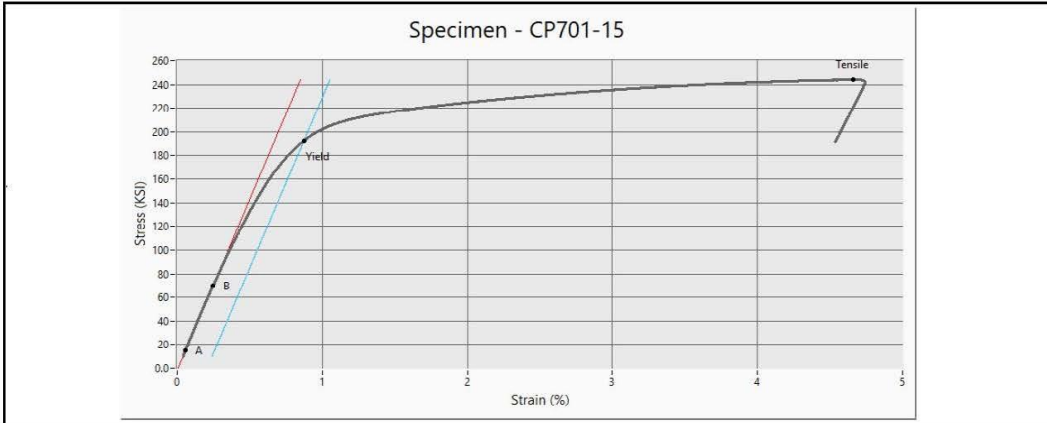
Method File:
EM22 Tensile Test Template_v5

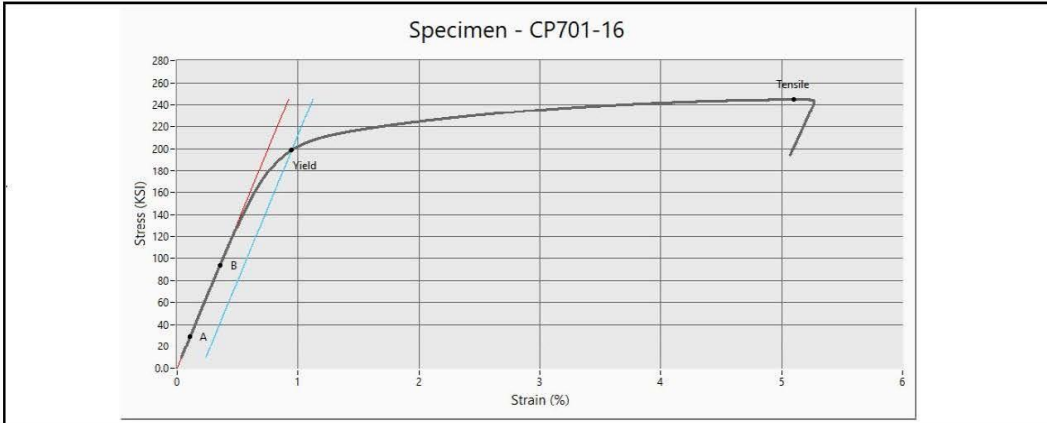
Method File:
EM22 Tensile Test Template_v5

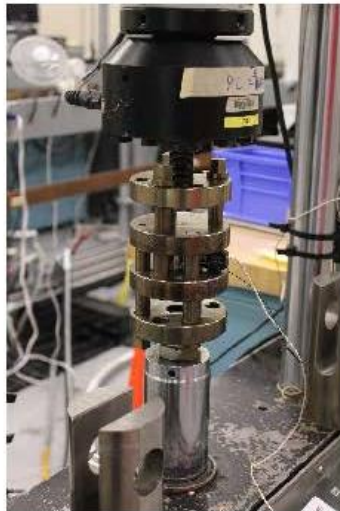
Figure 1 – Setup on Test Station 3

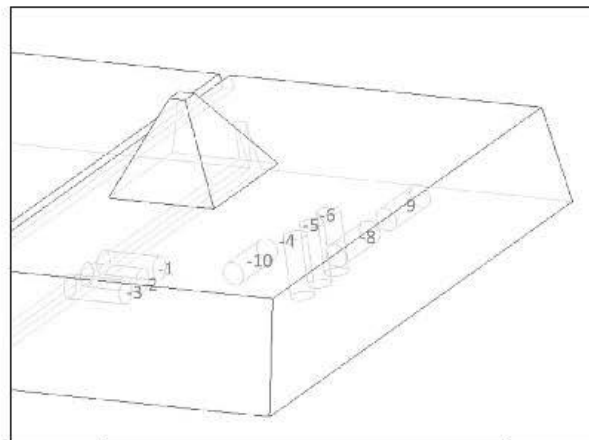
Figure 3 – Cast Zinc Ingot Diagram with Small Diameter Compression Specimen Locations and Directions

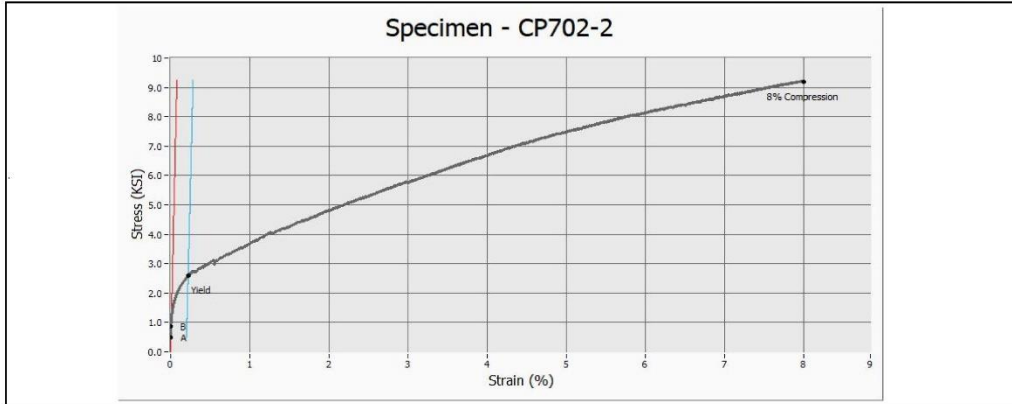
Method File:
 Compression Test to Failure with Bridgman Fixture
 Comments:

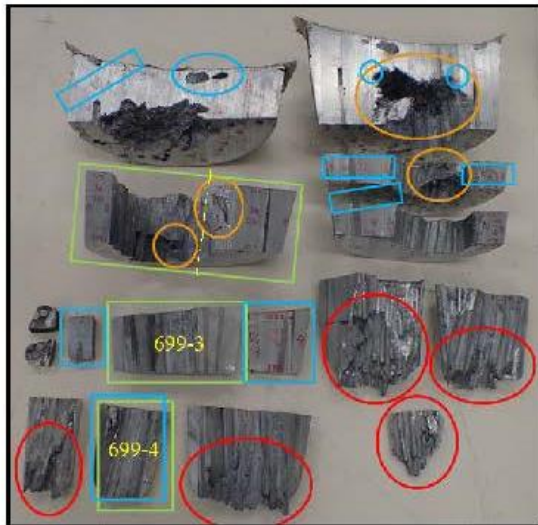
Figure 1 - Initial Dissection of Socket Slug Material

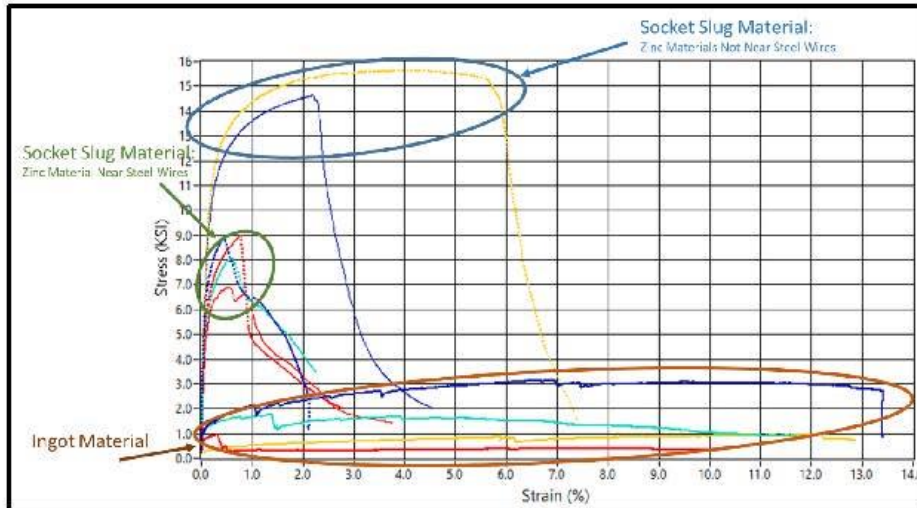
Figure 5 – Comparison of Small Scale Tensile Results

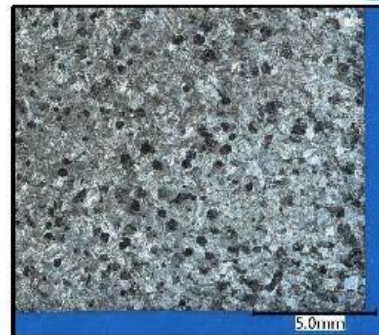
Figure 6 – Metallography of Socket Slug Material

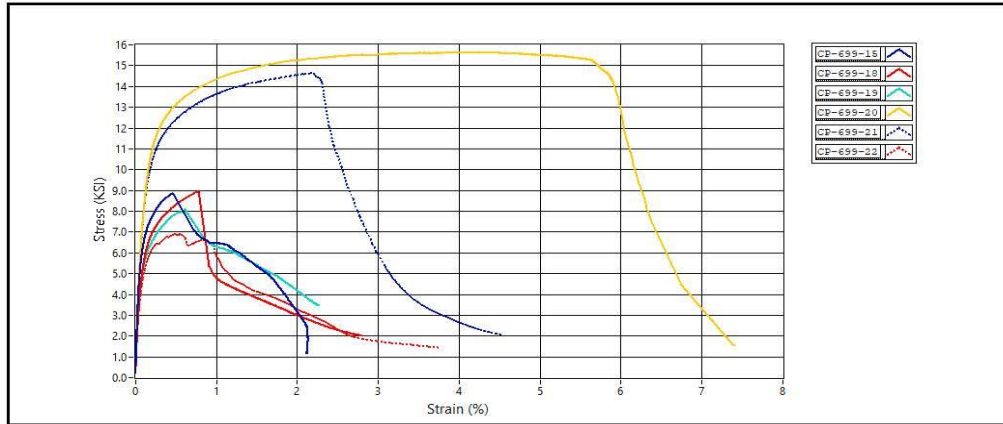
Material	Zinc
Nominal Temperature (°F)	70
Nominal Pressure (psig)	0
Test Frame	TS-26
Drawing Number	5-474

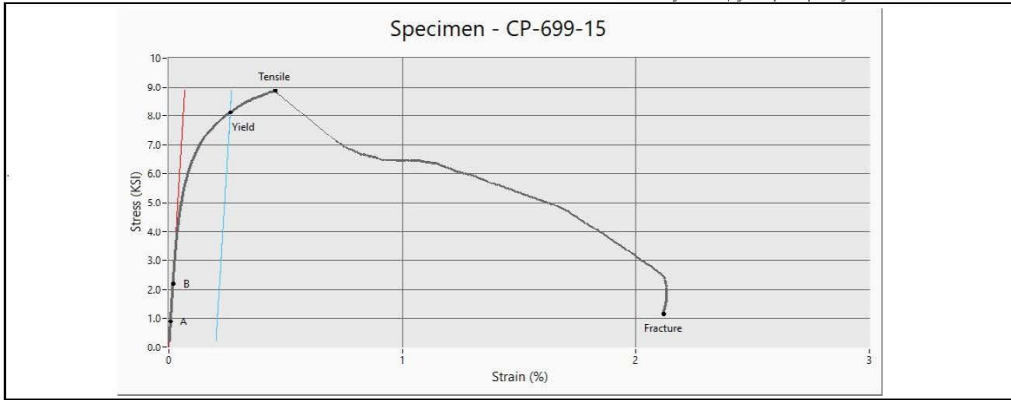
Method File:
 C:\Users\Administrator\Desktop\Catherine\EM22 Bluehill Universal Rectangular Tensile Testing Method WITH EXTENSOMETER - SpaceX BellowW1.3.im_tens
 Comments:

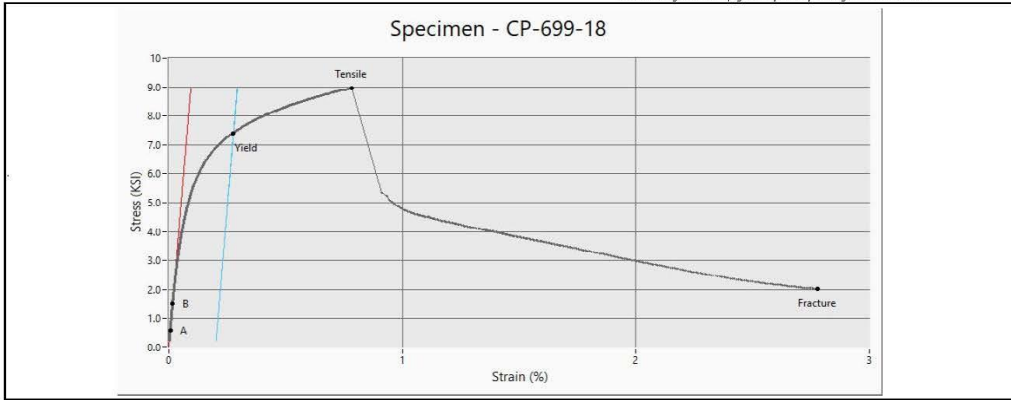
Method File:
 C:\Users\Administrator\Desktop\Catherine\EM22 Bluehill Universal Rectangular Tensile Testing Method WITH EXTENSOMETER - SpaceX BellowW1.3.im_tens
 Comments:

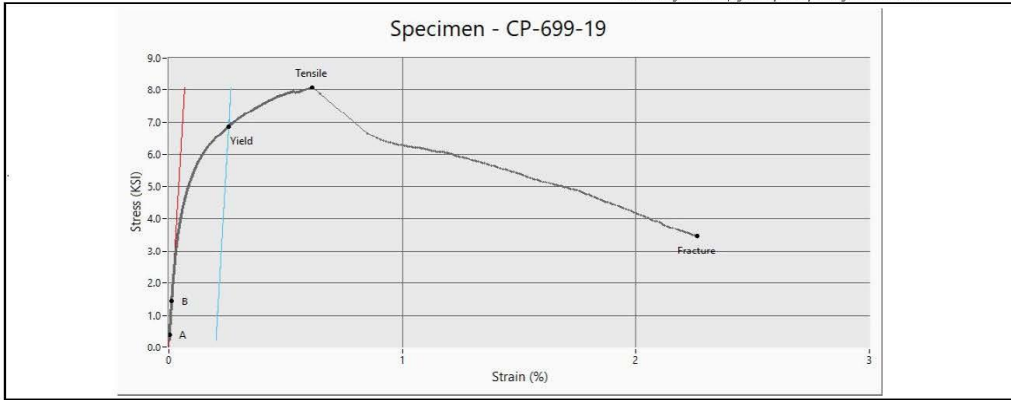
Method File:
 C:\Users\Administrator\Desktop\Catherine\EM22 Bluehill Universal Rectangular Tensile Testing Method WITH EXTENSOMETER - SpaceX BellowW1.3.im_tens
 Comments:
