NASA/TM-20210017934
NESC-RP-20-01585

Arecibo Observatory Auxiliary M4N Socket Termination Failure Investigation

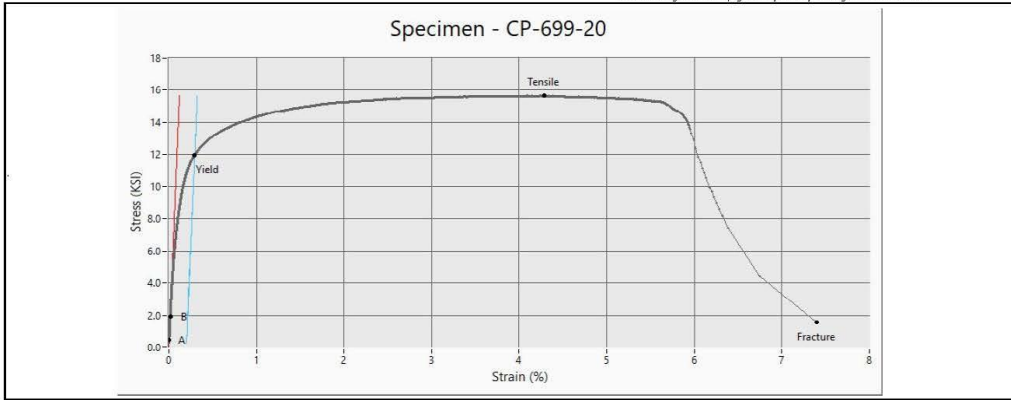
Method File:
 C:\Users\Administrator\Desktop\Catherine\EM22 Bluehill Universal Rectangular Tensile Testing Method WITH EXTENSOMETER - SpaceX BellowW1.3.im_tens
 Comments:

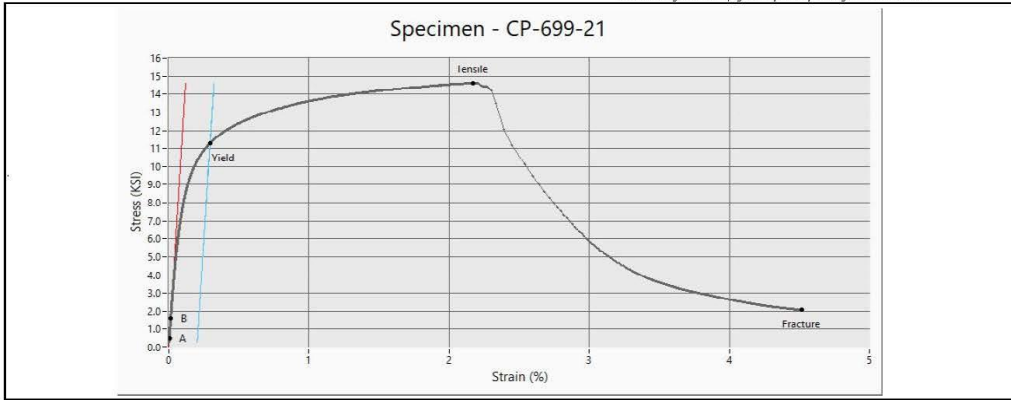
Method File:
 C:\Users\Administrator\Desktop\Catherine\EM22 Bluehill Universal Rectangular Tensile Testing Method WITH EXTENSOMETER - SpaceX BellowW1.3.im_tens
 Comments:

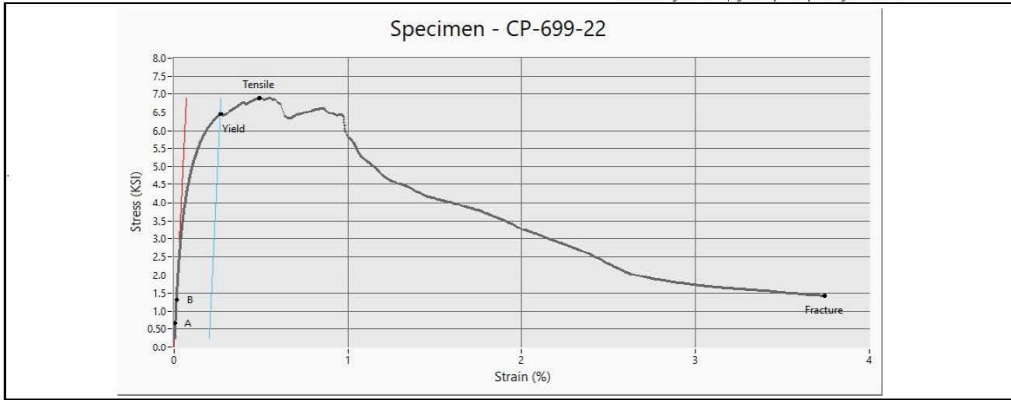
Method File:
 C:\Users\Administrator\Desktop\C:\athena\EM22 Bluehill Universal Rectangular Tensile Testing Method WITH EXTENSOMETER - SpaceX BellowW1.3.im_tens
 Comments:

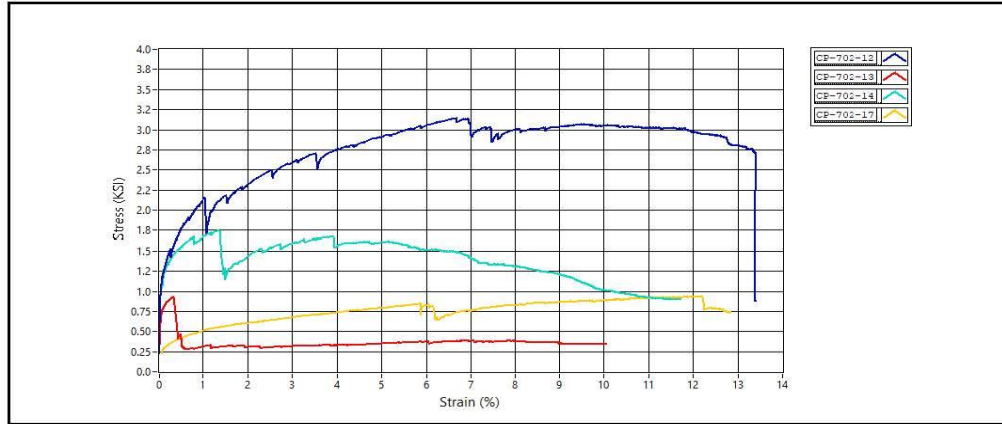
Material:	Zinc
Nominal Temperature (°F):	70
Nominal Pressure (psig):	0
Test Frame:	TS-26
Drawing Number:	S-474

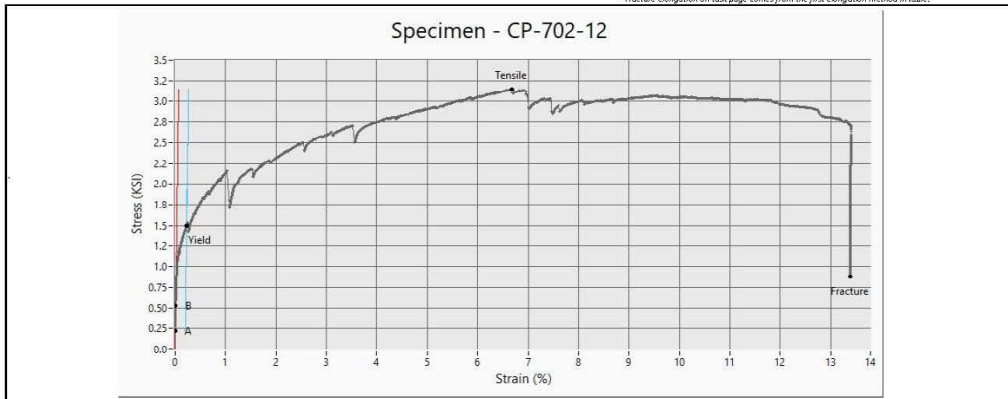
Method File:
 C:\Users\Administrator\Desktop\C:\athena\EM22 Bluehill Universal Rectangular Tensile Testing Method WITH EXTENSOMETER.im_lens
 Comments:

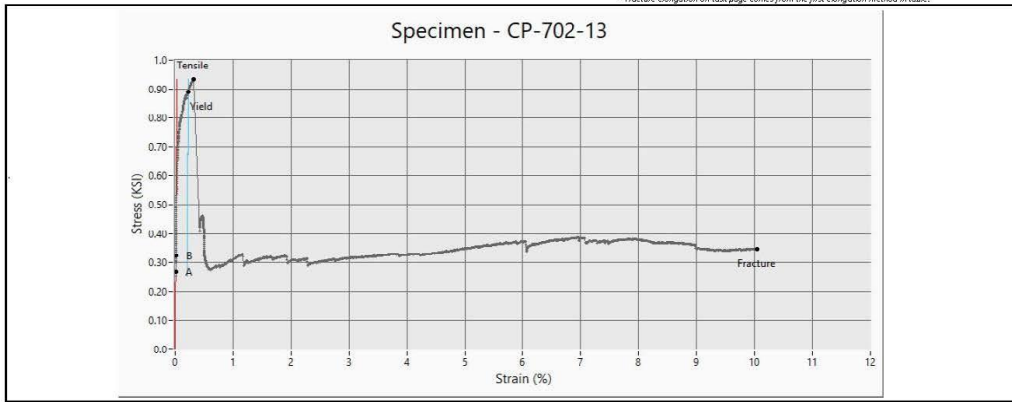
Method File:
 C:\Users\Administrator\Desktop\Catherine\EM22 Bluehill Universal Rectangular Tensile Testing Method WITH EXTENSOMETER.in_lens
 Comments:

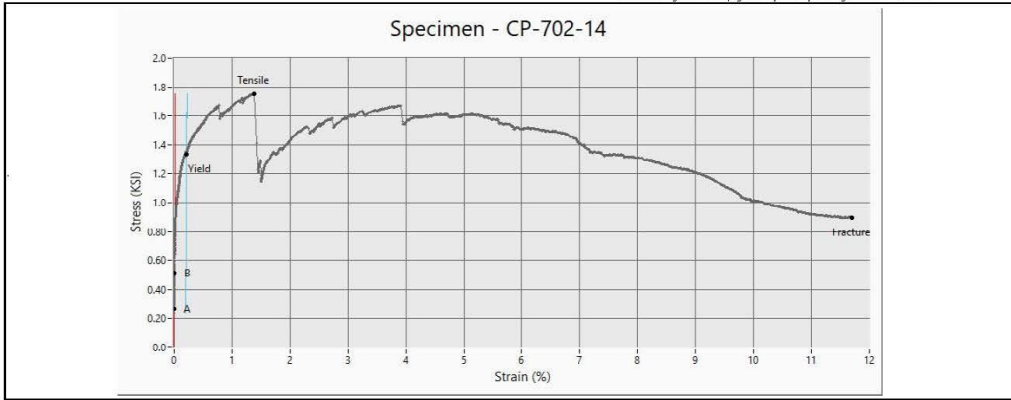
Method File:
 C:\Users\Administrator\Desktop\Catherine\EM22 Bluehill Universal Rectangular Tensile Testing Method WITH EXTENSOMETER.in_lens
 Comments:

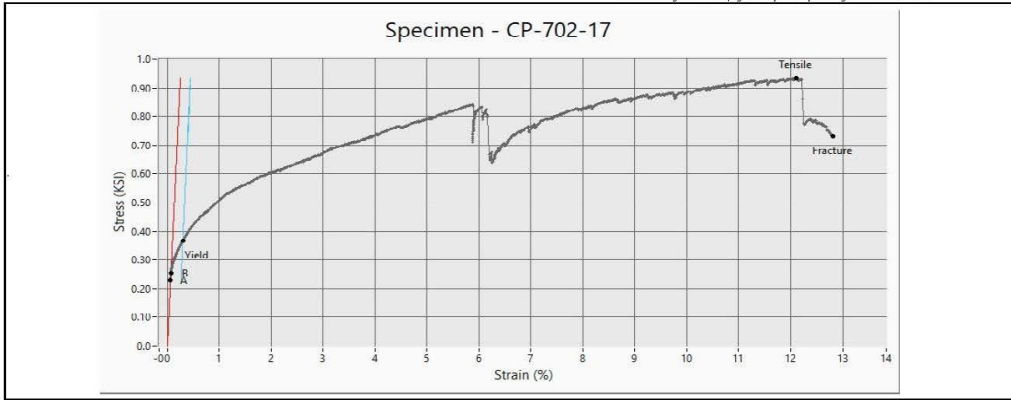
Method File:
 C:\Users\Administrator\Desktop\C:\athena\EM22 Bluehill Universal Rectangular Tensile Testing Method WITH EXTENSOMETER.im_lens
 Comments:

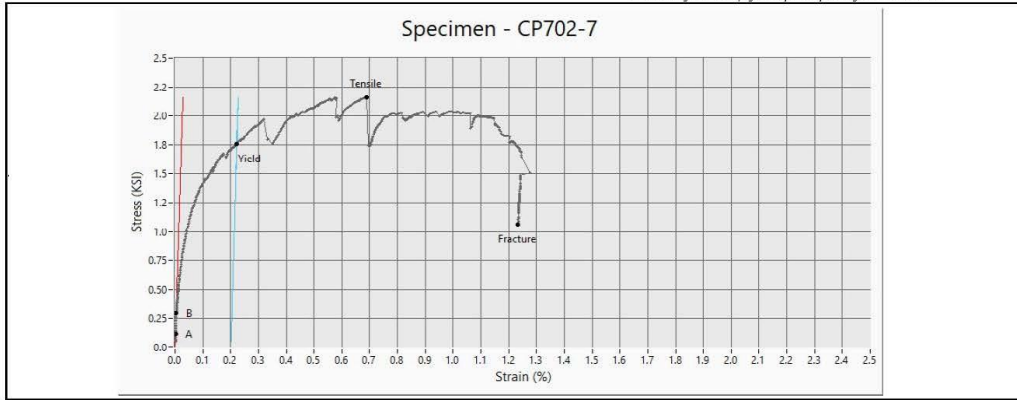
¹ Fracture elongation on task page comes from the first elongation method in table.

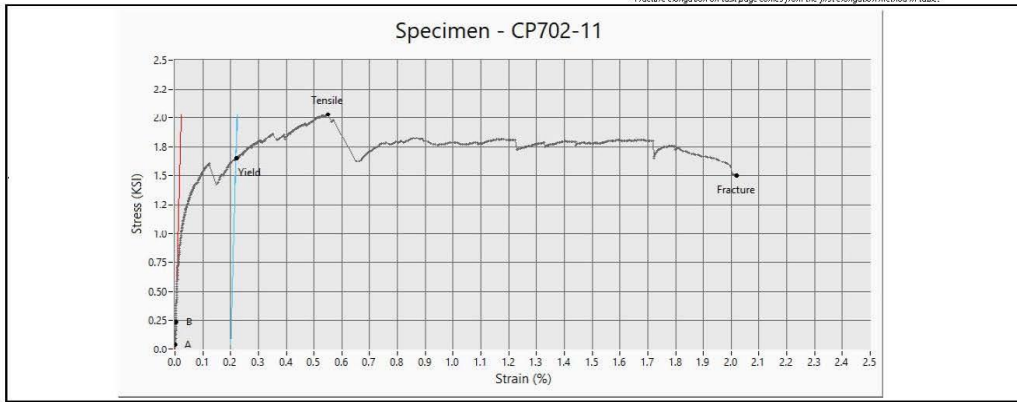
* Fracture elongation on task page comes from the first elongation method in table.

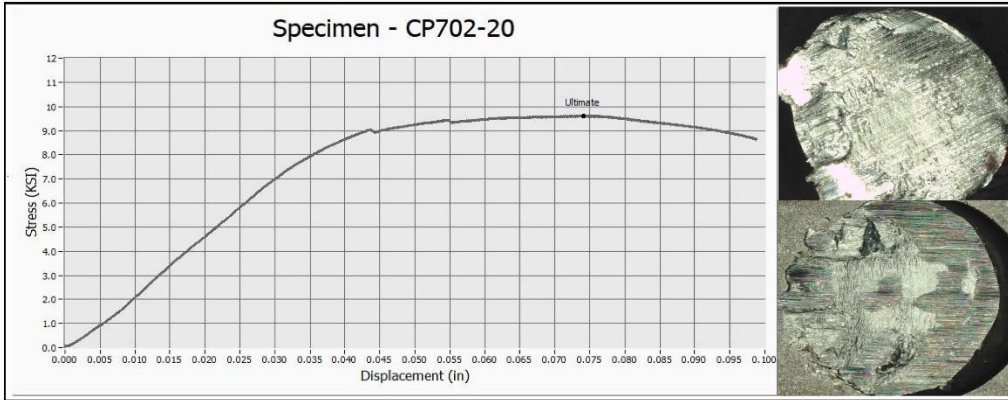
Method File:
 C:\Data\2021\2021-0110\2021-0110 Seq 7\2021-0110 - NO EXTENSOMETER 1.in.tens
 Comments:

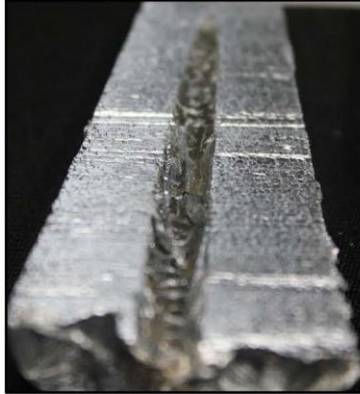
Figure 3 – Bisected Zinc Slug from Composite8 Specimen

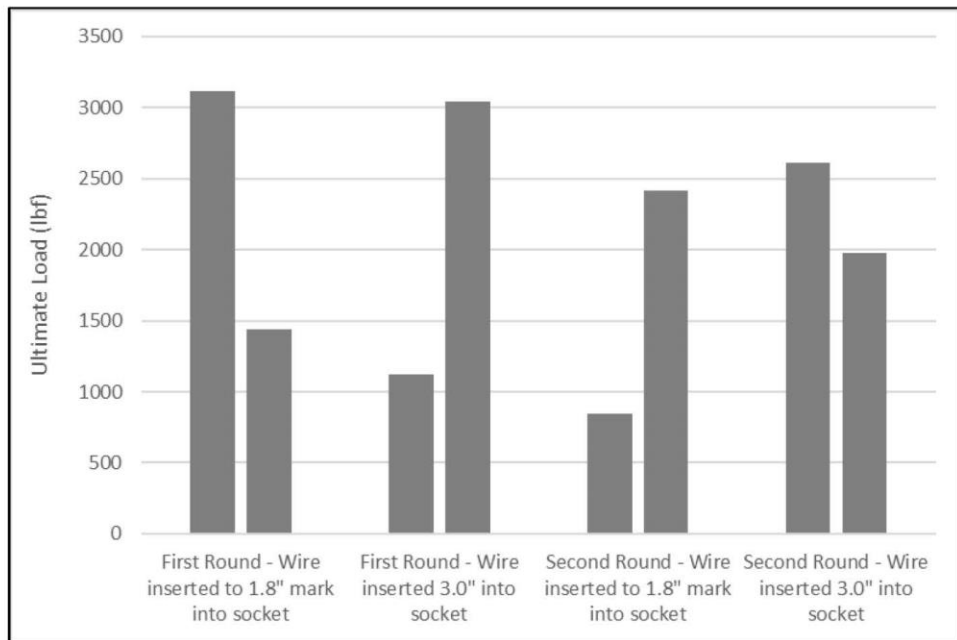
Figure 5 – Ultimate Load Comparison

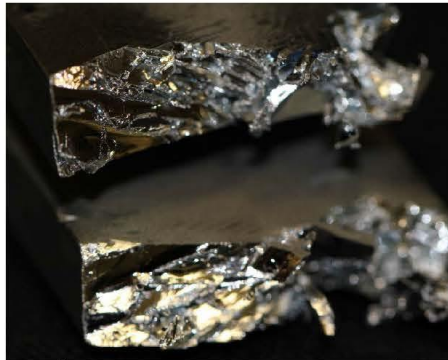
Figure 2: Digital Image of Fractured Specimen

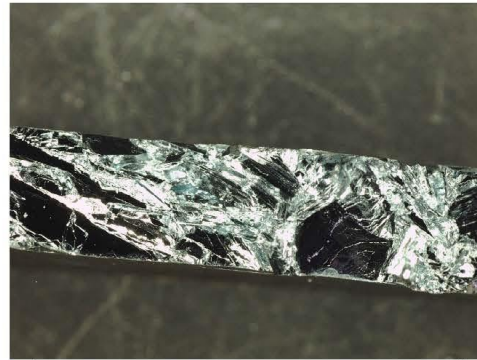
Figure 3: Image of Fractured Specimen – Originally 12x

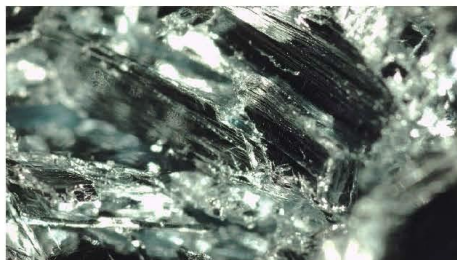
Figure 4: Image of Fractured Specimen – Originally 40x

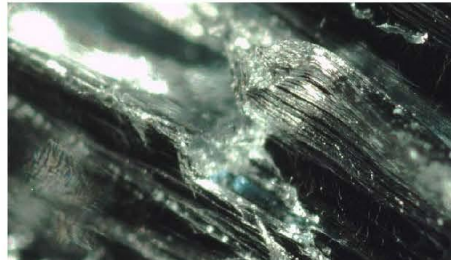
Figure 5: Image of Fractured Specimen – Originally 120x

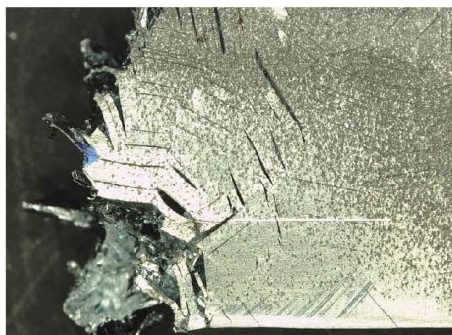
Figure 6: Top Image of Fractured Specimen

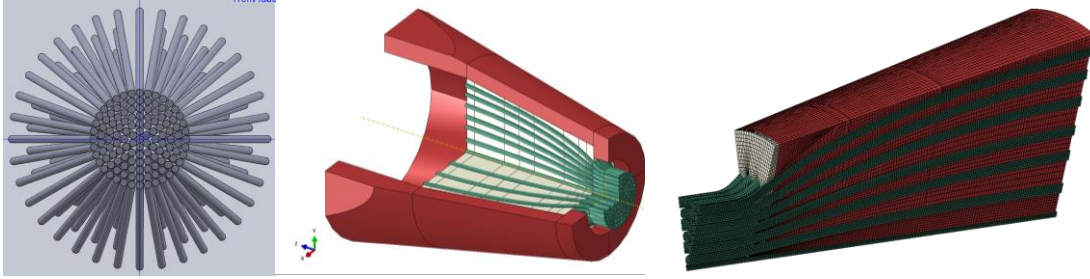
Figure C-1. Socket is Modeled as Simplified Version that does not Consider Clevis Pin and Holes

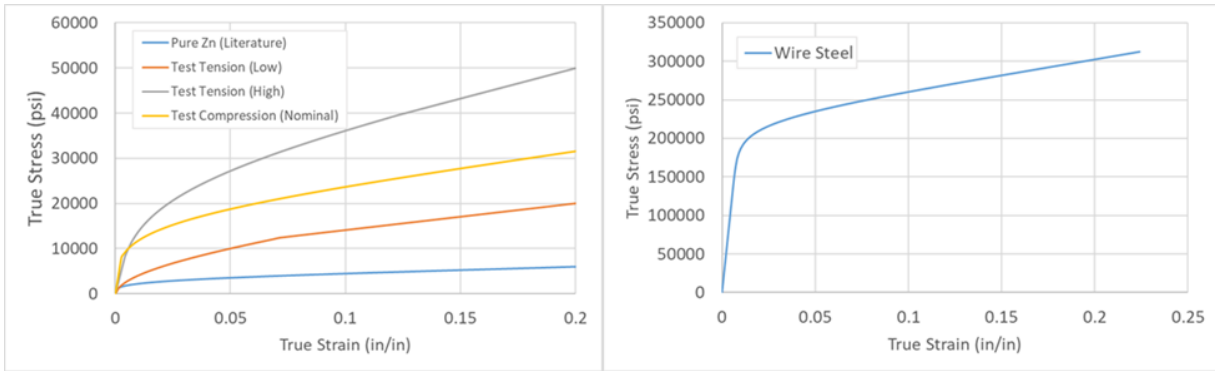
Figure C-2. True Stress-Strain Curves for the Range of Zinc Material Properties (left) and Baseline Steel Material Property (right)

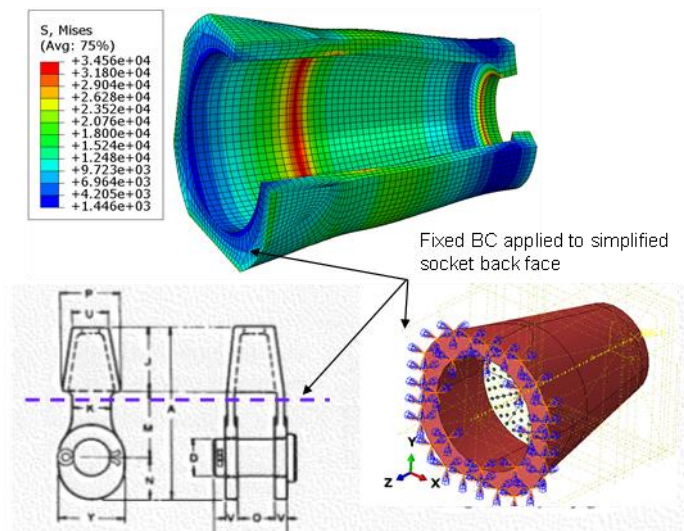
Figure C-3. Clevis Joint was not Modeled in Baseline FEMs as its Effects were Found to be Insignificant

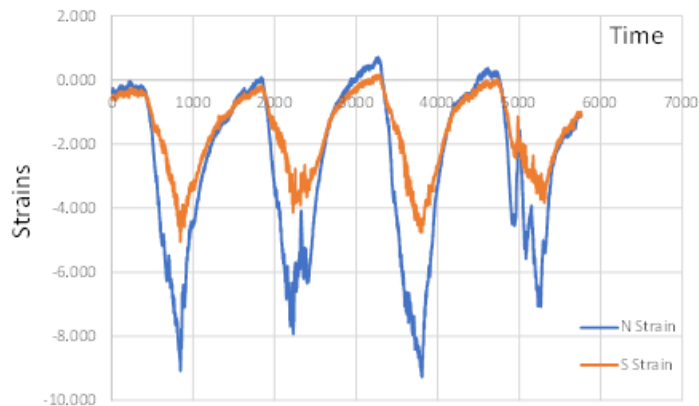
Figure C-6. Strain Measurements in Microstrain between October 30 and November 2, 2020 (timescale in seconds)

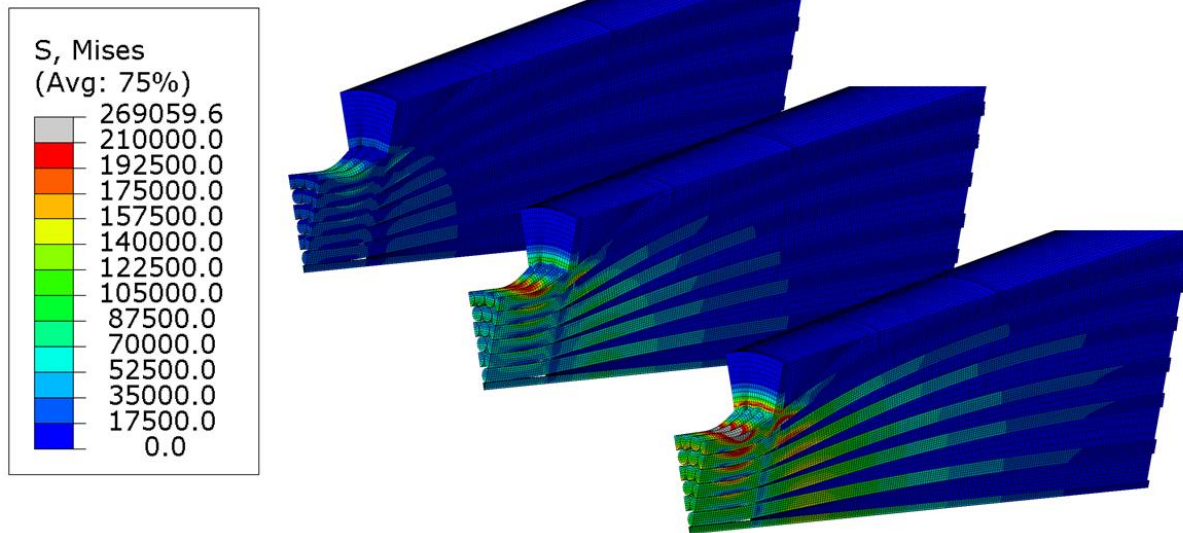
Figure C-7. As Loading in Cables Increases (left to right), the Zinc Distributes Load amongst Wires within Socket in Mechanism Analogous to Metal Matrix Reinforced Composites

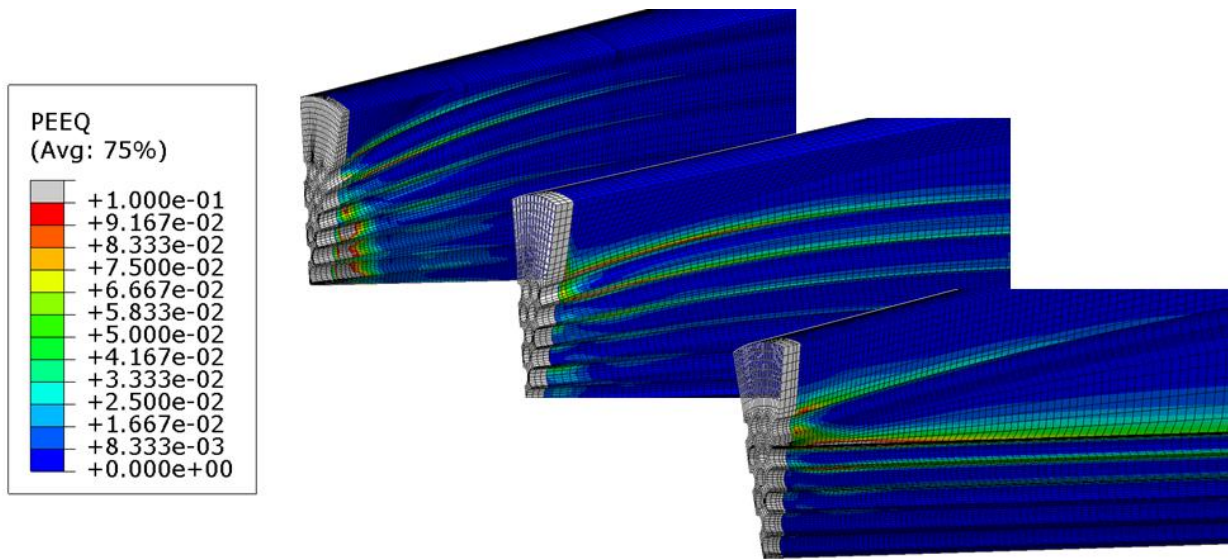
Figure C-8. Comparison of Representative Zinc Plastic Strain Fields for Three Different Wire Brooming Configurations, highlighting Bands of Significant Shear for Less-broomed Cable Ends

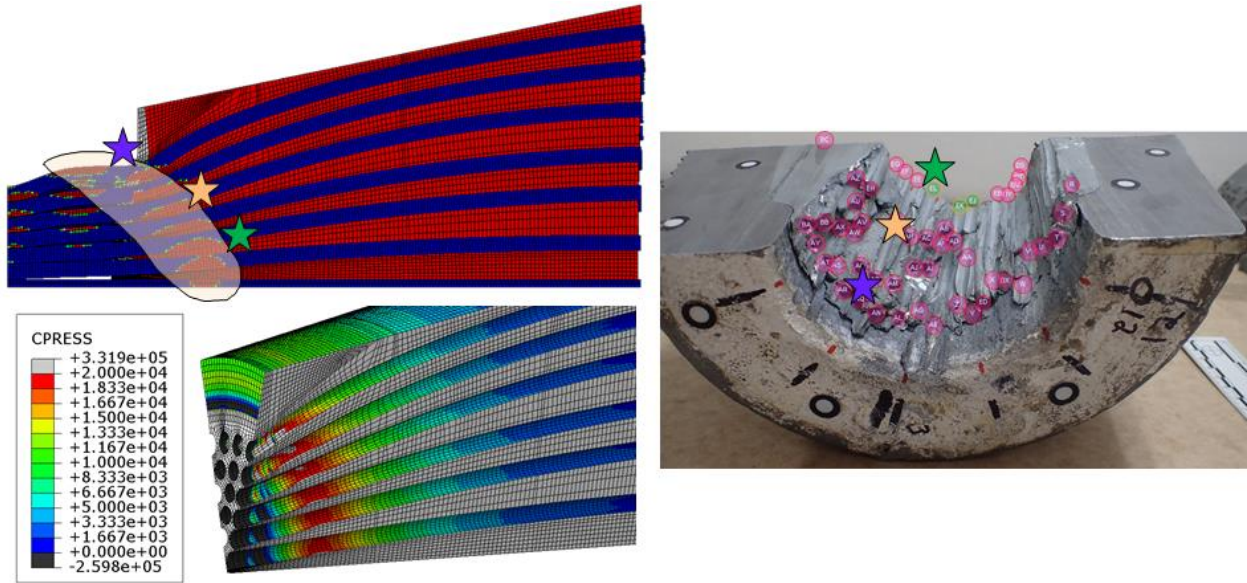
Figure C-9. Highest Stresses were not Predicted to be Planar; Failure Surface followed a Spheroid Shape, matching Stepped Patterns seen in Forensic Investigation
 Regions of colored stars show different "steps" of failure in socket. Note that yellow shading (top left) and red high stress zones (lower left) match shape of failure surfaces in right figure.

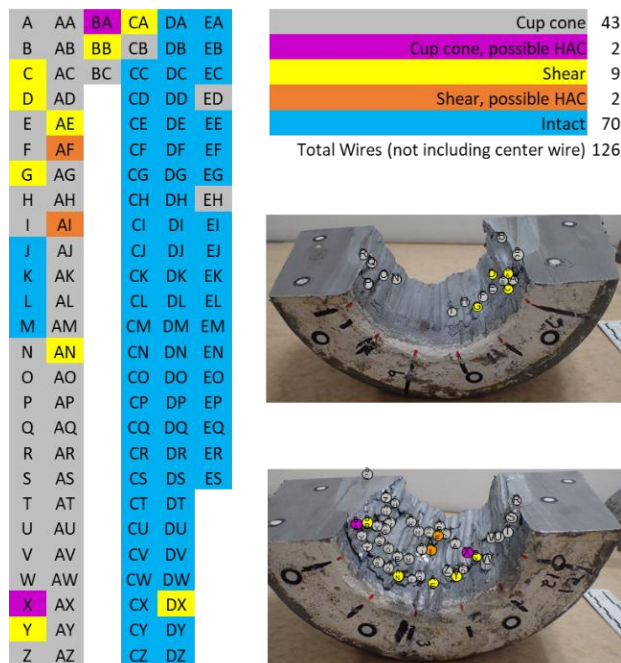
Figure C-10. Many Outer Wires Exhibited a Shear-type Failure (orange and yellow), while Inner wires exhibited Cup-cone Failure (gray and purple)

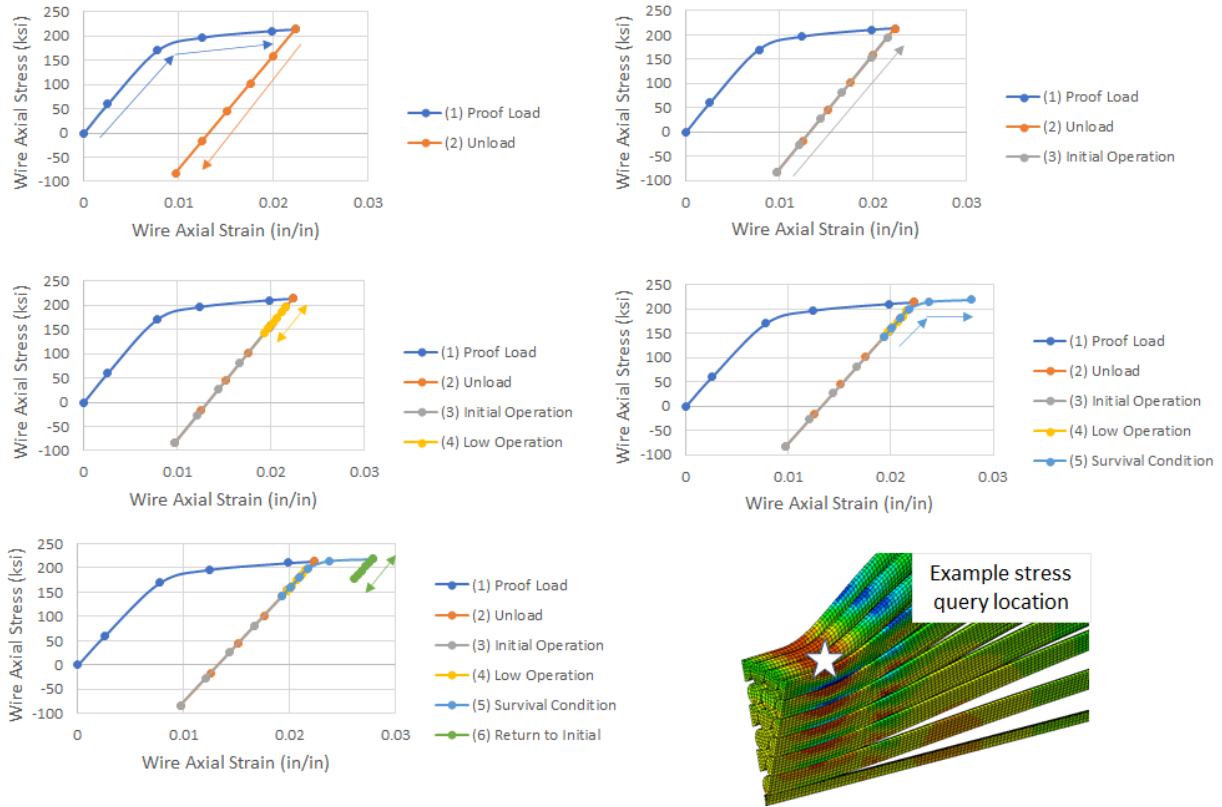
Figure C-12. Stress History and Hysteresis from Repeated Loading above Proof Load Level
Stresses Shown from Starred Location in Bottom Right Graphic.

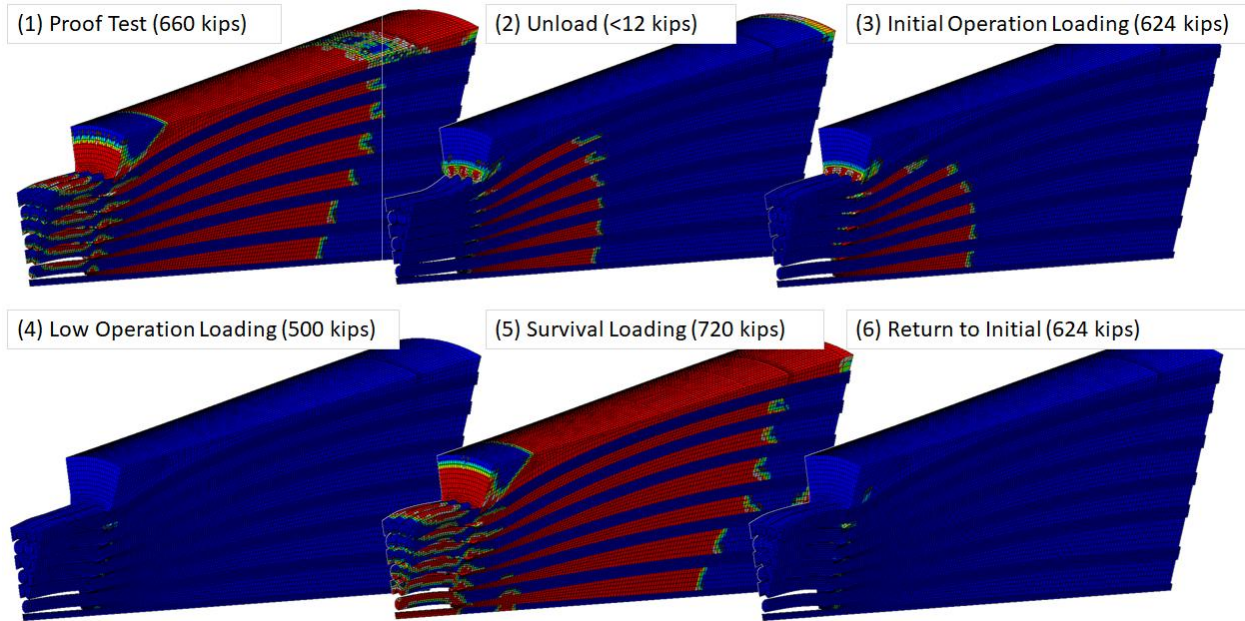
Figure C-13. Yield State (shown in red) for Zinc and Wires for each Analysis Step

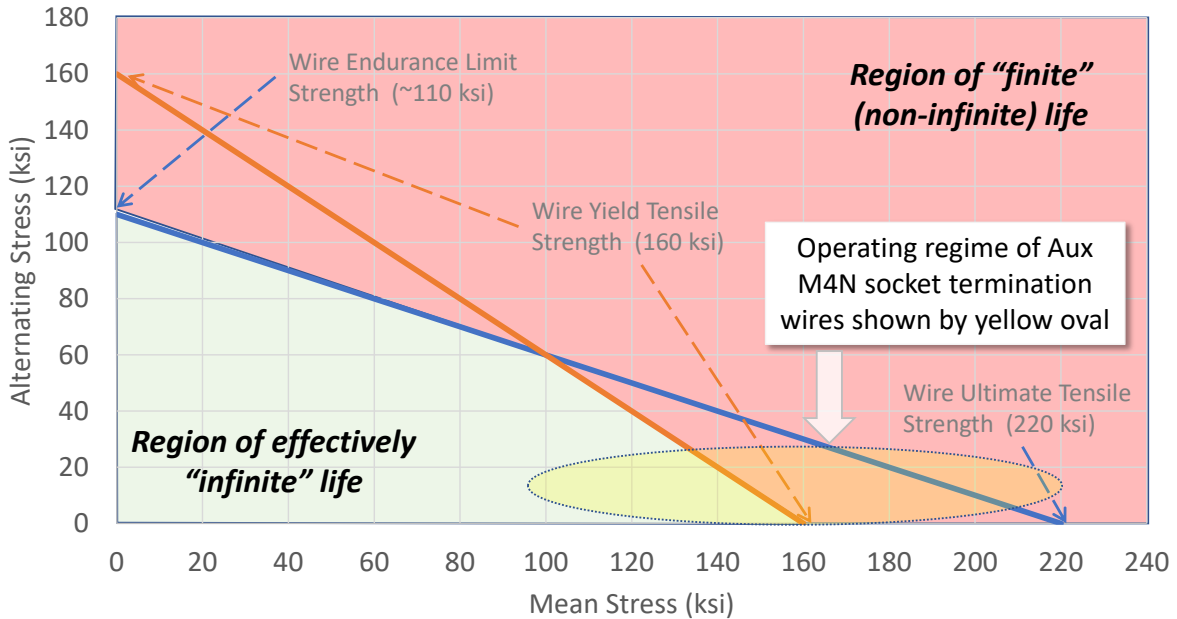
Figure C-14. Modified Goodman Diagram showing Separation of Finite and Infinite Life Regions with Annotations for Aux M4N Operational Space

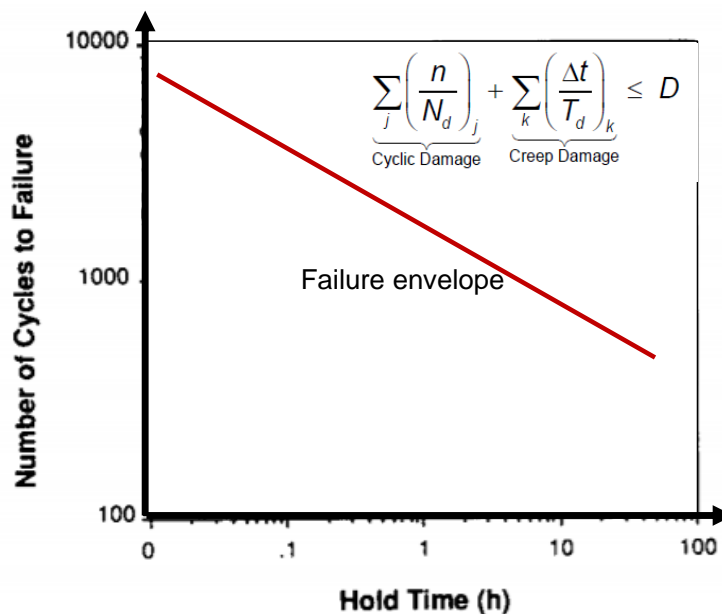
Figure C-15. Cumulative Damage Can Occur due to Combination of Cyclic Loading and Sustained Loading

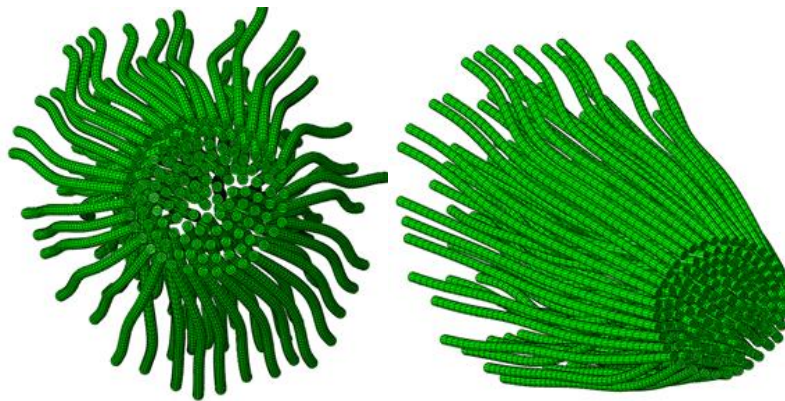
Figure C-16. Isometric Views of As-built Wire Brooming within Failed M4N Socket

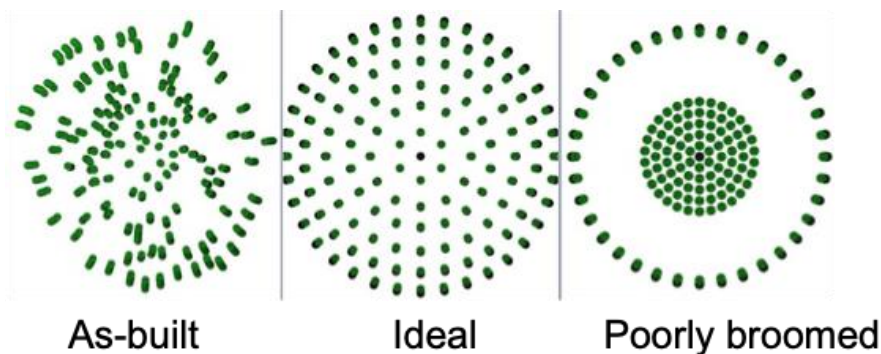
Figure C-17. As-built Wire Distribution compared with Ideal Brooming Configuration and Poorly Broomed Configuration

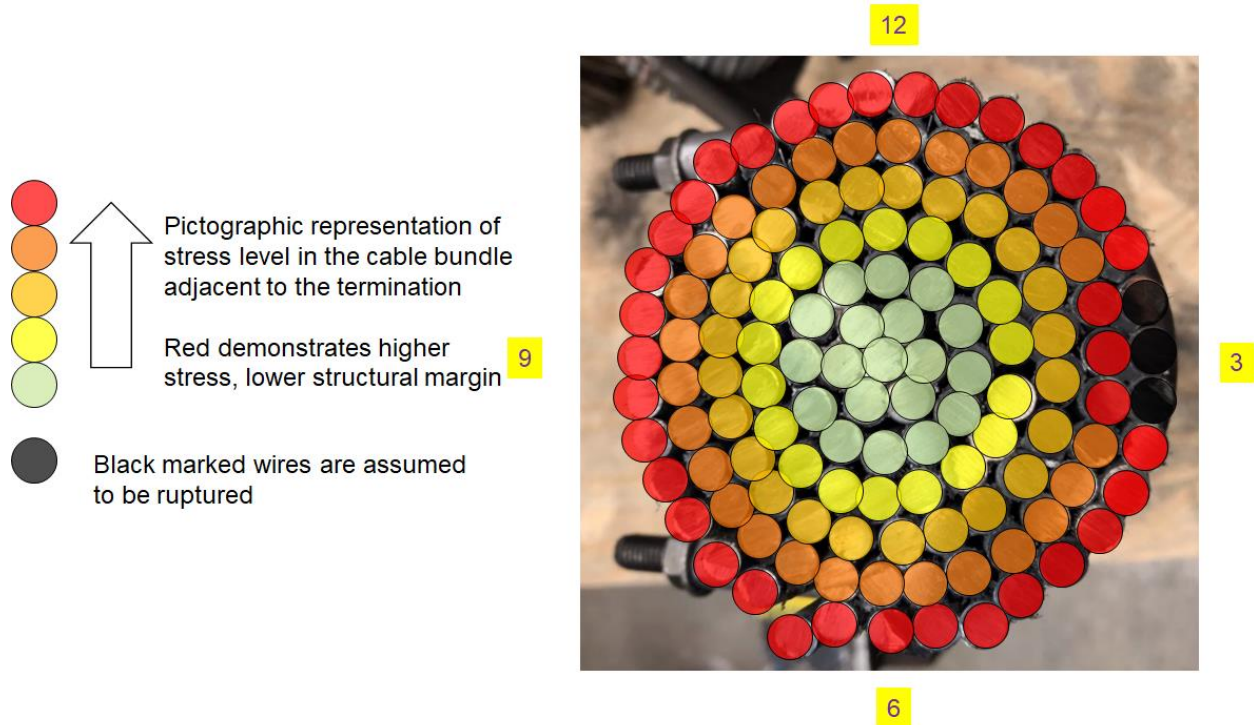
Figure C-19. Pictographic Representation of Wire Stress over Cross Section and Initially Failed Wires at 3 o'clock Side

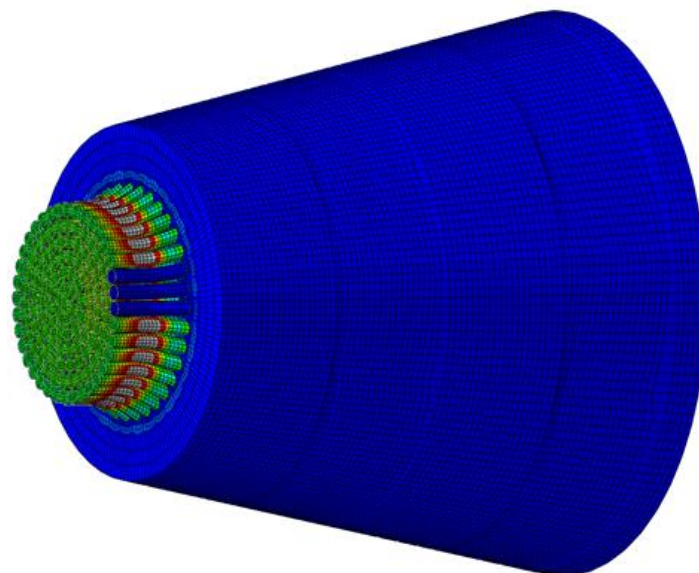
Figure C-20. FEM Visualization of Three Initially Failed Wires

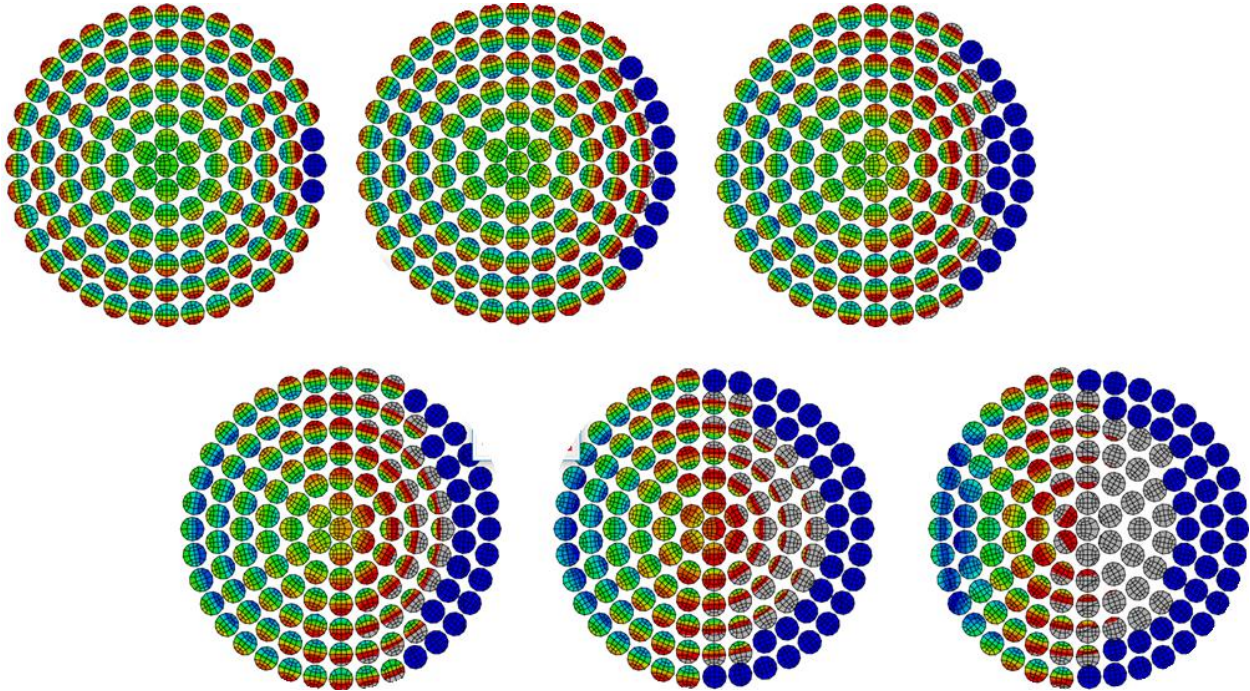
Figure C-21. Model Cross-sectional Stresses for Differing Numbers of Failed Wires showing Stress Redistribution Radially and Circumferentially

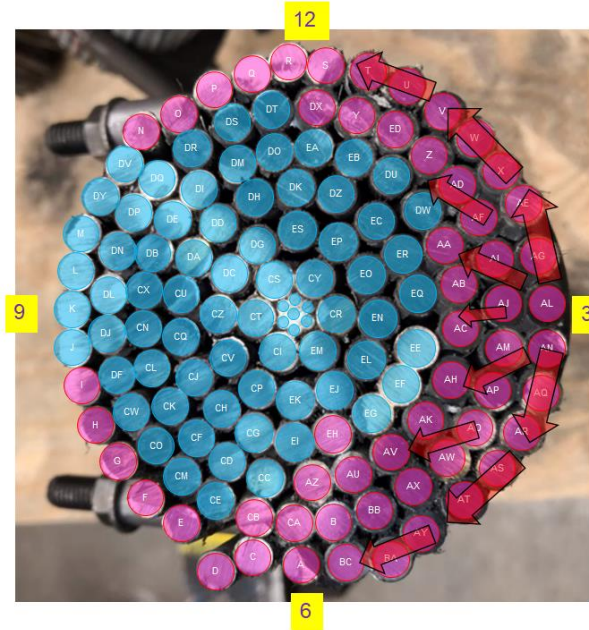
Figure C-22. Pictographic Representation of Failure Progression Overlaid on Forensics Failure Mode Coloring

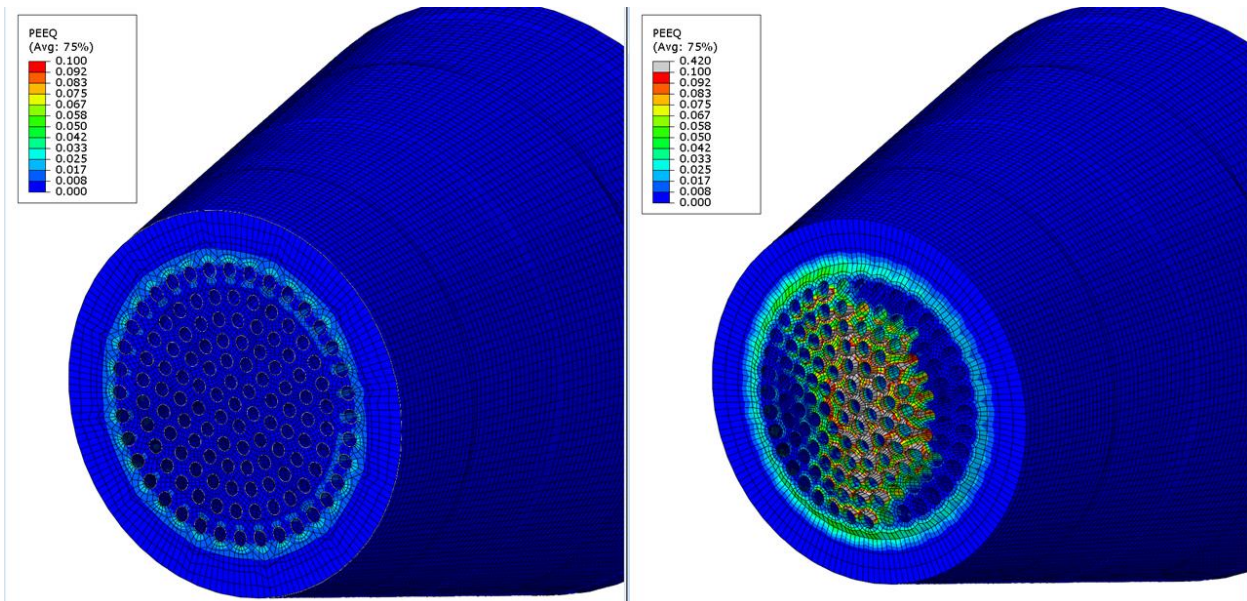
Figure C-23. Plastic Strain Field Comparison between Three (left) and 38 Failed Wires (right)

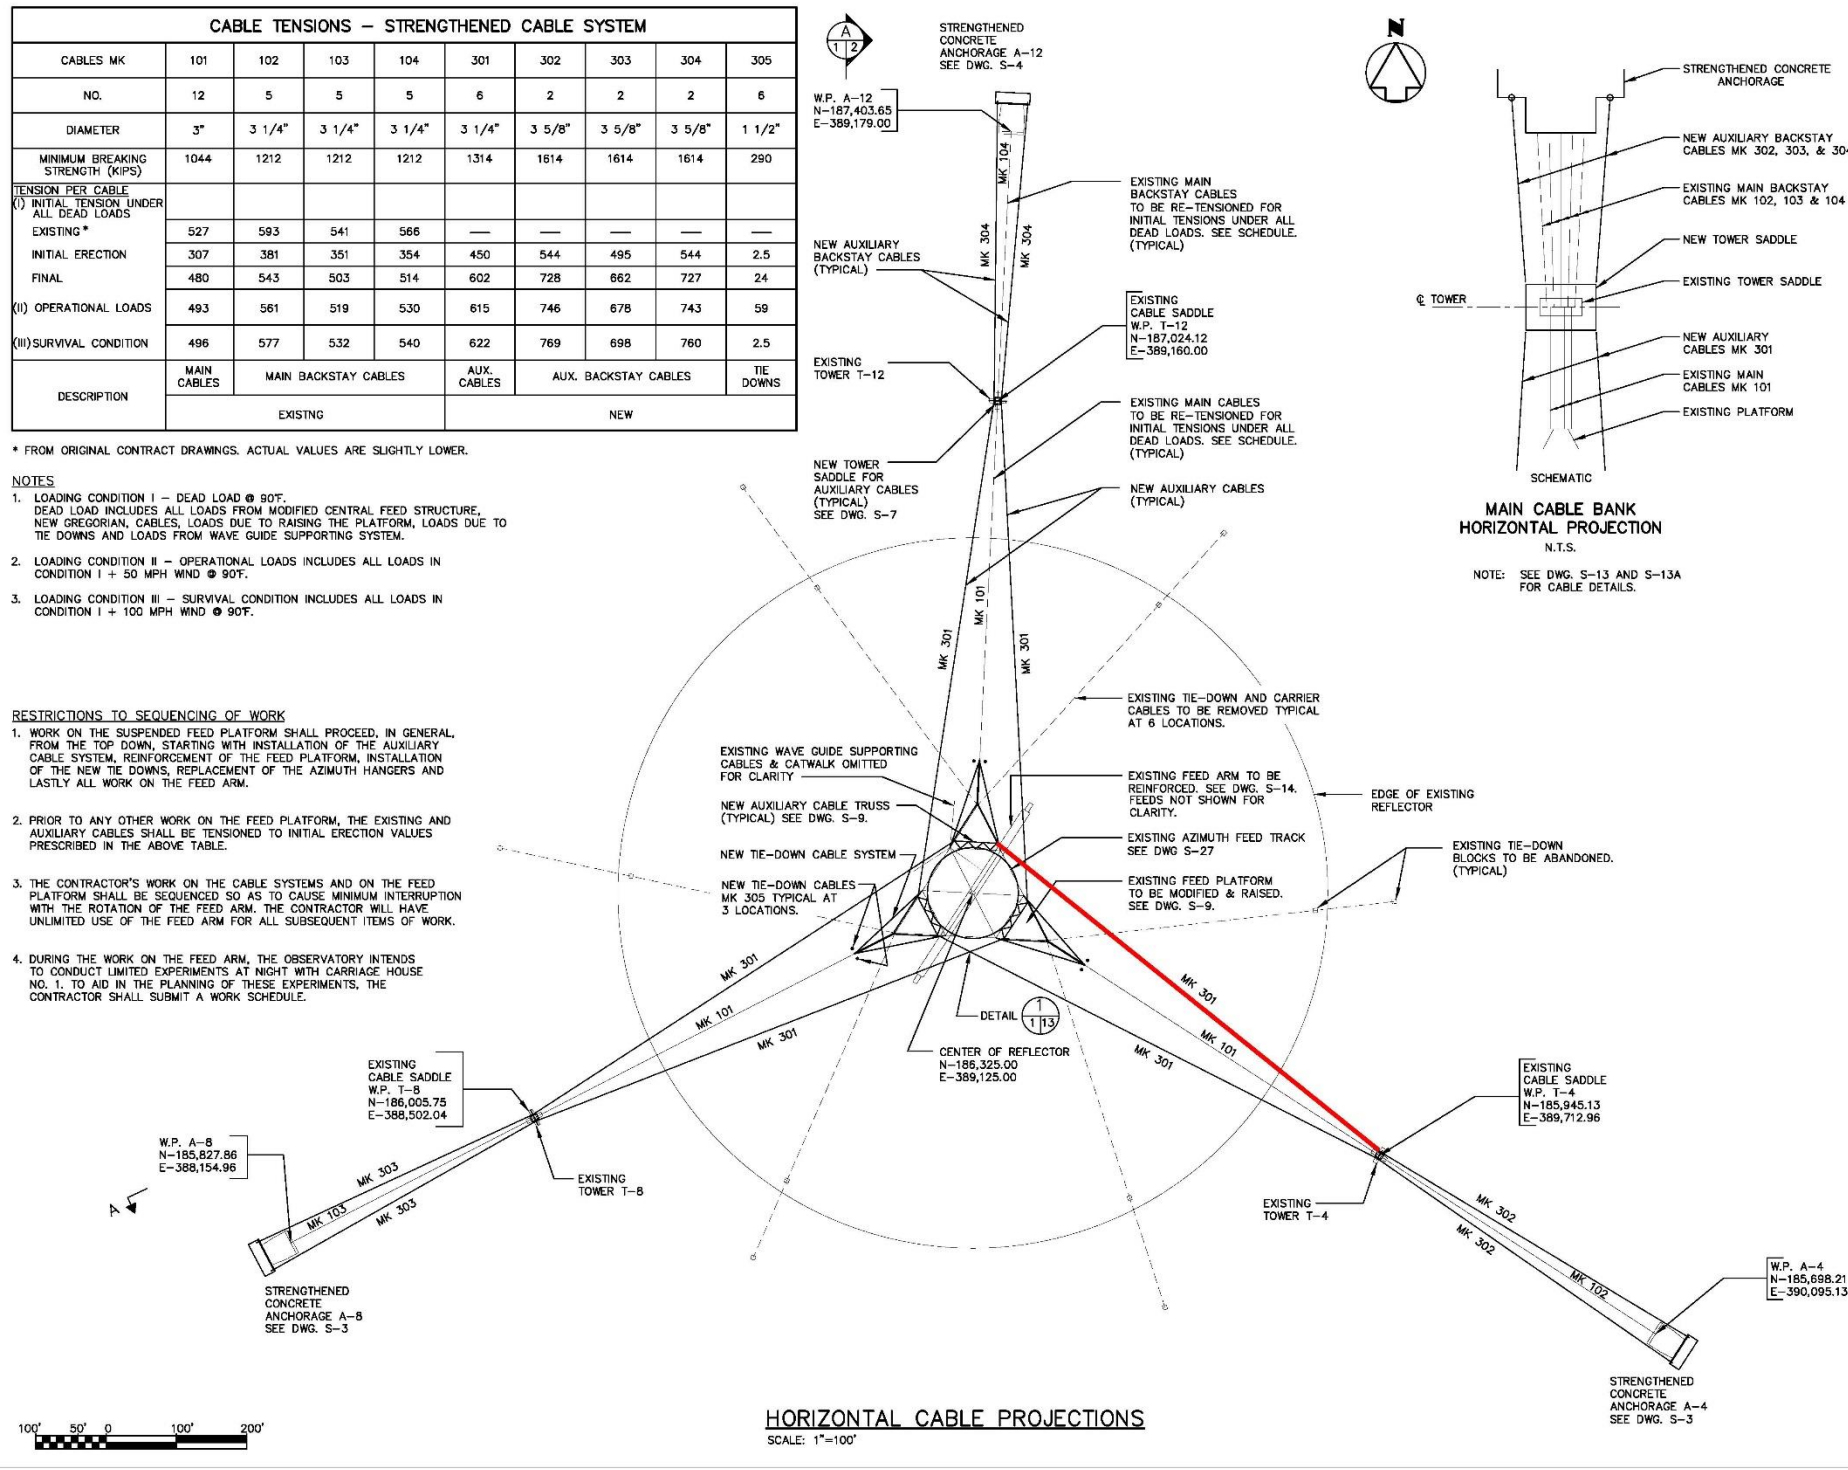
- DURING THE WORK ON THE FEED ARM, THE OBSERVATORY INTENDS TO CONDUCT LIMITED EXPERIMENTS AT NIGHT WITH CARRIAGE HOUSE NO. 1. TO AID IN THE PLANNING OF THESE EXPERIMENTS, THE CONTRACTOR SHALL SUBMIT A WORK SCHEDULE.

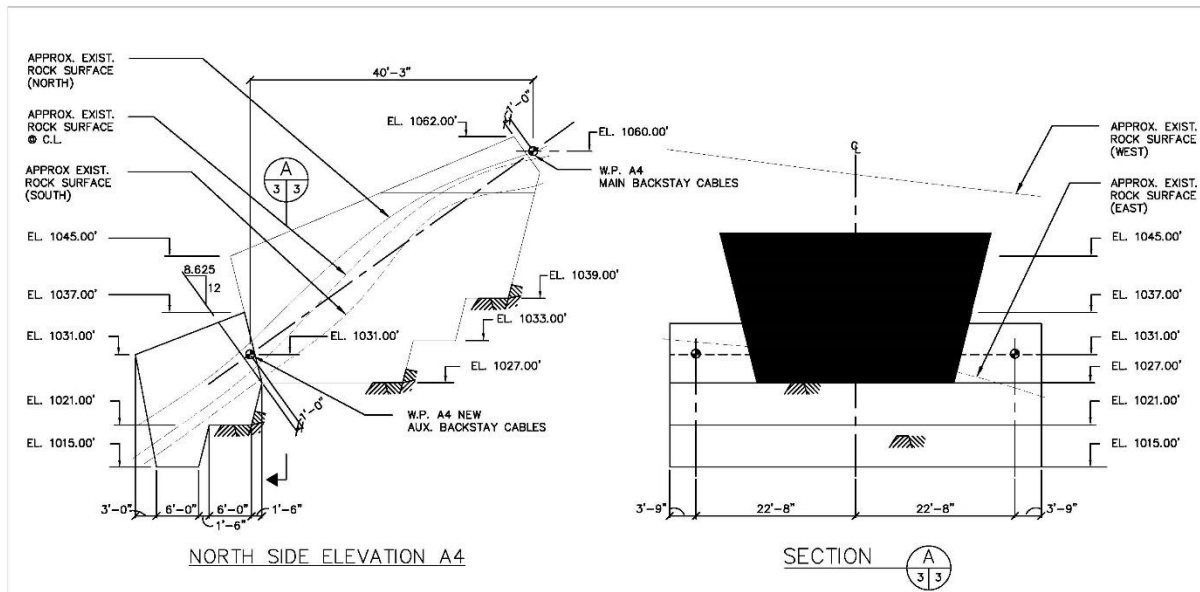
NORTH SIDE ELEVATION A4

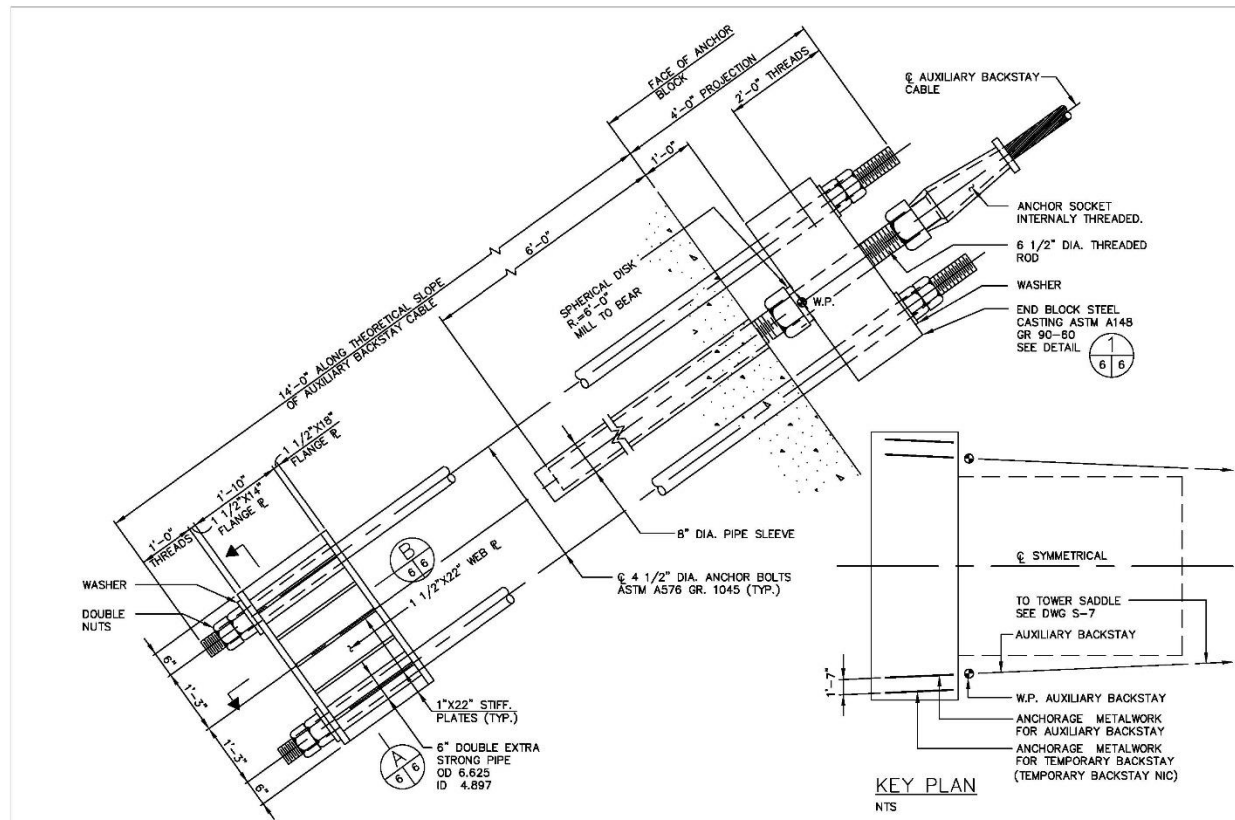
STRENGTHENED ANCHORAGES - A4, A8 & A12
 (12 ASSEMBLIES REQUIRED)
 SCALE: 3/4"=1'-0"

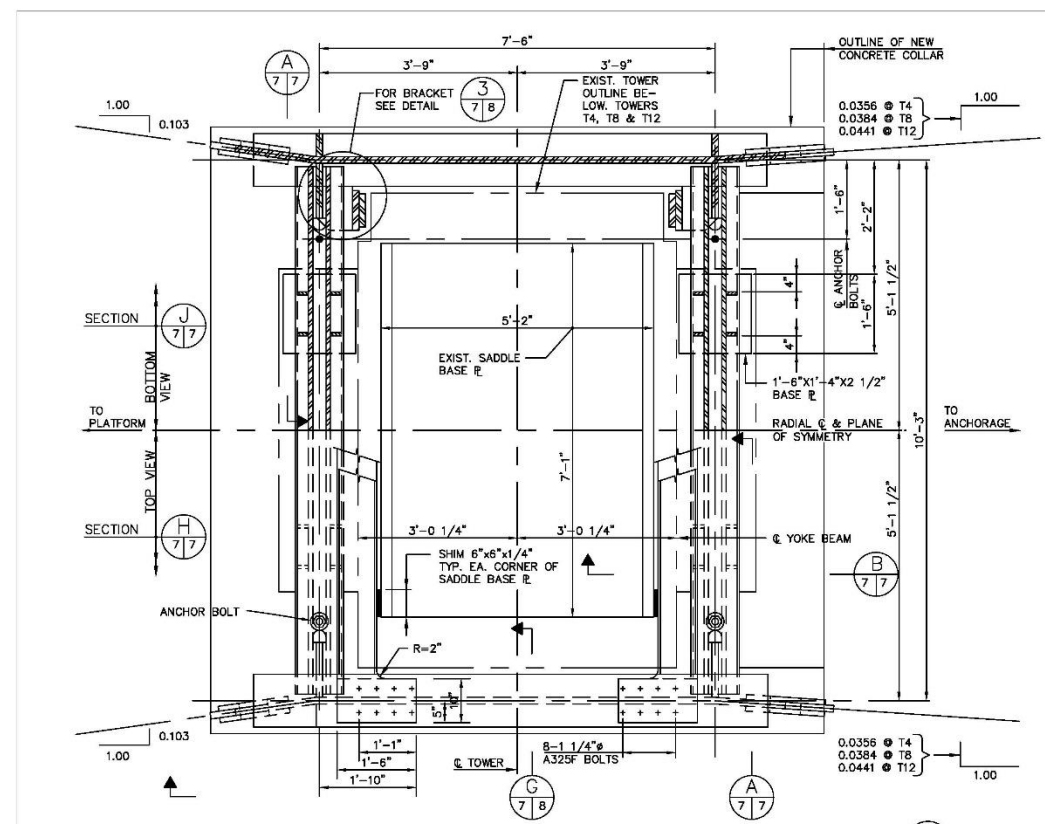
TOWER SADDLE PLAN
SCALE: 3/4"=1'
