NASA/TM-20210017934
NESC-RP-20-01585

Arecibo Observatory Auxiliary M4N Socket Termination Failure Investigation

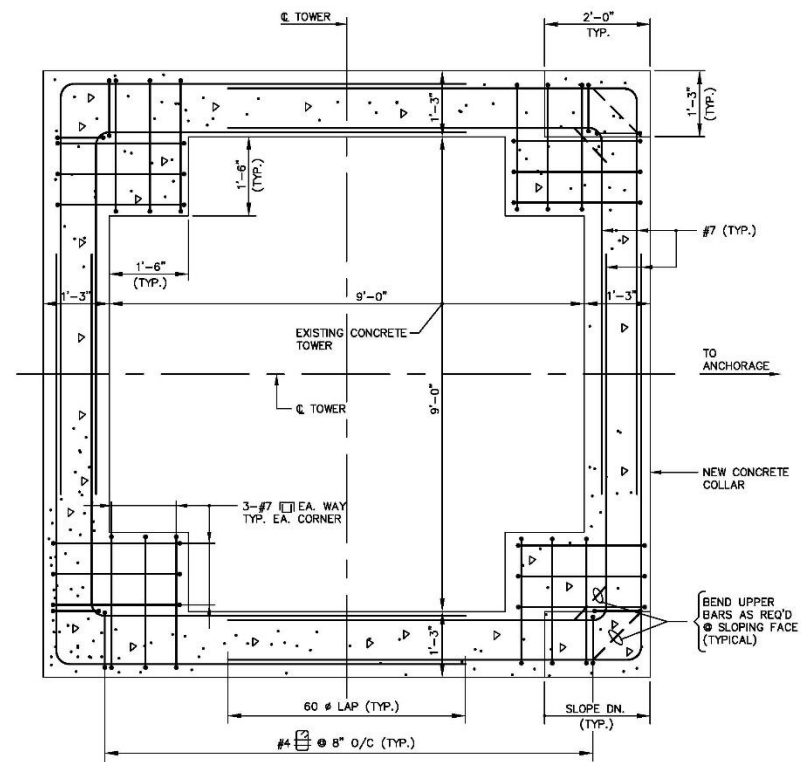
SECTION F
SCALE: 3/4"=1'-0" 7/8

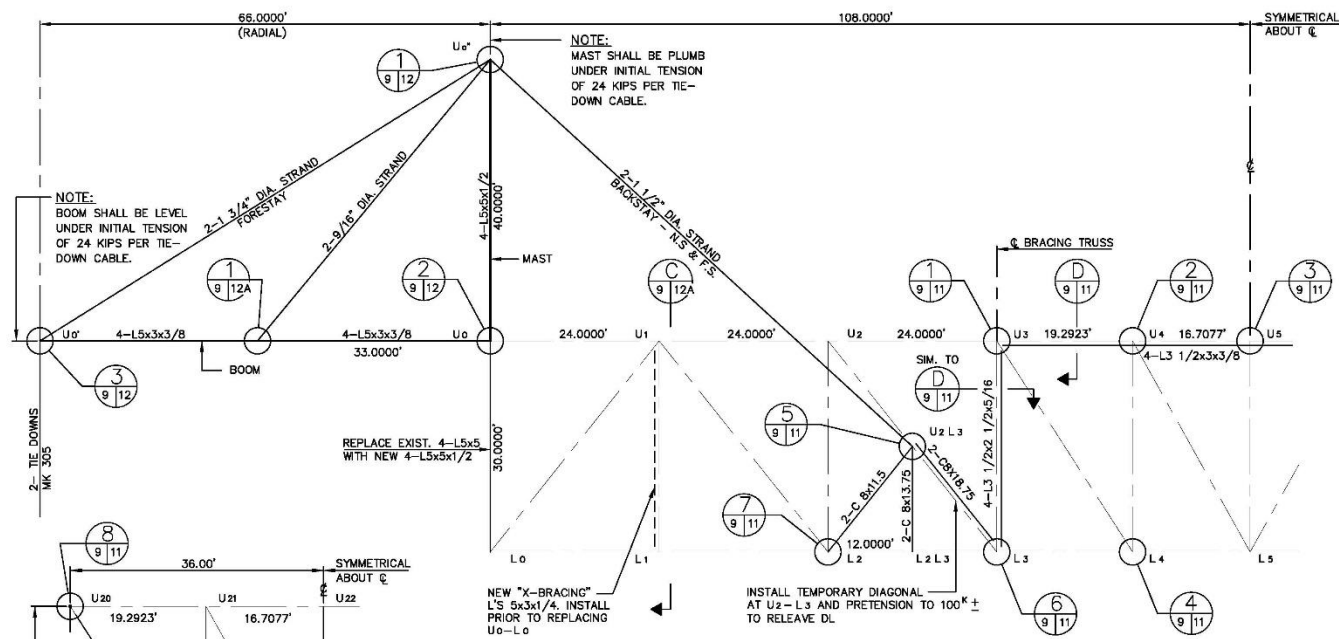
MAIN TRUSS
SCALE: 1"=10'-0"

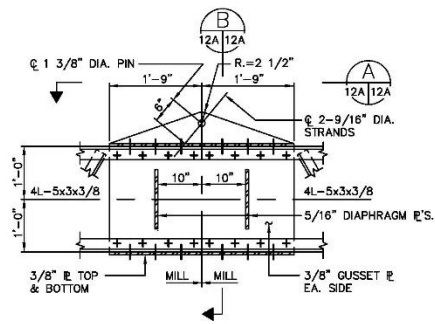
DETAIL 1
SCALE: 3/4"=1'-0"
9 12A

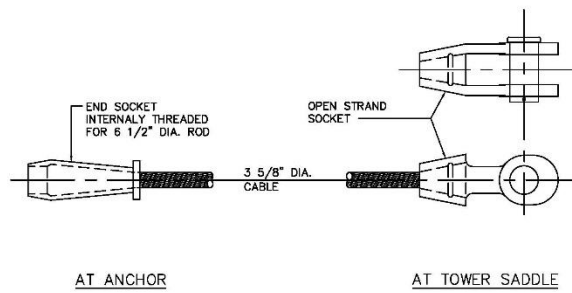
AUXILIARY BACKSTAY CABLES: MK302, MK303 & MK304
N.T.S.

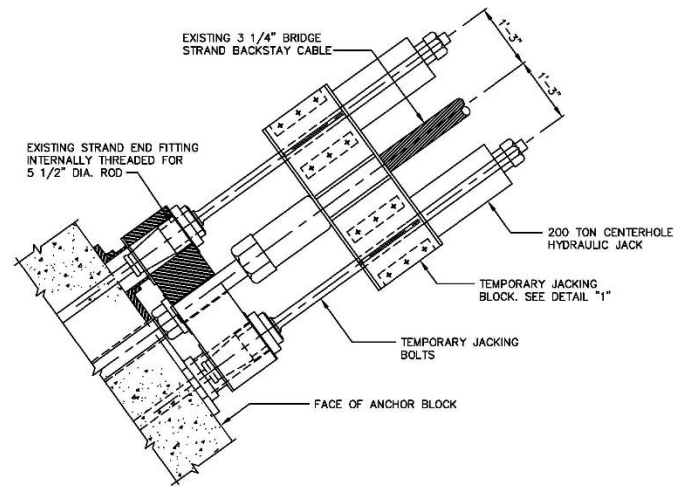
TENSIONING BACKSTAYS – MK 102, MK 103 & MK 104
SCALE: 3/4"=1'-0"

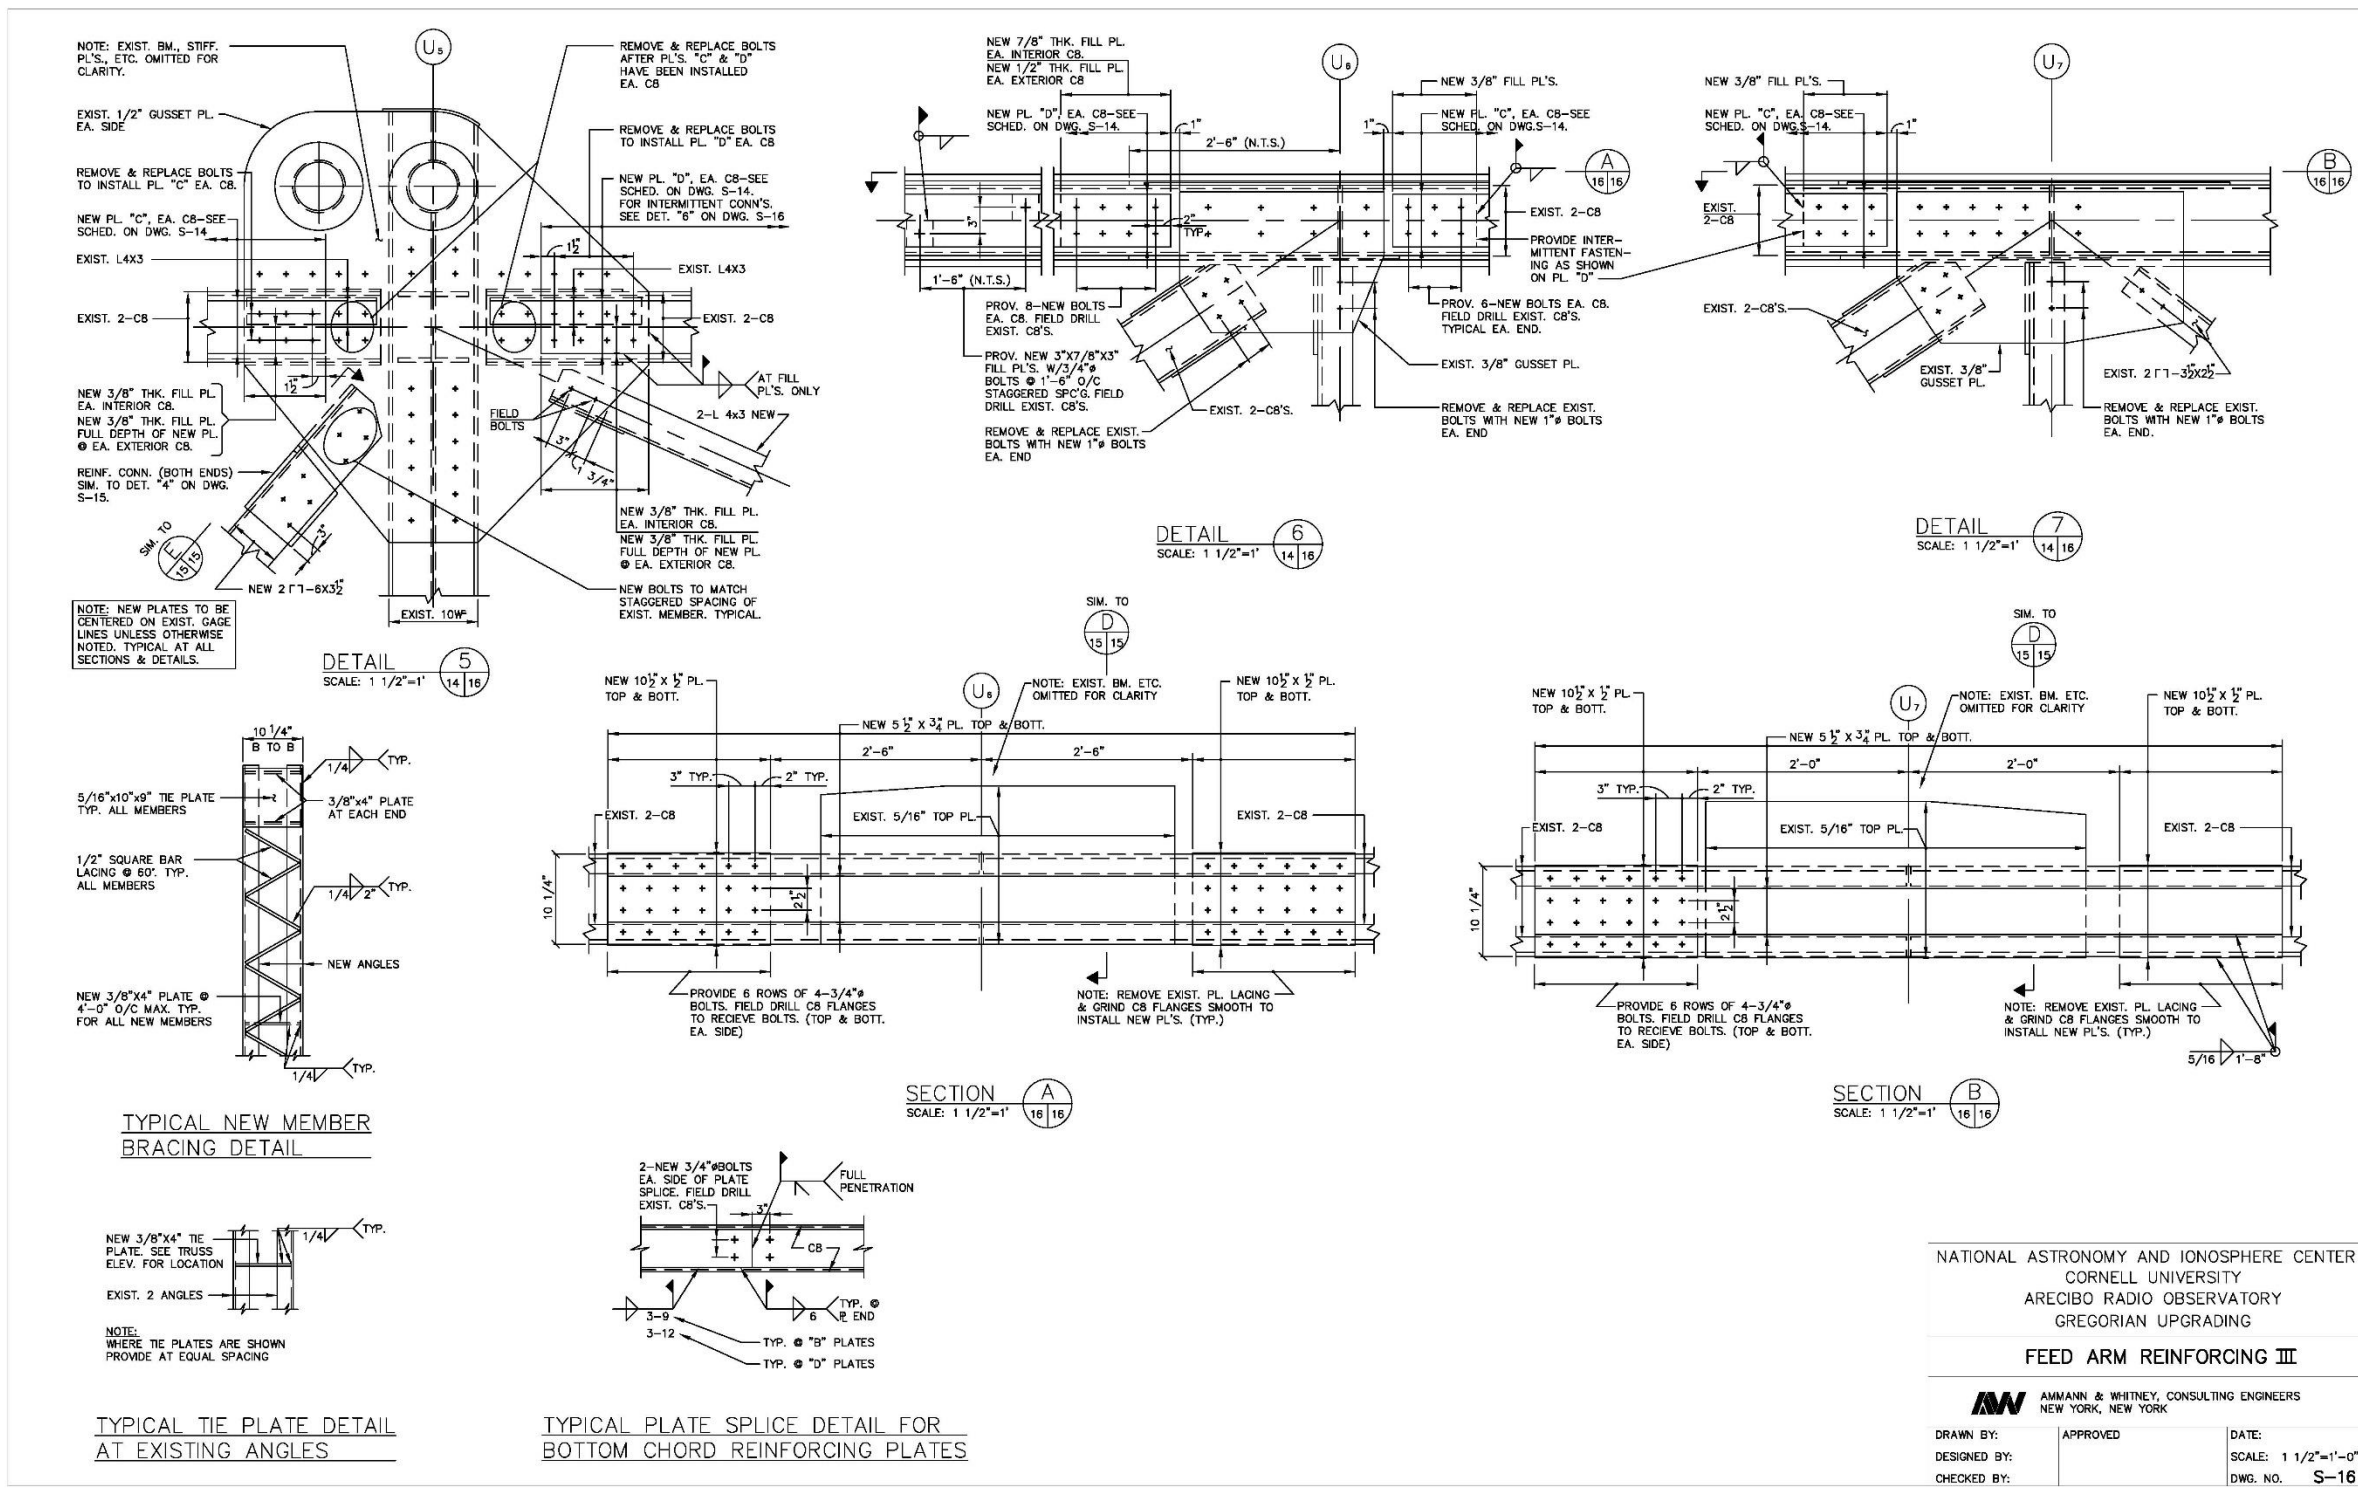
TYPICAL NEW MEMBER BRACING DETAIL

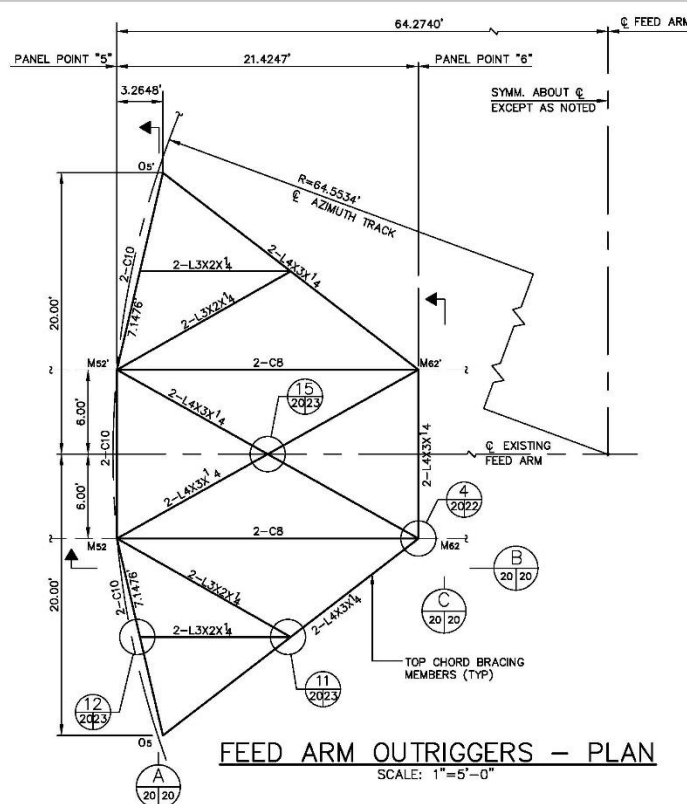
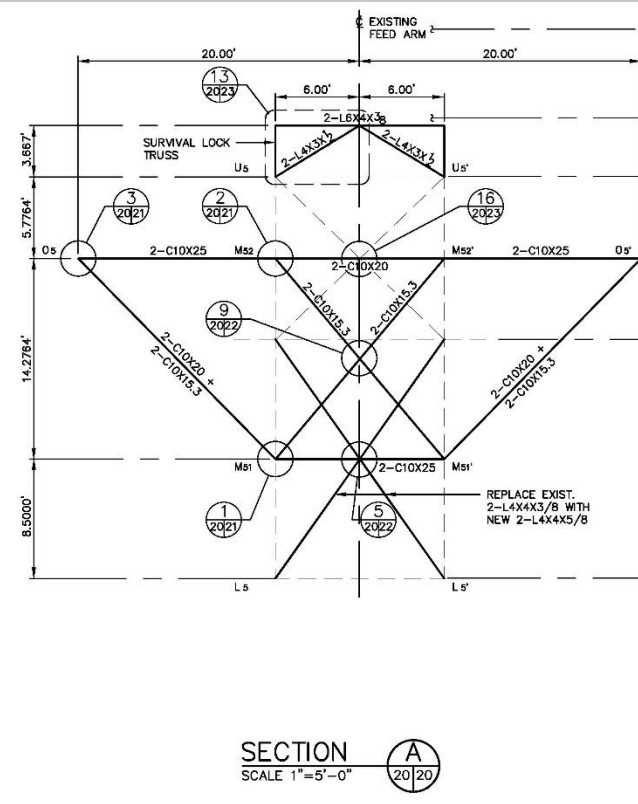
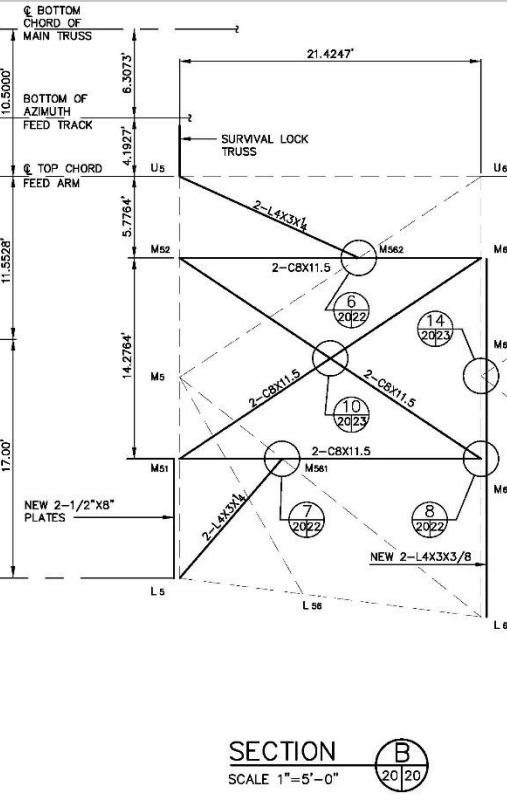
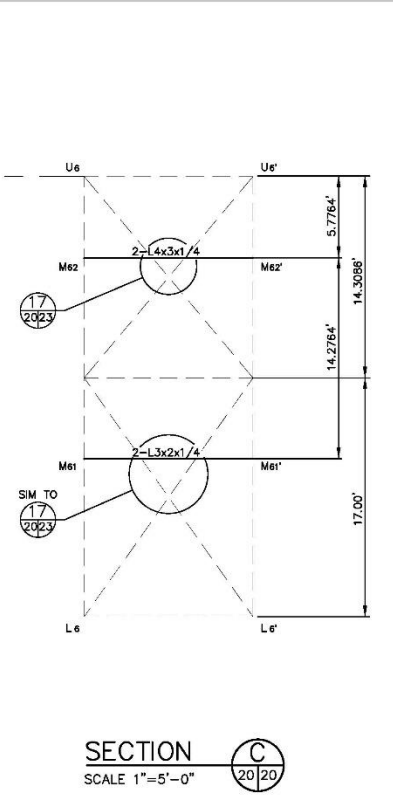
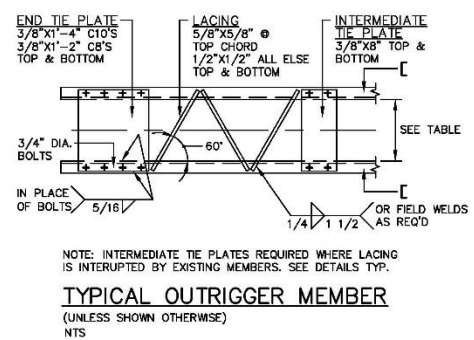
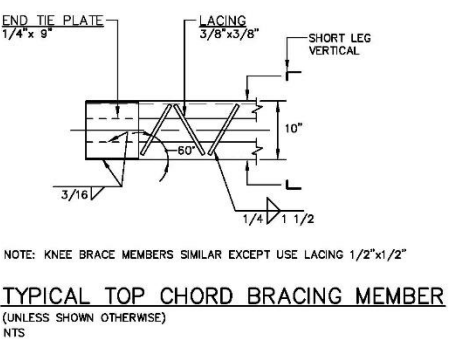
FEED ARM OUTRIGGER FORCE TABLE						
MAKE-UP	MEMBER	OPERATIONAL LOAD (KIPS)		SURVIVAL LOAD (KIPS)		
		T	C	T	C	
2-C 13 1/4"	OUTRIGGERS TOP CHORD					
	Os - Ms2		199		291	
	M52 - M52'		190		248	
4-C 13 1/4"	OUTRIGGERS BOTTOM CHORD					
	Os - Ms1	296		413		
2-C 13 1/4"	X-BRACES	M51 - Ms1'	212		285	
		M52 - Ms1'		17	45	85
		M51 - Ms2'		17	45	85
2-C 12"	FACE MEMBERS HORIZ.	M52 - Ms22	16	9	34	10
		M522 - Ms2	60		60	
		M51 - Ms21	15		15	31
		M521 - Ms1		44		50
2-C 12"	FACE MEMBERS X-BRACES	M51 - Ms2	53	65	60	73
		M51 - Ms2			60	
2-L 10 1/4"	FACE MEMBERS KNEE BRACES	Us - Ms22	46		38	4
		Ls - Ms21		35	37	5

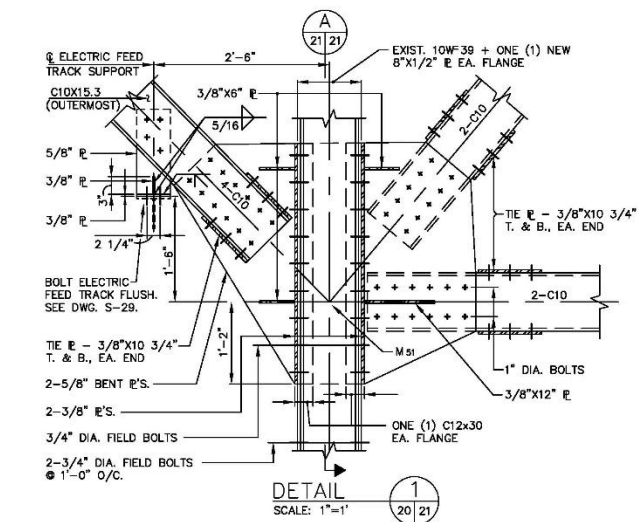
DETAIL 1
SCALE: 1"=1"

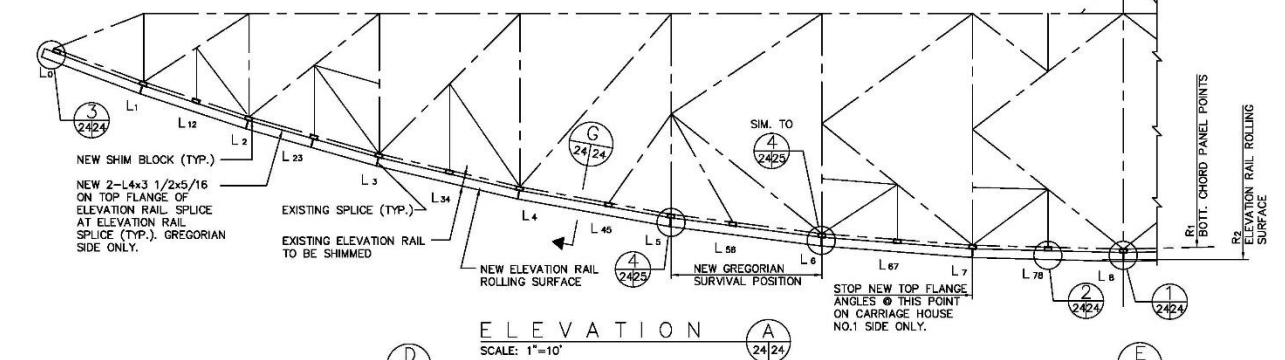
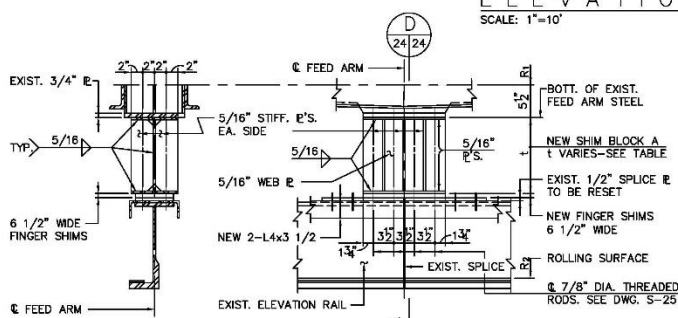
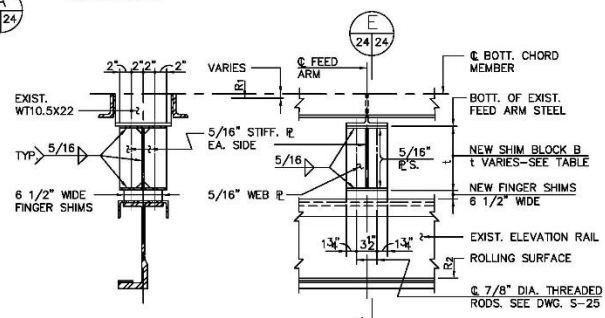
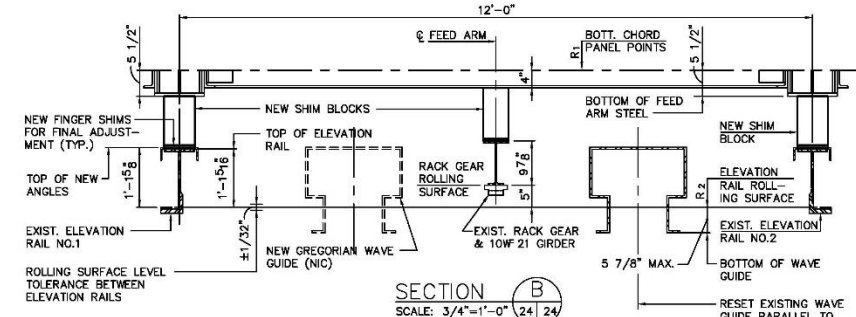
NOTES:
 1. FINGER SHIMS SHALL BE STAINLESS STEEL.
 2. THE THICKNESS OF FINGER SHIMS SHALL BE DETERMINED BY LOADING EACH PANEL POINT WITH APPROPRIATE FEED SYSTEM, TO FORM THE REQUIRED ROLLING SURFACE. HOWEVER, THE THICKNESS SHALL NOT EXCEED 1". IF NECESSARY INCREASE BLOCK SIZE.
 3. THE ROLLING SURFACE R2 SHALL MEET A TOLERANCE OF ±.01" WITH THE UPHILL ROLLERS, OF EITHER FEED SYSTEM, CENTERED ON EACH SHIM PACK.
 4. ALL THREADED RODS SHALL CONFORM TO ASTM A354 GR. BC.
 5. NEW ELEVATION RAIL CURVATURE MAY CAUSE EXISTING HOLES IN TOP FLANGE OF RAIL TO MISALIGN WITH HOLES IN BOTTOM OF FEED ARM. HOLES IN TOP FLANGE OF RAIL SHOULD BE REAMED IF REQUIRED.
 6. CONTRACTOR SHALL SUBMIT HIS PROCEDURE FOR SETTING THE ELEVATION RAIL CURVATURE AND MEETING THE LEVEL TOLERANCE BETWEEN RAILS.

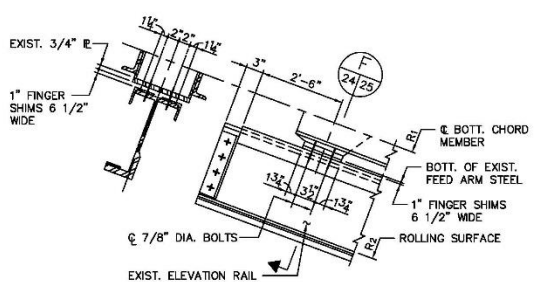
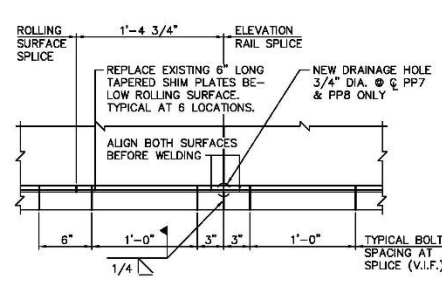
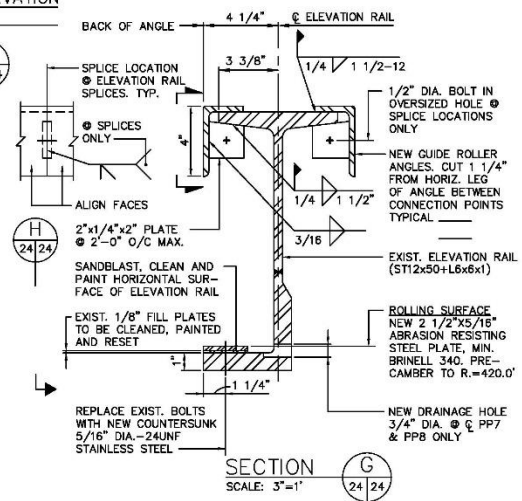
NATIONAL ASTRONOMY AND IONOSPHERE CENTER
 CORNELL UNIVERSITY
 ARECIBO RADIO OBSERVATORY
 GREGORIAN UPGRADING

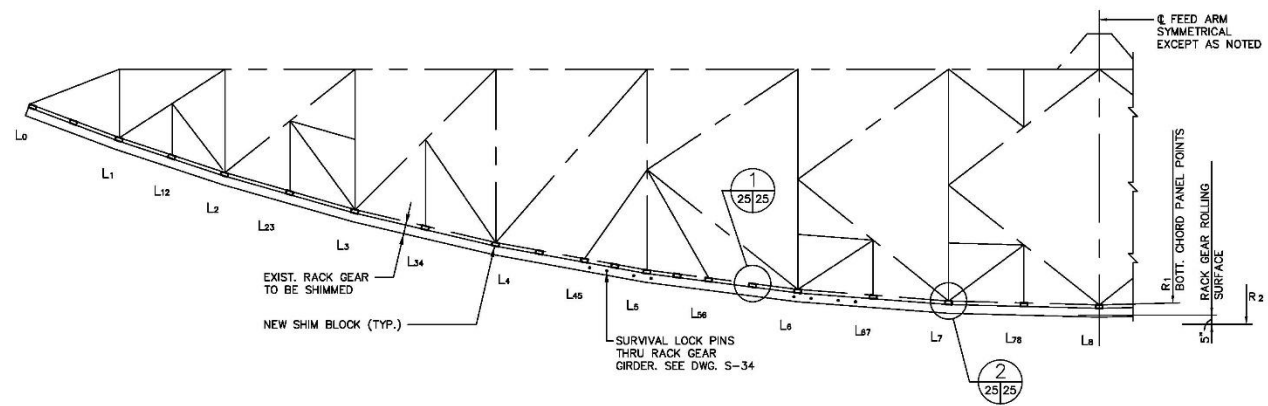
SECTION C
SCALE: 1"=10"
24/25

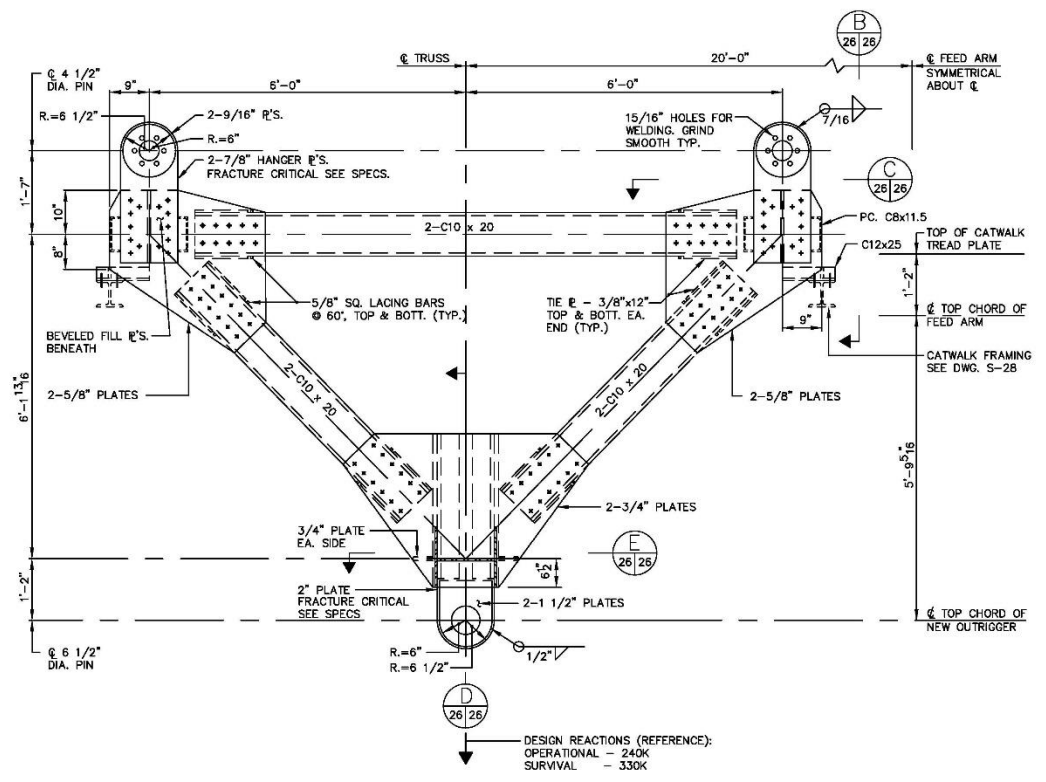
SECTION A
SCALE: 3/4\"=1\"

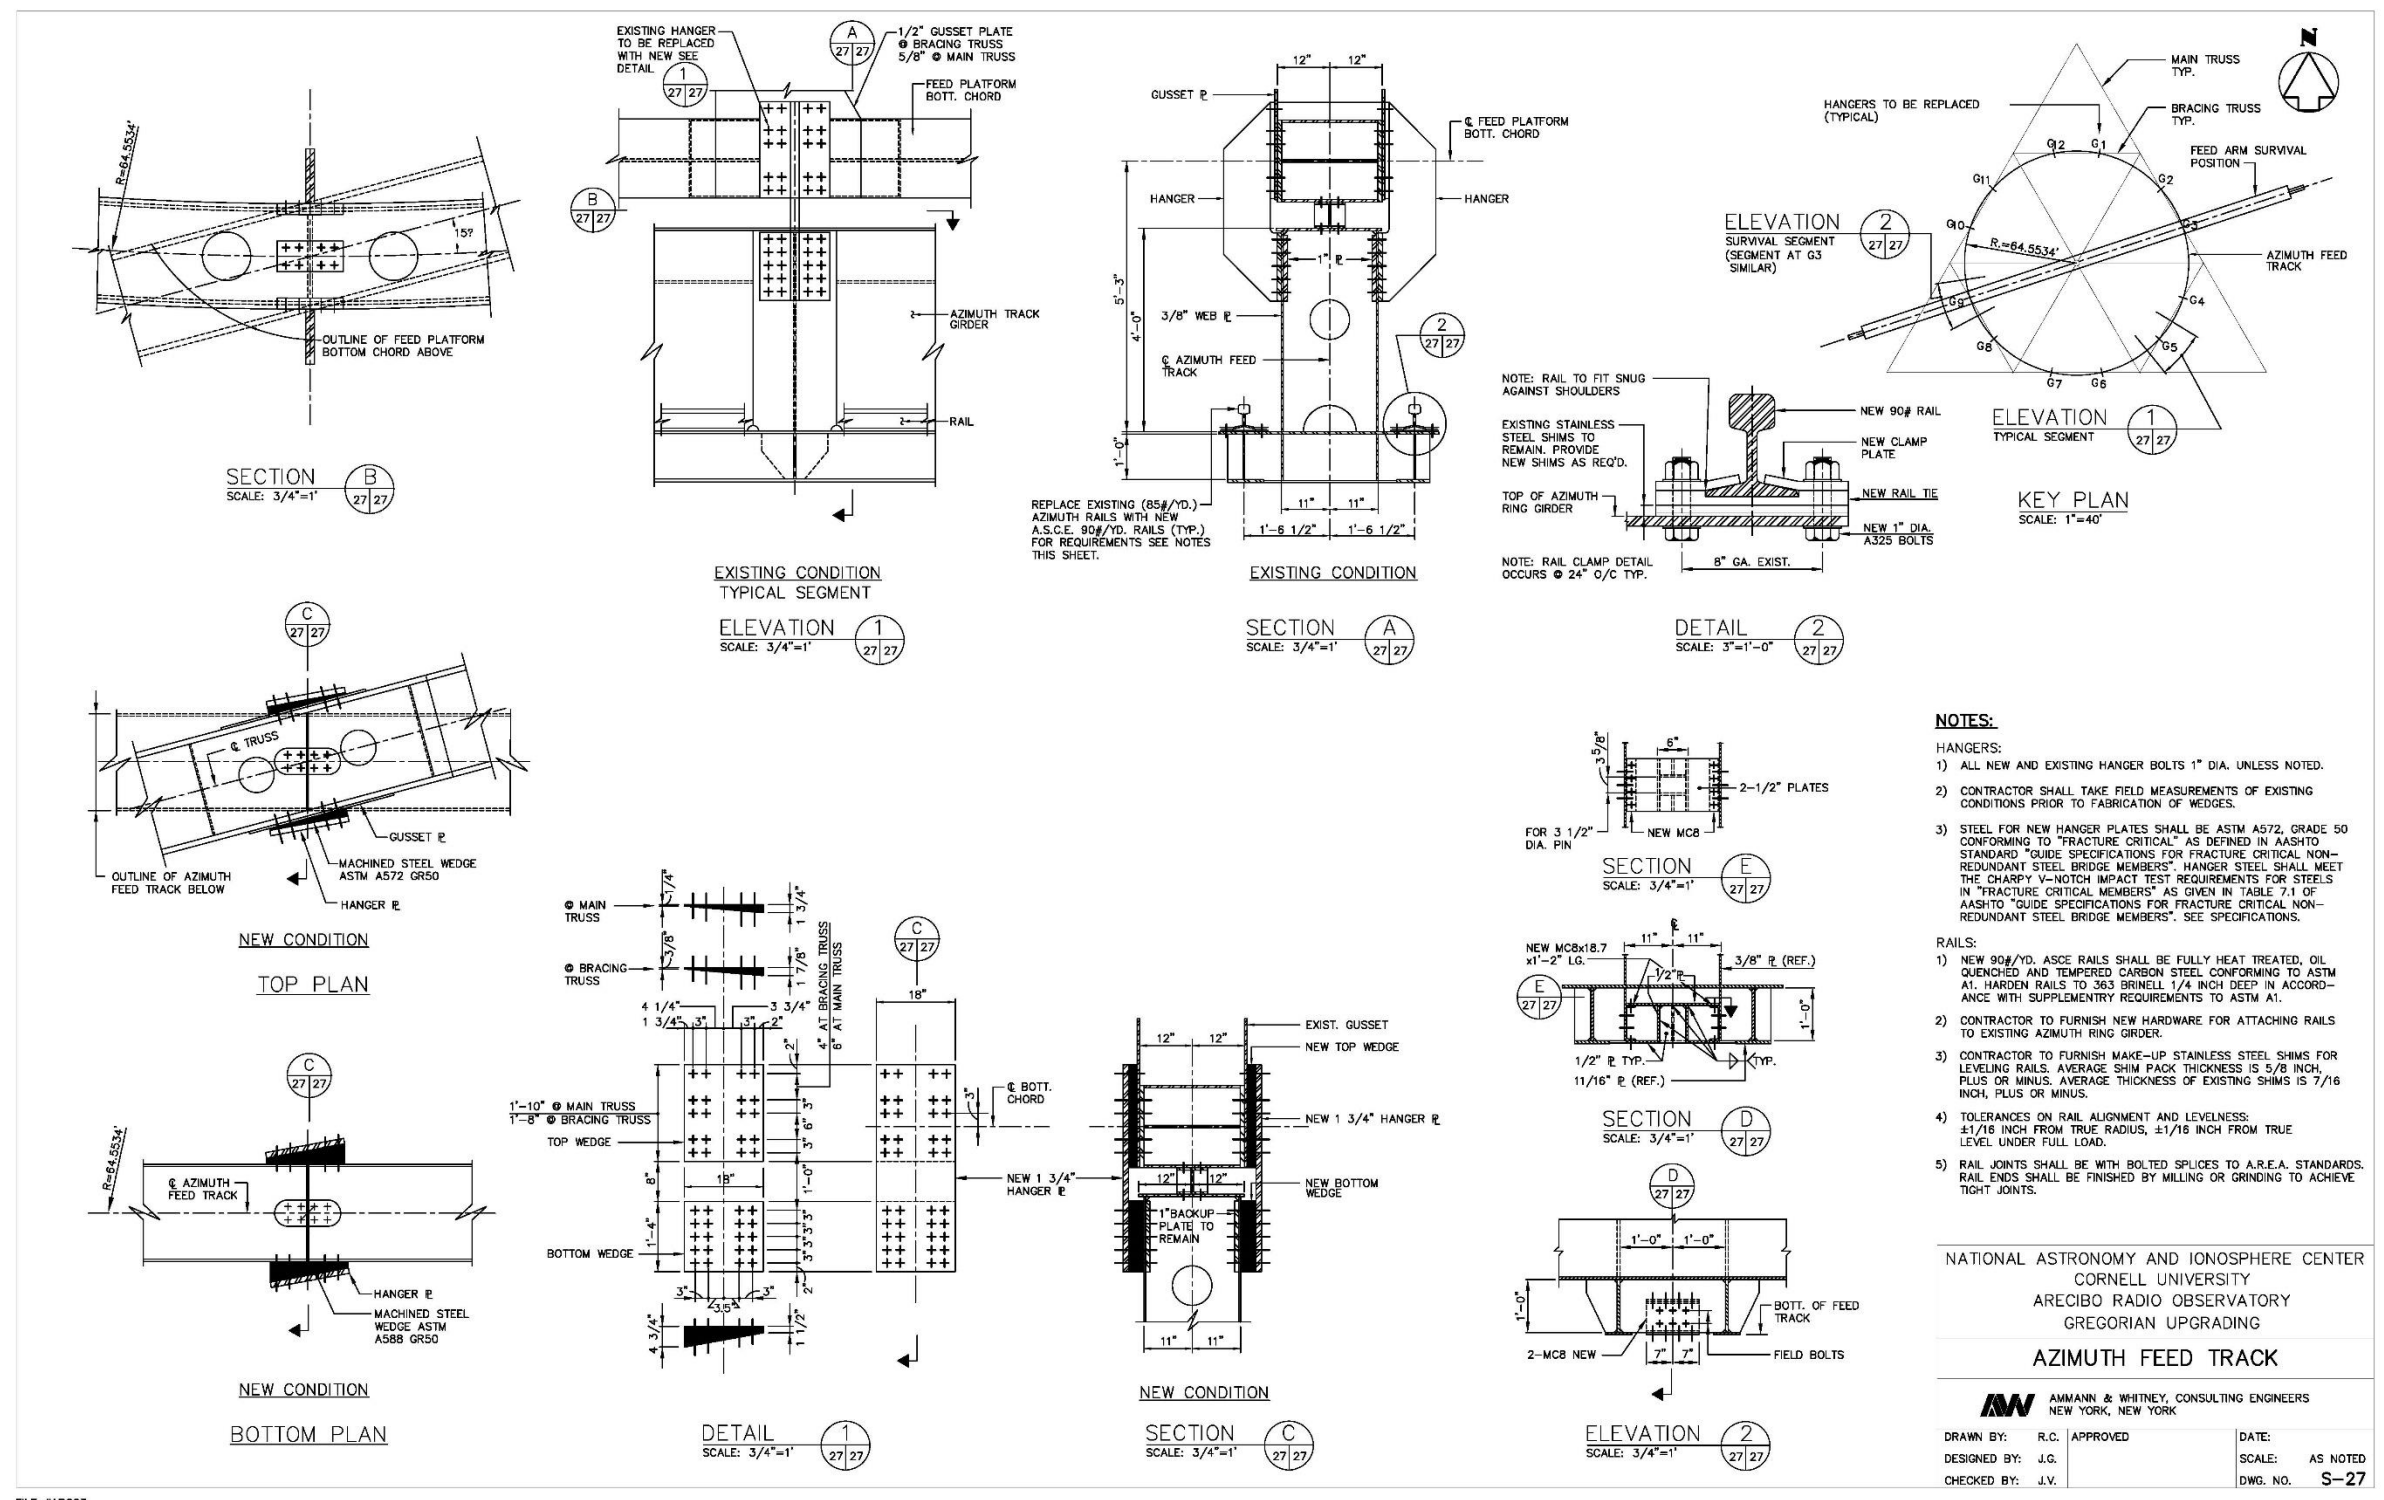
- NOTES:**
- HANGERS:**
- 1) ALL NEW AND EXISTING HANGER BOLTS 1" DIA. UNLESS NOTED.
 - 2) CONTRACTOR SHALL TAKE FIELD MEASUREMENTS OF EXISTING CONDITIONS PRIOR TO FABRICATION OF WEDGES.

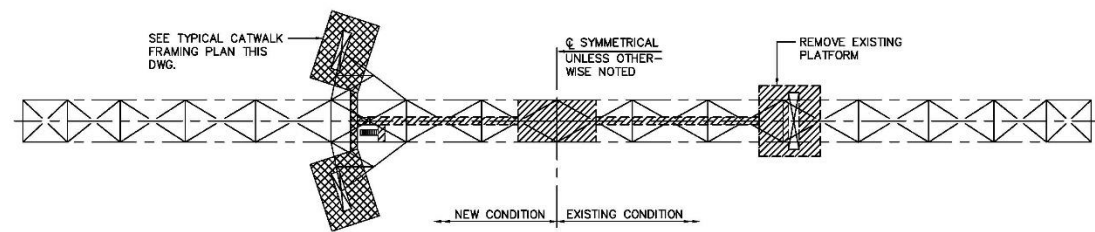
CATWALK PLAN - TOP CHORD OF FEED ARM
SCALE: 1"=20'-0"

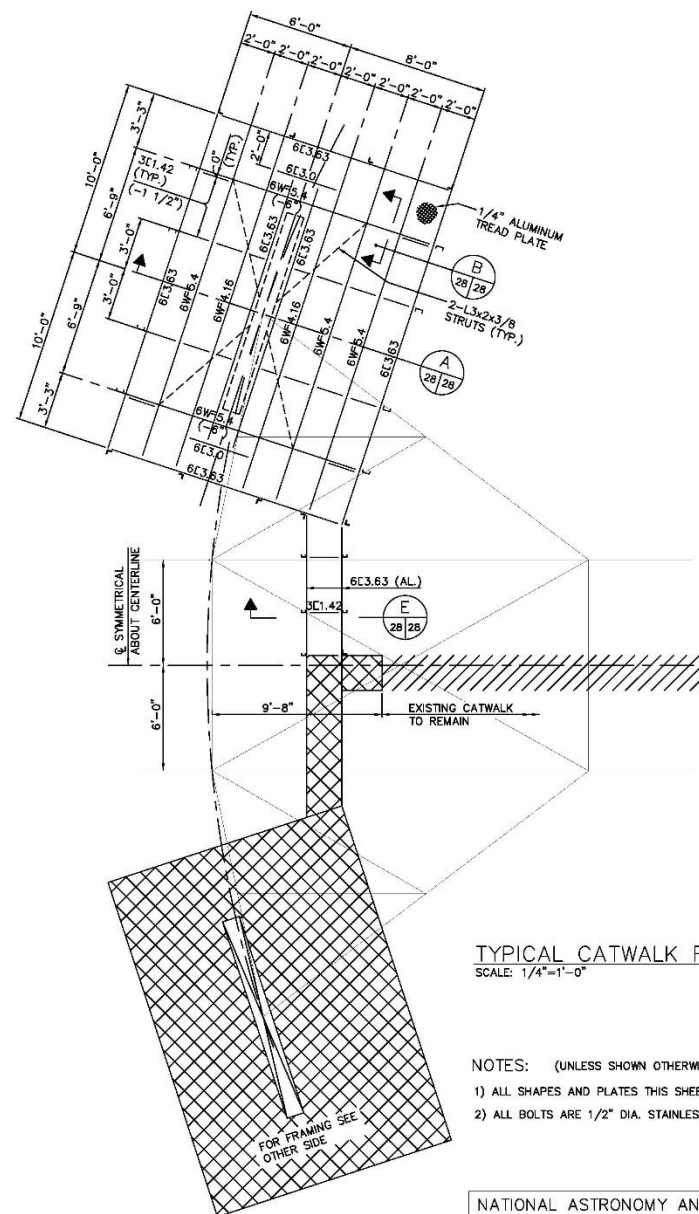
NOTES: (UNLESS SHOWN OTHERWISE)
1) ALL SHAPES AND PLATES THIS SHEET ARE 6061-T6 ALUMINUM.
2) ALL BOLTS ARE 1/2" DIA. STAINLESS STEEL.

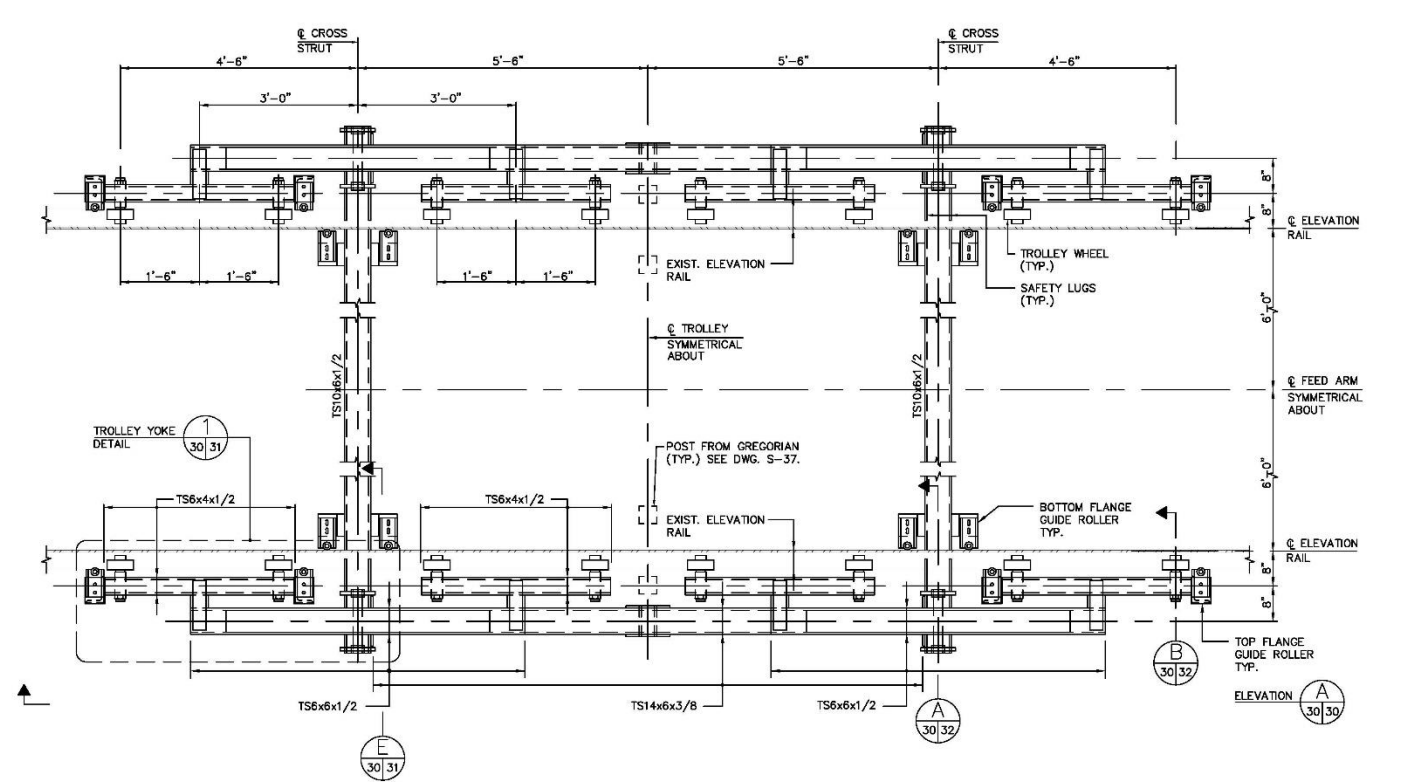
GREGORIAN TROLLEY PLAN
SCALE: 3/4"=1'-0" (2 REQUIRED)

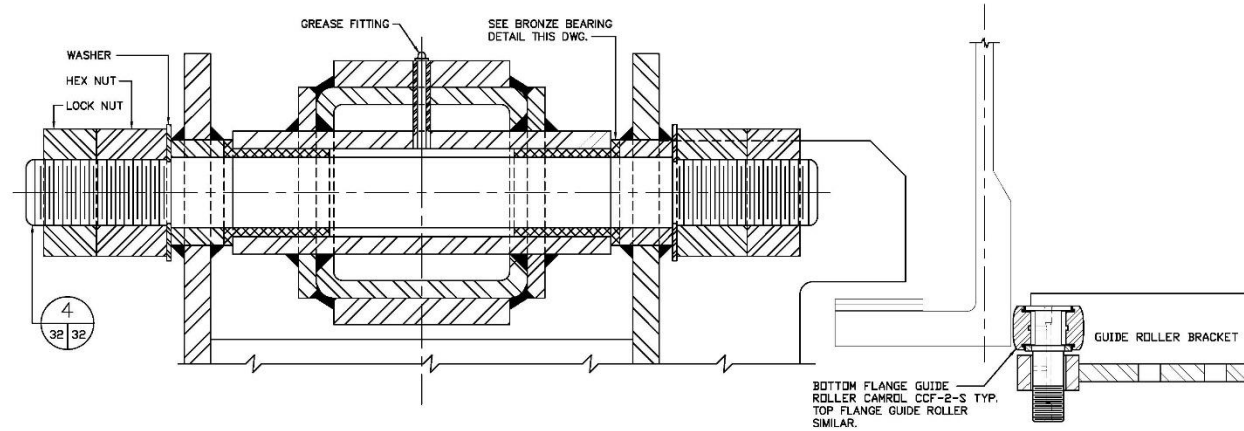
SECTION A
SCALE: 6"=1"

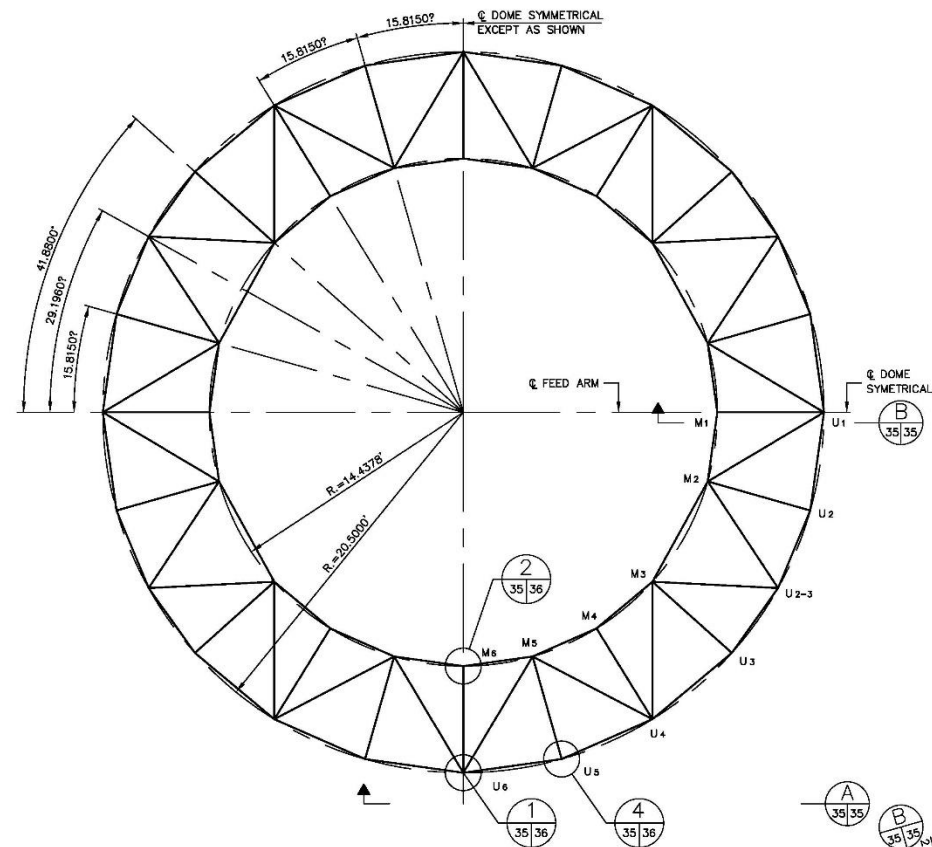
NOTE:
ALL MEMBERS TO BE 2-L2 1/2x2x3/16 UNLESS OTHERWISE NOTED

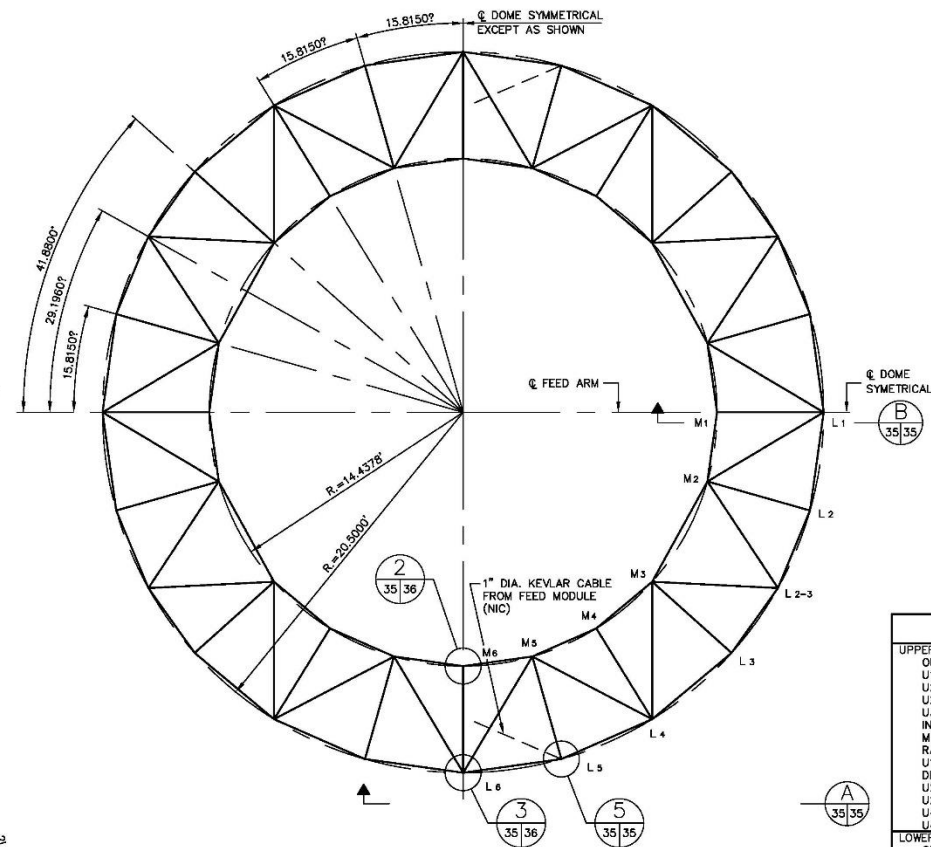
NOTE:
ALL MEMBERS TO BE 2-L2 1/2x2x3/16 UNLESS OTHERWISE NOTED

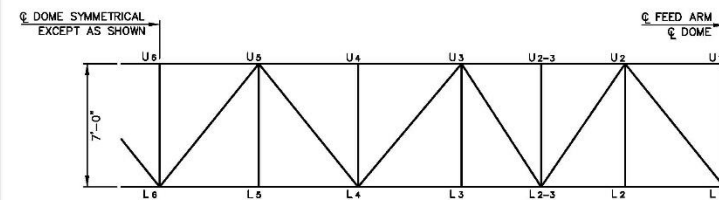
NOTE:
ALL MEMBERS TO BE 2-L2 1/2x2x3/16 UNLESS OTHERWISE NOTED

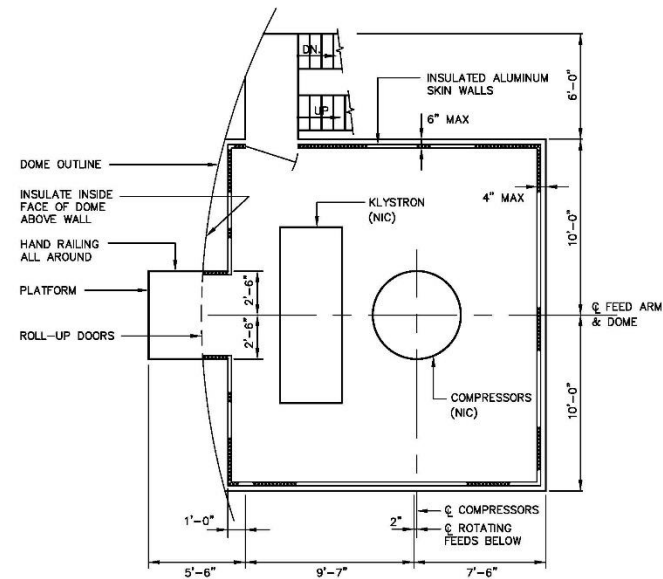
PLAN — KLYSTRON CABIN FLOOR
SCALE: 1/4"=1'-0"

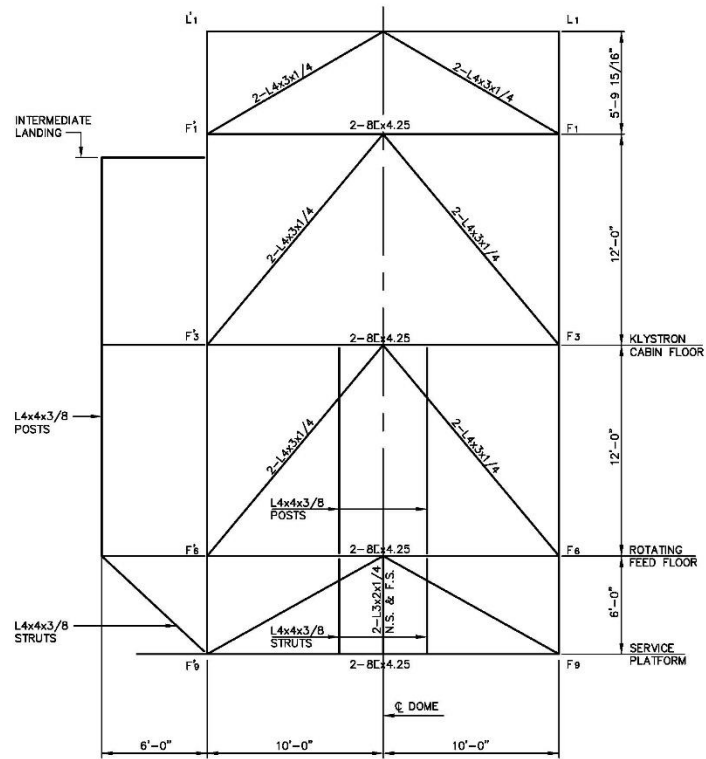
ELEVATION A
SCALE: 1/4"=1'-0" 41 41

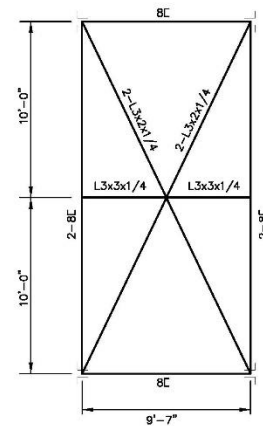
SECTION C
SCALE: 1/4"=1'-0" 41 41

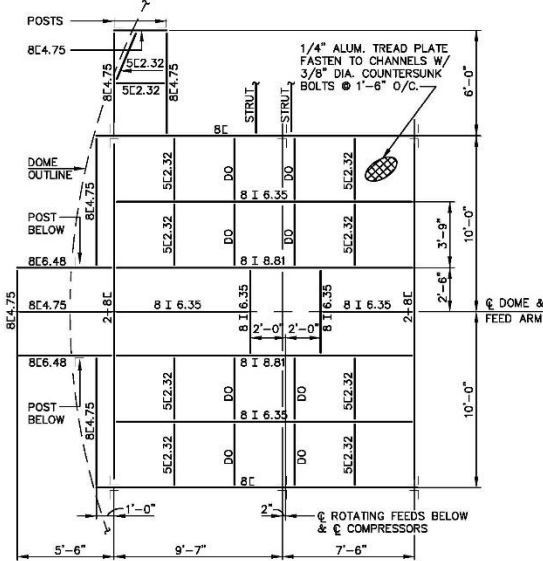
KLYSTRON CABIN FLOOR FRAMING PLAN
SCALE: 1/4"=1'-0"

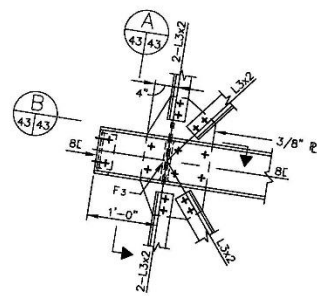
DETAIL 1
SCALE: 1"=1'-0" 41 | 43
