NASA/TM-20210017934
NESC-RP-20-01585

Arecibo Observatory Auxiliary M4N Socket Termination Failure Investigation

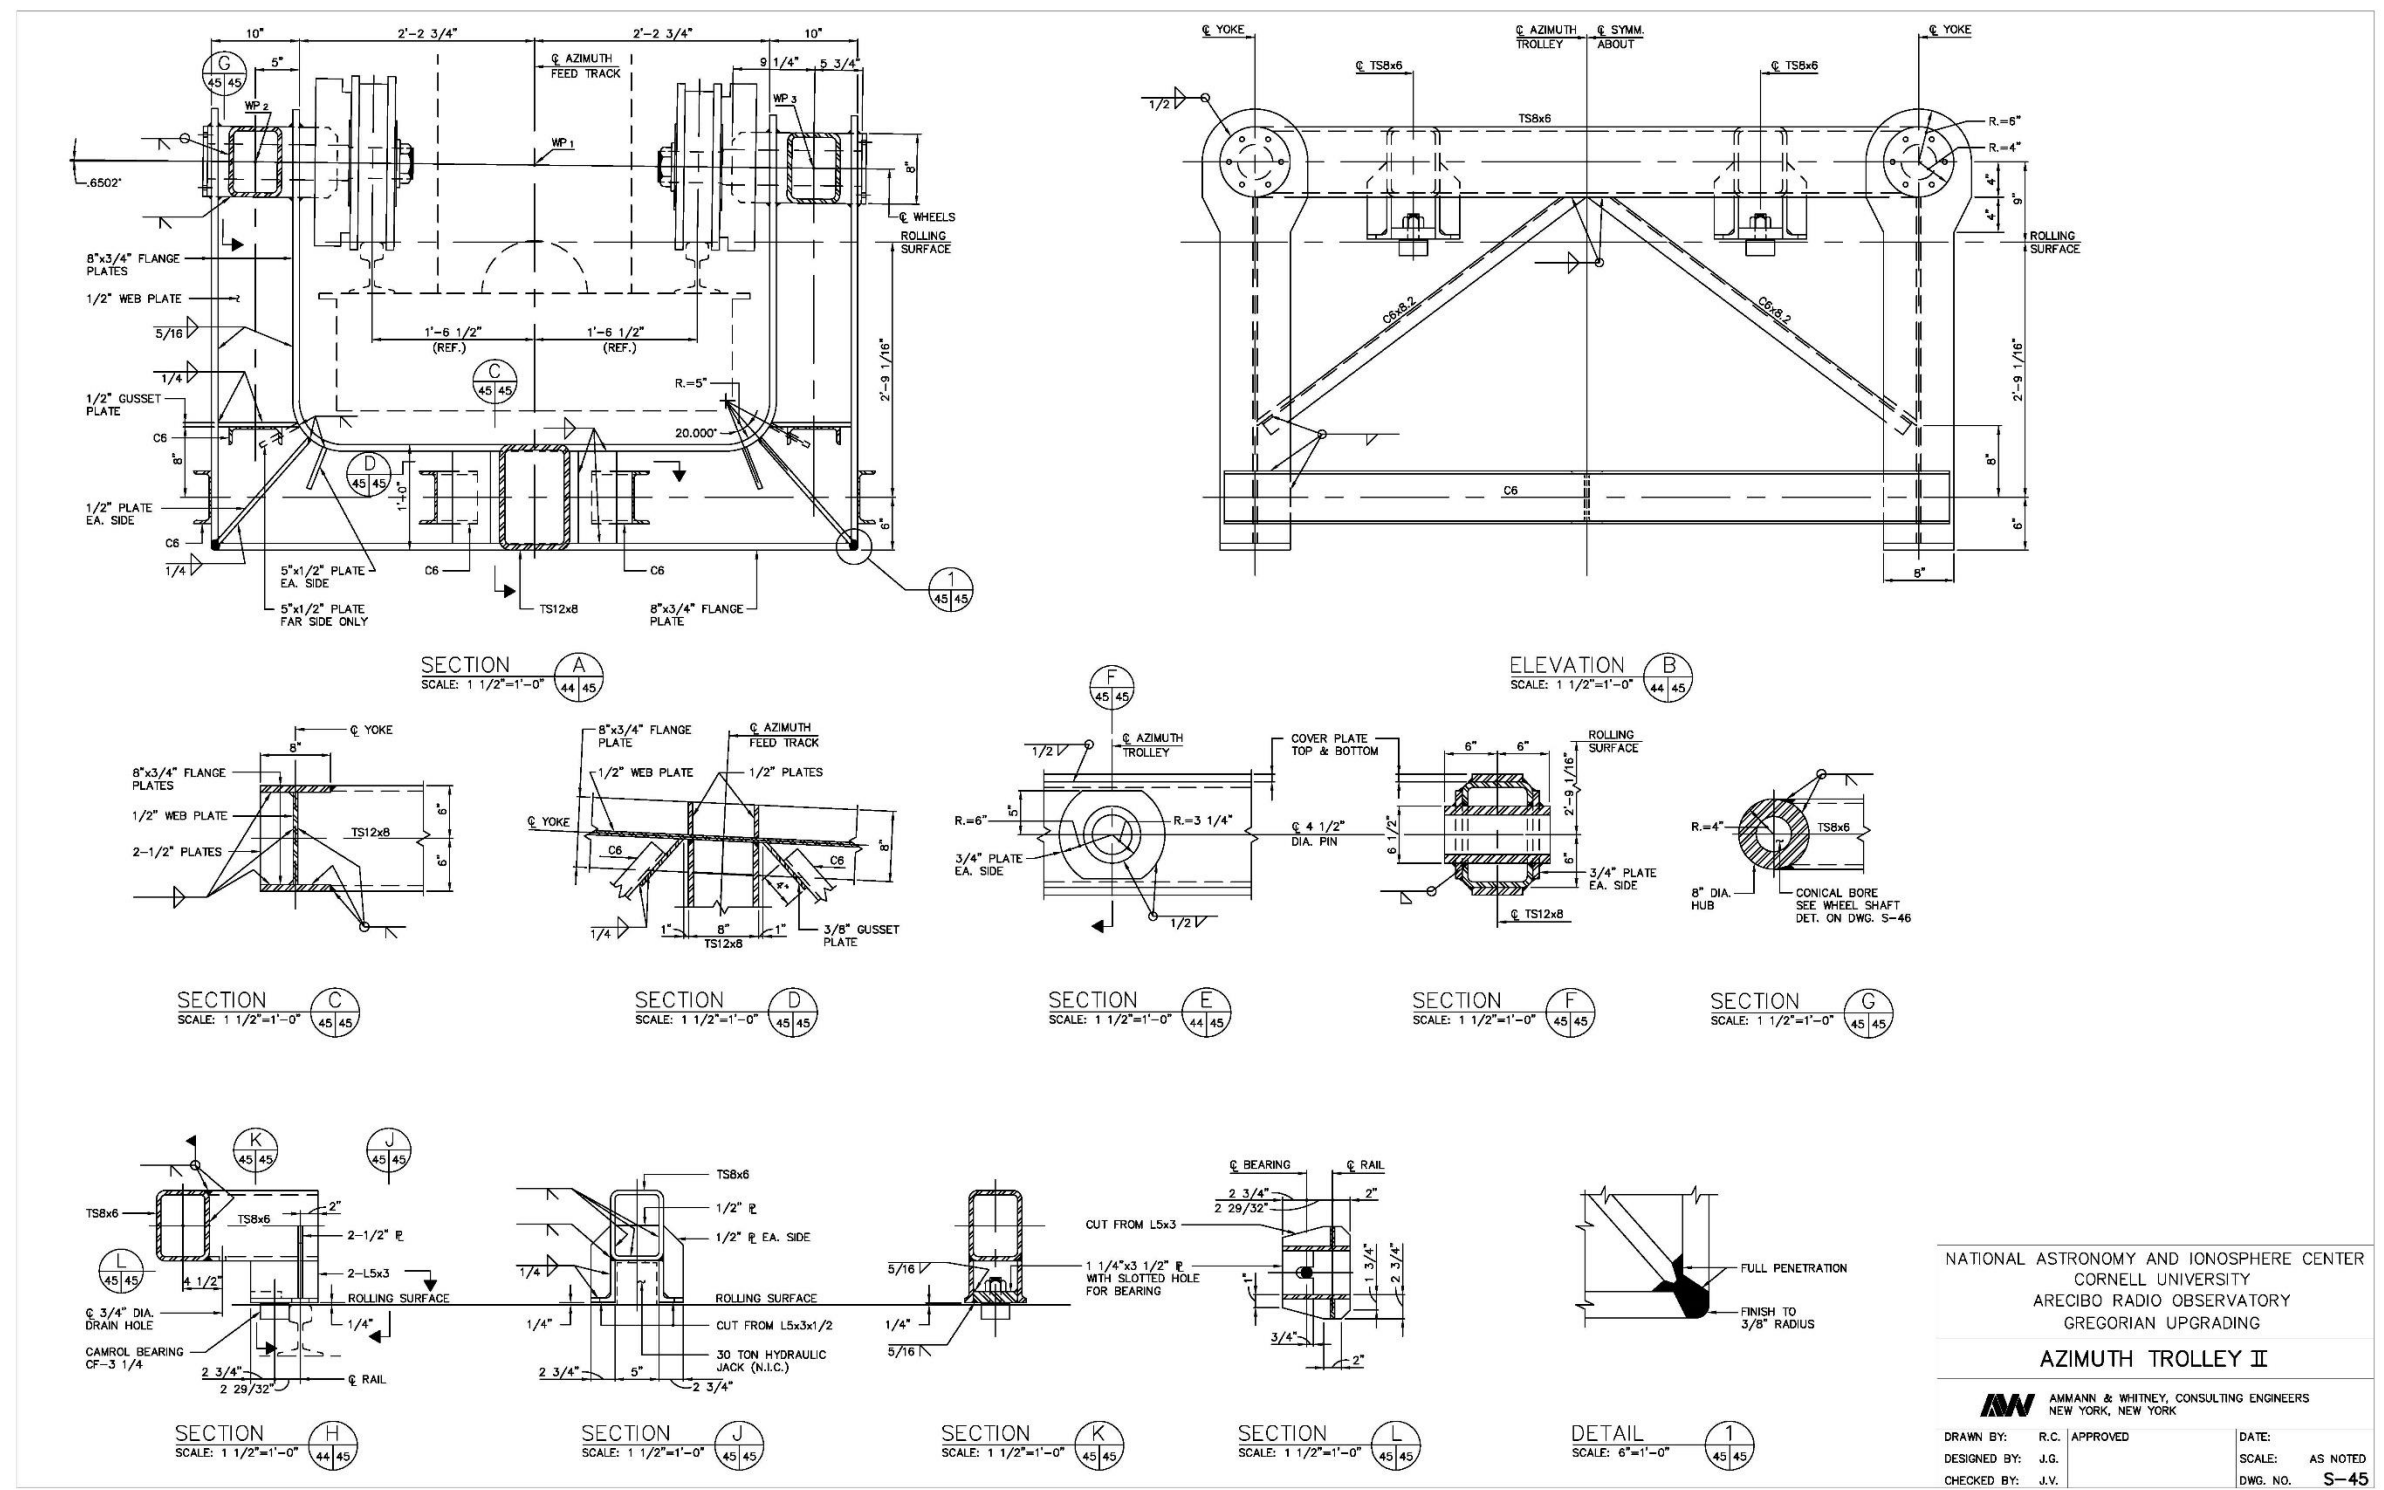
NATIONAL ASTRONOMY AND IONOSPHERE CENTER
 CORNELL UNIVERSITY
 ARECIBO RADIO OBSERVATORY
 GREGORIAN UPGRADING
