FD/TDR data on the Heliac cable for dipole HF-3B (used with TX4)

Dana Whitlow  
16 June 2015

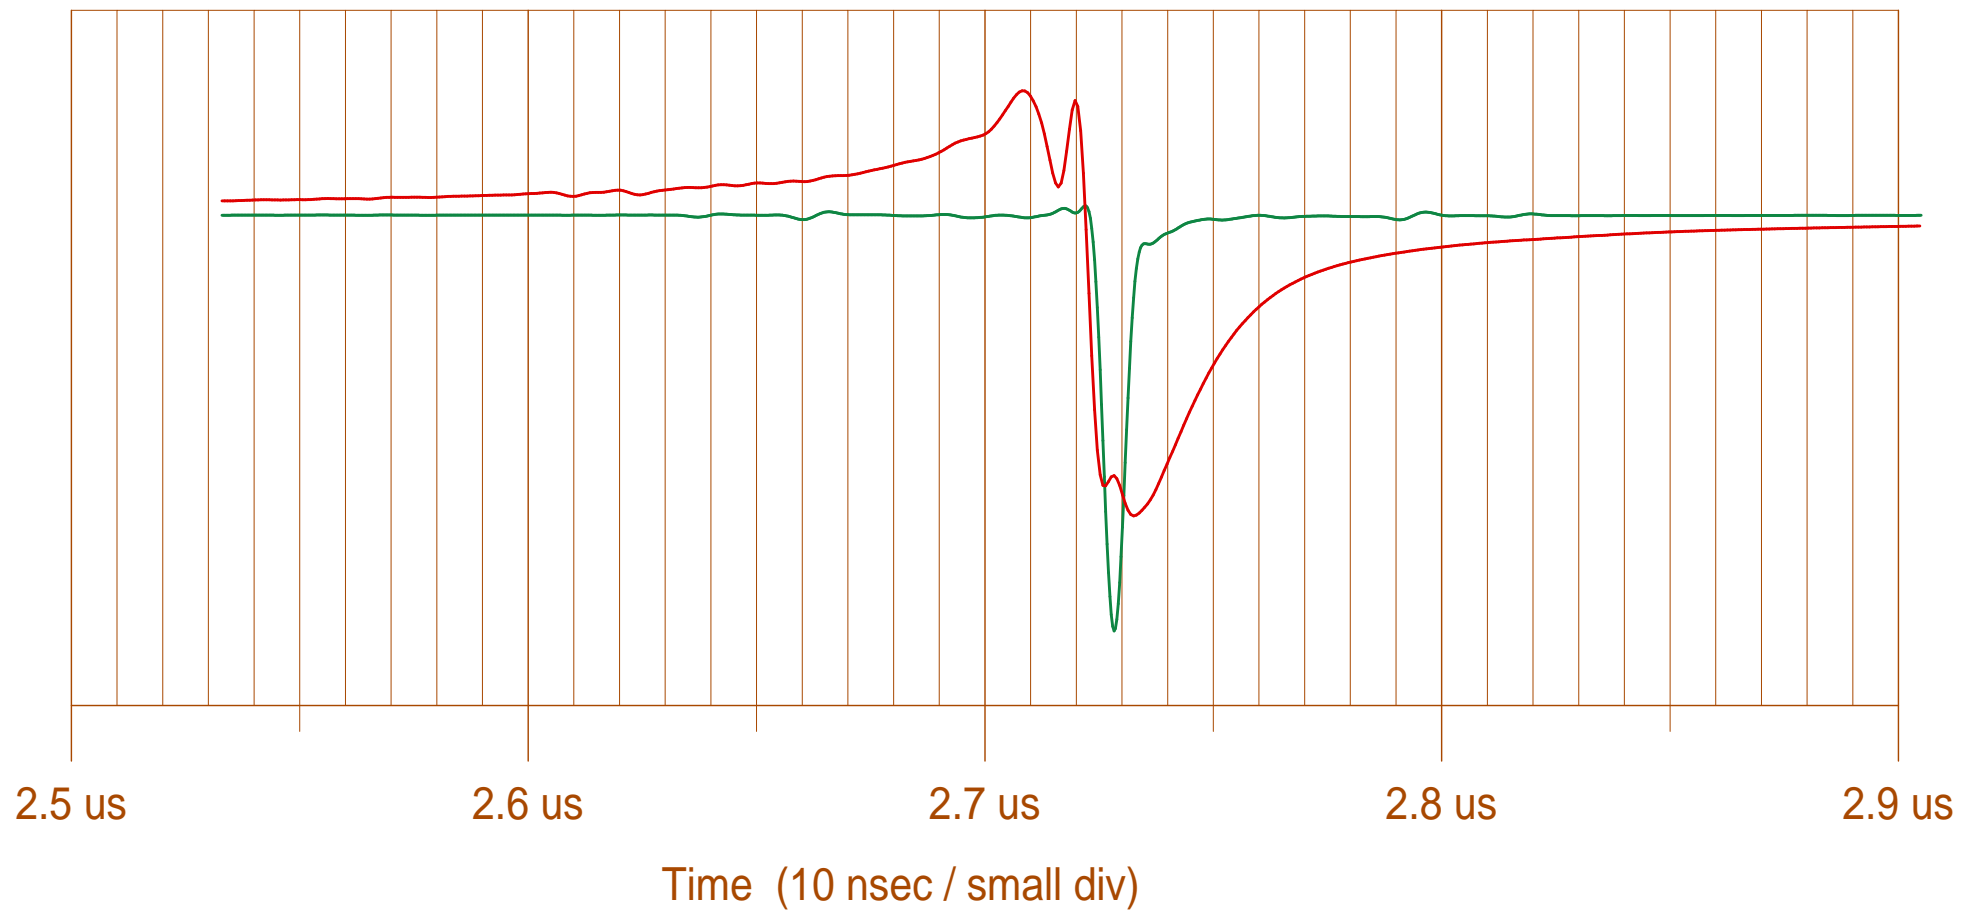
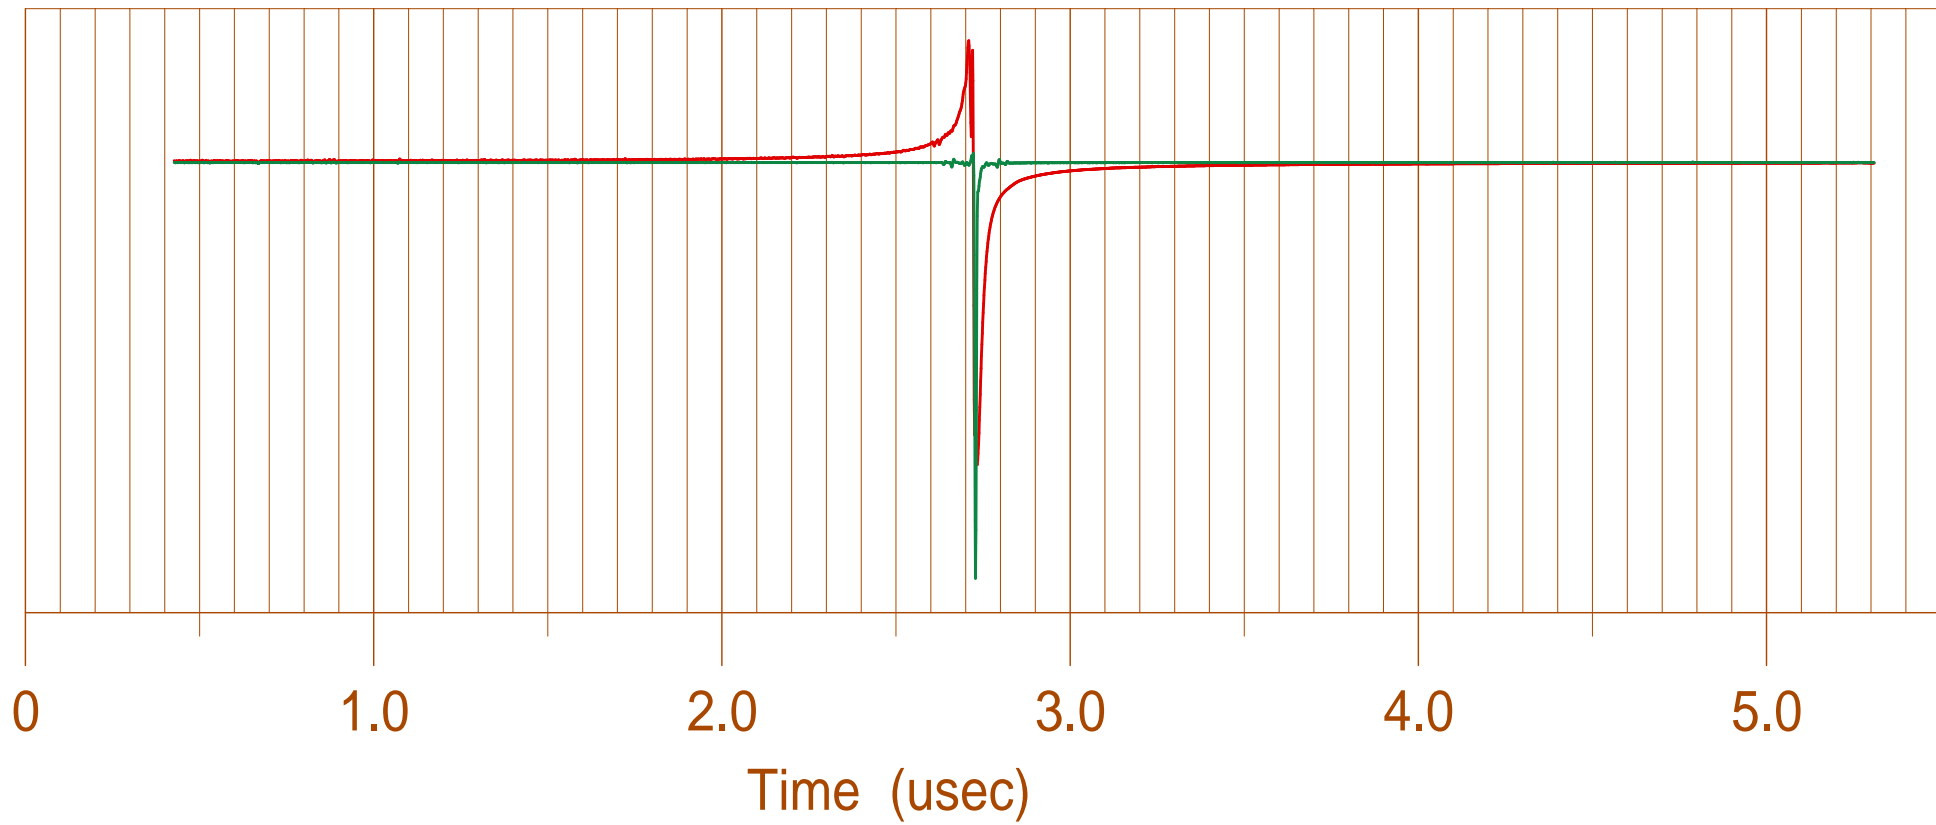
The following two plots are from the same data, but plotted at differing time scales.

In each plot the green curve is from final data taken just after we had finished cutting the 5-MHz heliac lines to length.

The red curve in each plot is data taken after the first repair attempt was made following the arc incident in early June 2015. This arc initially appeared to be confined to the very top end of the line, but from this TDR data the effects are temporally more widespread than seems consistent with localized damage.
