National Science Foundation Arecibo Observatory Damage Press Call

NSF begins planning for decommissioning of Arecibo Observatory's 305-meter telescope due to safety concerns

RE: RECOMMENDATION FOR COURSE OF ACTION AT ARECIBO OBSERVATORY
TT Project No. U20209

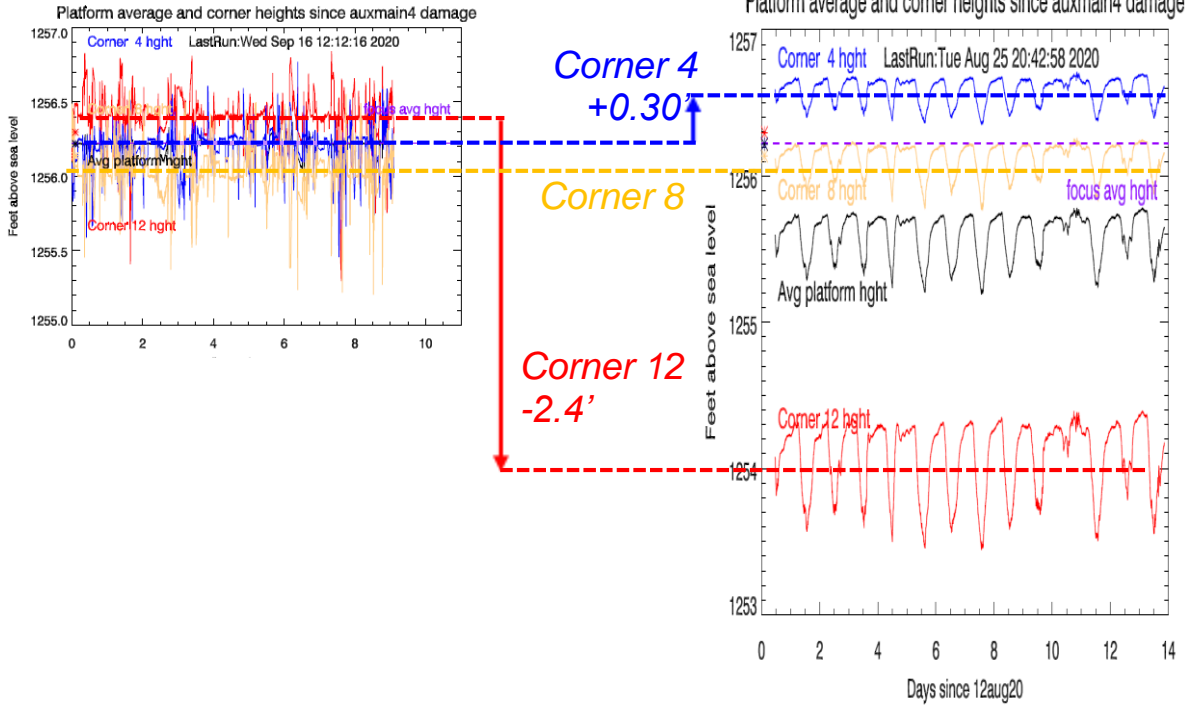
Corner 4	Corner 8	Corner 12
Monitoring	0.30' (3.6")	0' (0")	-2.4' (-28.8")
FE Model	0.14' (1.6")	-0.32' (-3.9")	-2.5' (30.1")

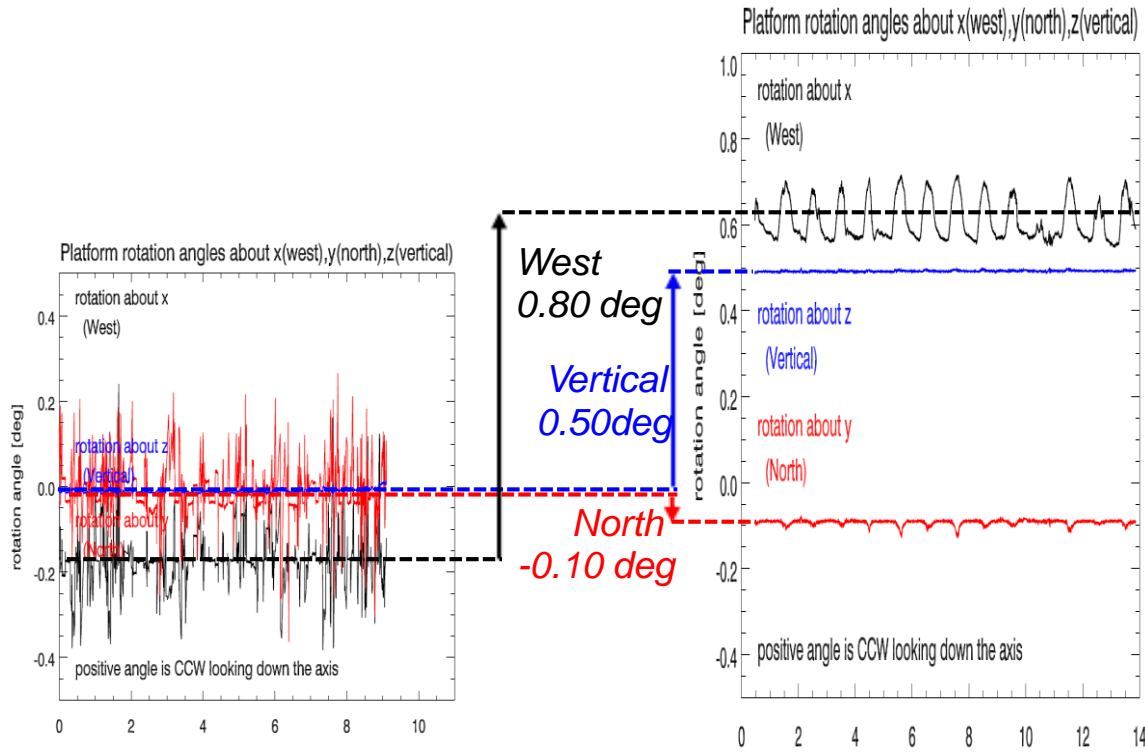
West axis	North axis	Vertical axis
Monitoring	0.80°	-0.10°	0.50°
FE Model	0.73°	-0.12°	0.53°

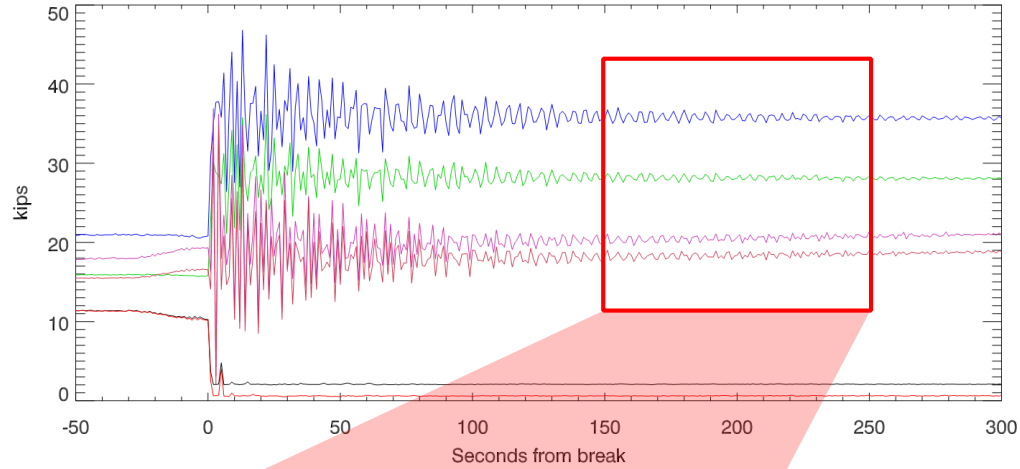
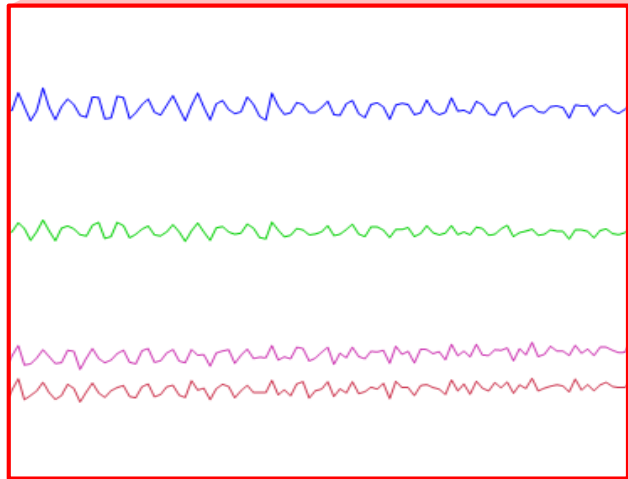
Tiedown forces during failure

24.5 cycles in 100 sec
→ $f = 0.245 \text{ Hz}$
→ $T = 4.08 \text{ s}$

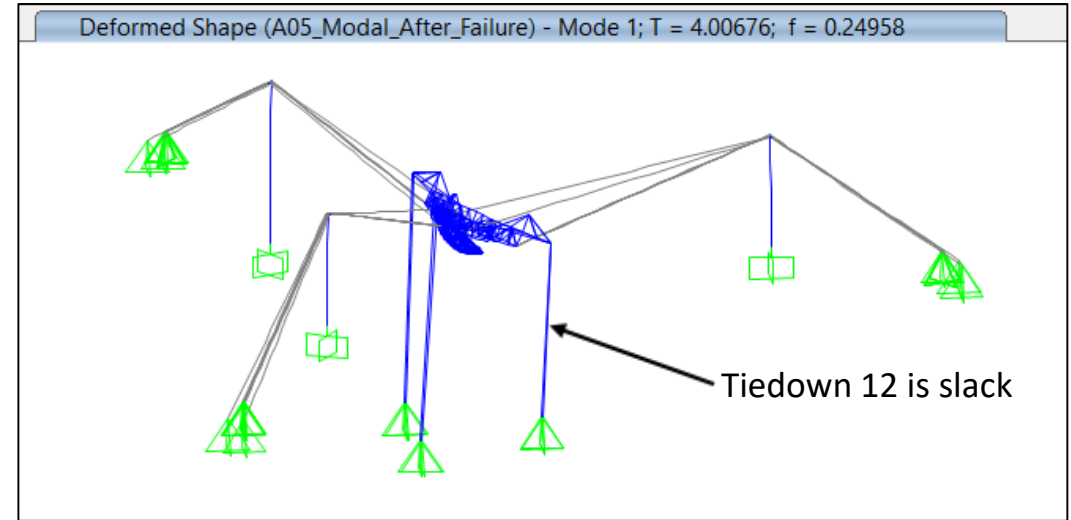
FE Model

Modal analysis with total structure mass of 1,826 kip and tiedown 12 removed

→ $f = 0.233 \text{ Hz}$
→ $T = 4.30 \text{ s}$
