14sep15 hf rf monitor cable loss (from S11)

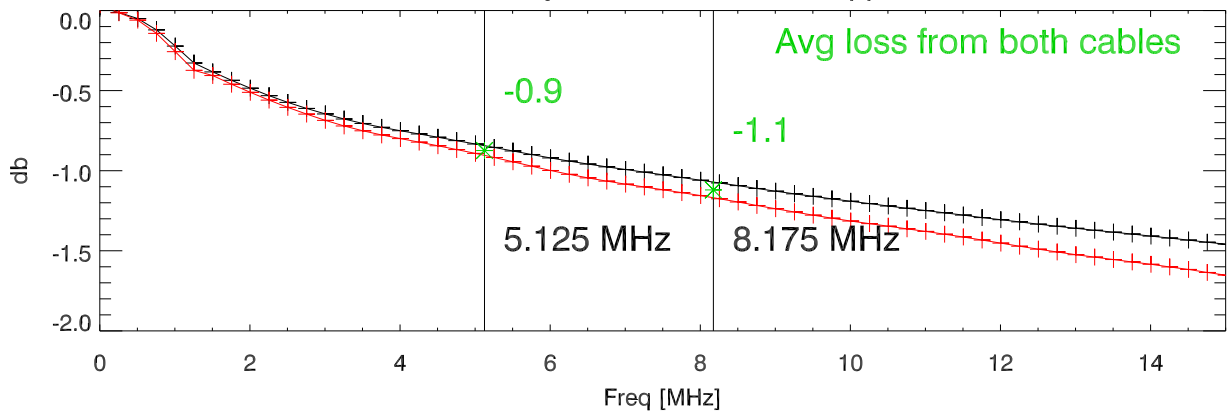
smooth by 3.25 Mhz to remove ripple

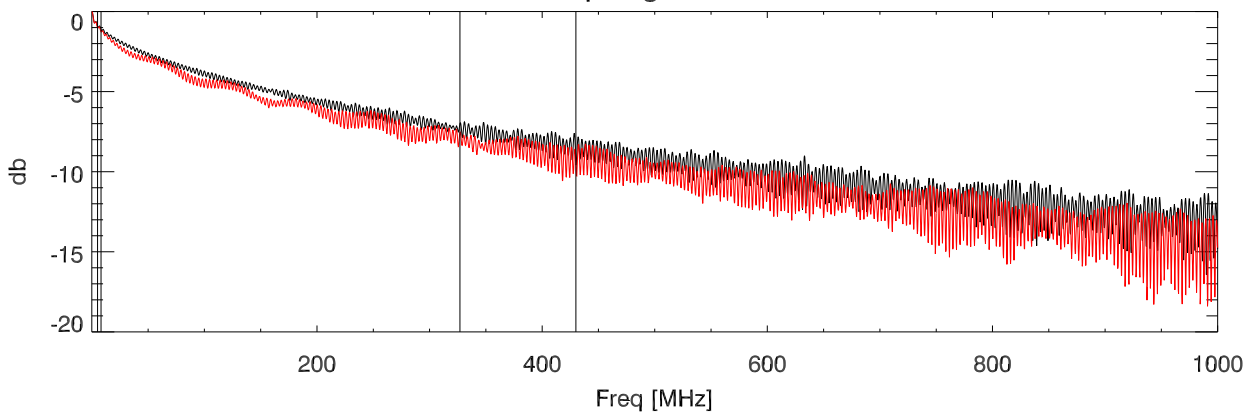
full freq range measured

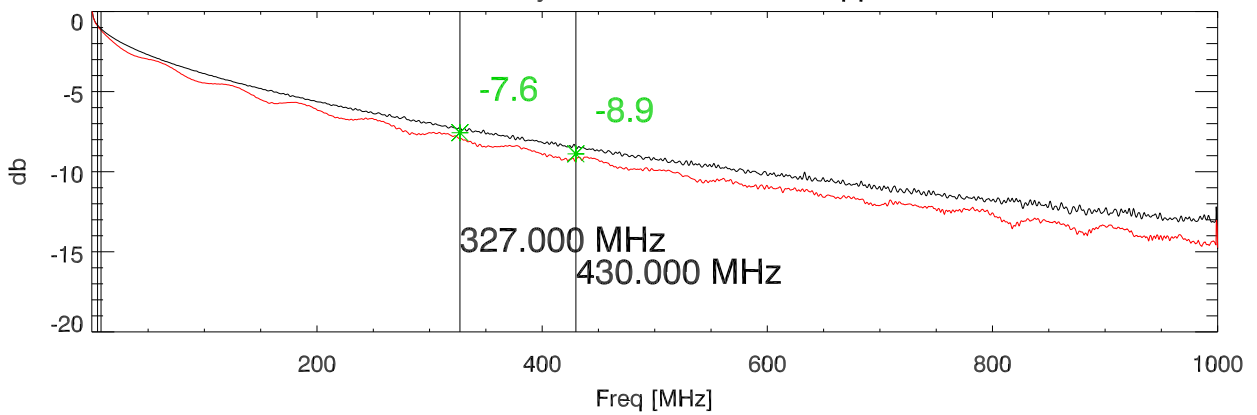
smooth by 3.25 Mhz to remove ripple
