430 TRANSMITTER
 DWG. 430_102.ecw
 TITLE: CROWBAR (BOTH CHASSIS)
 DRAWN 12-99 TO REPLACE D349C102 & C349C108
 REV 7-23-02

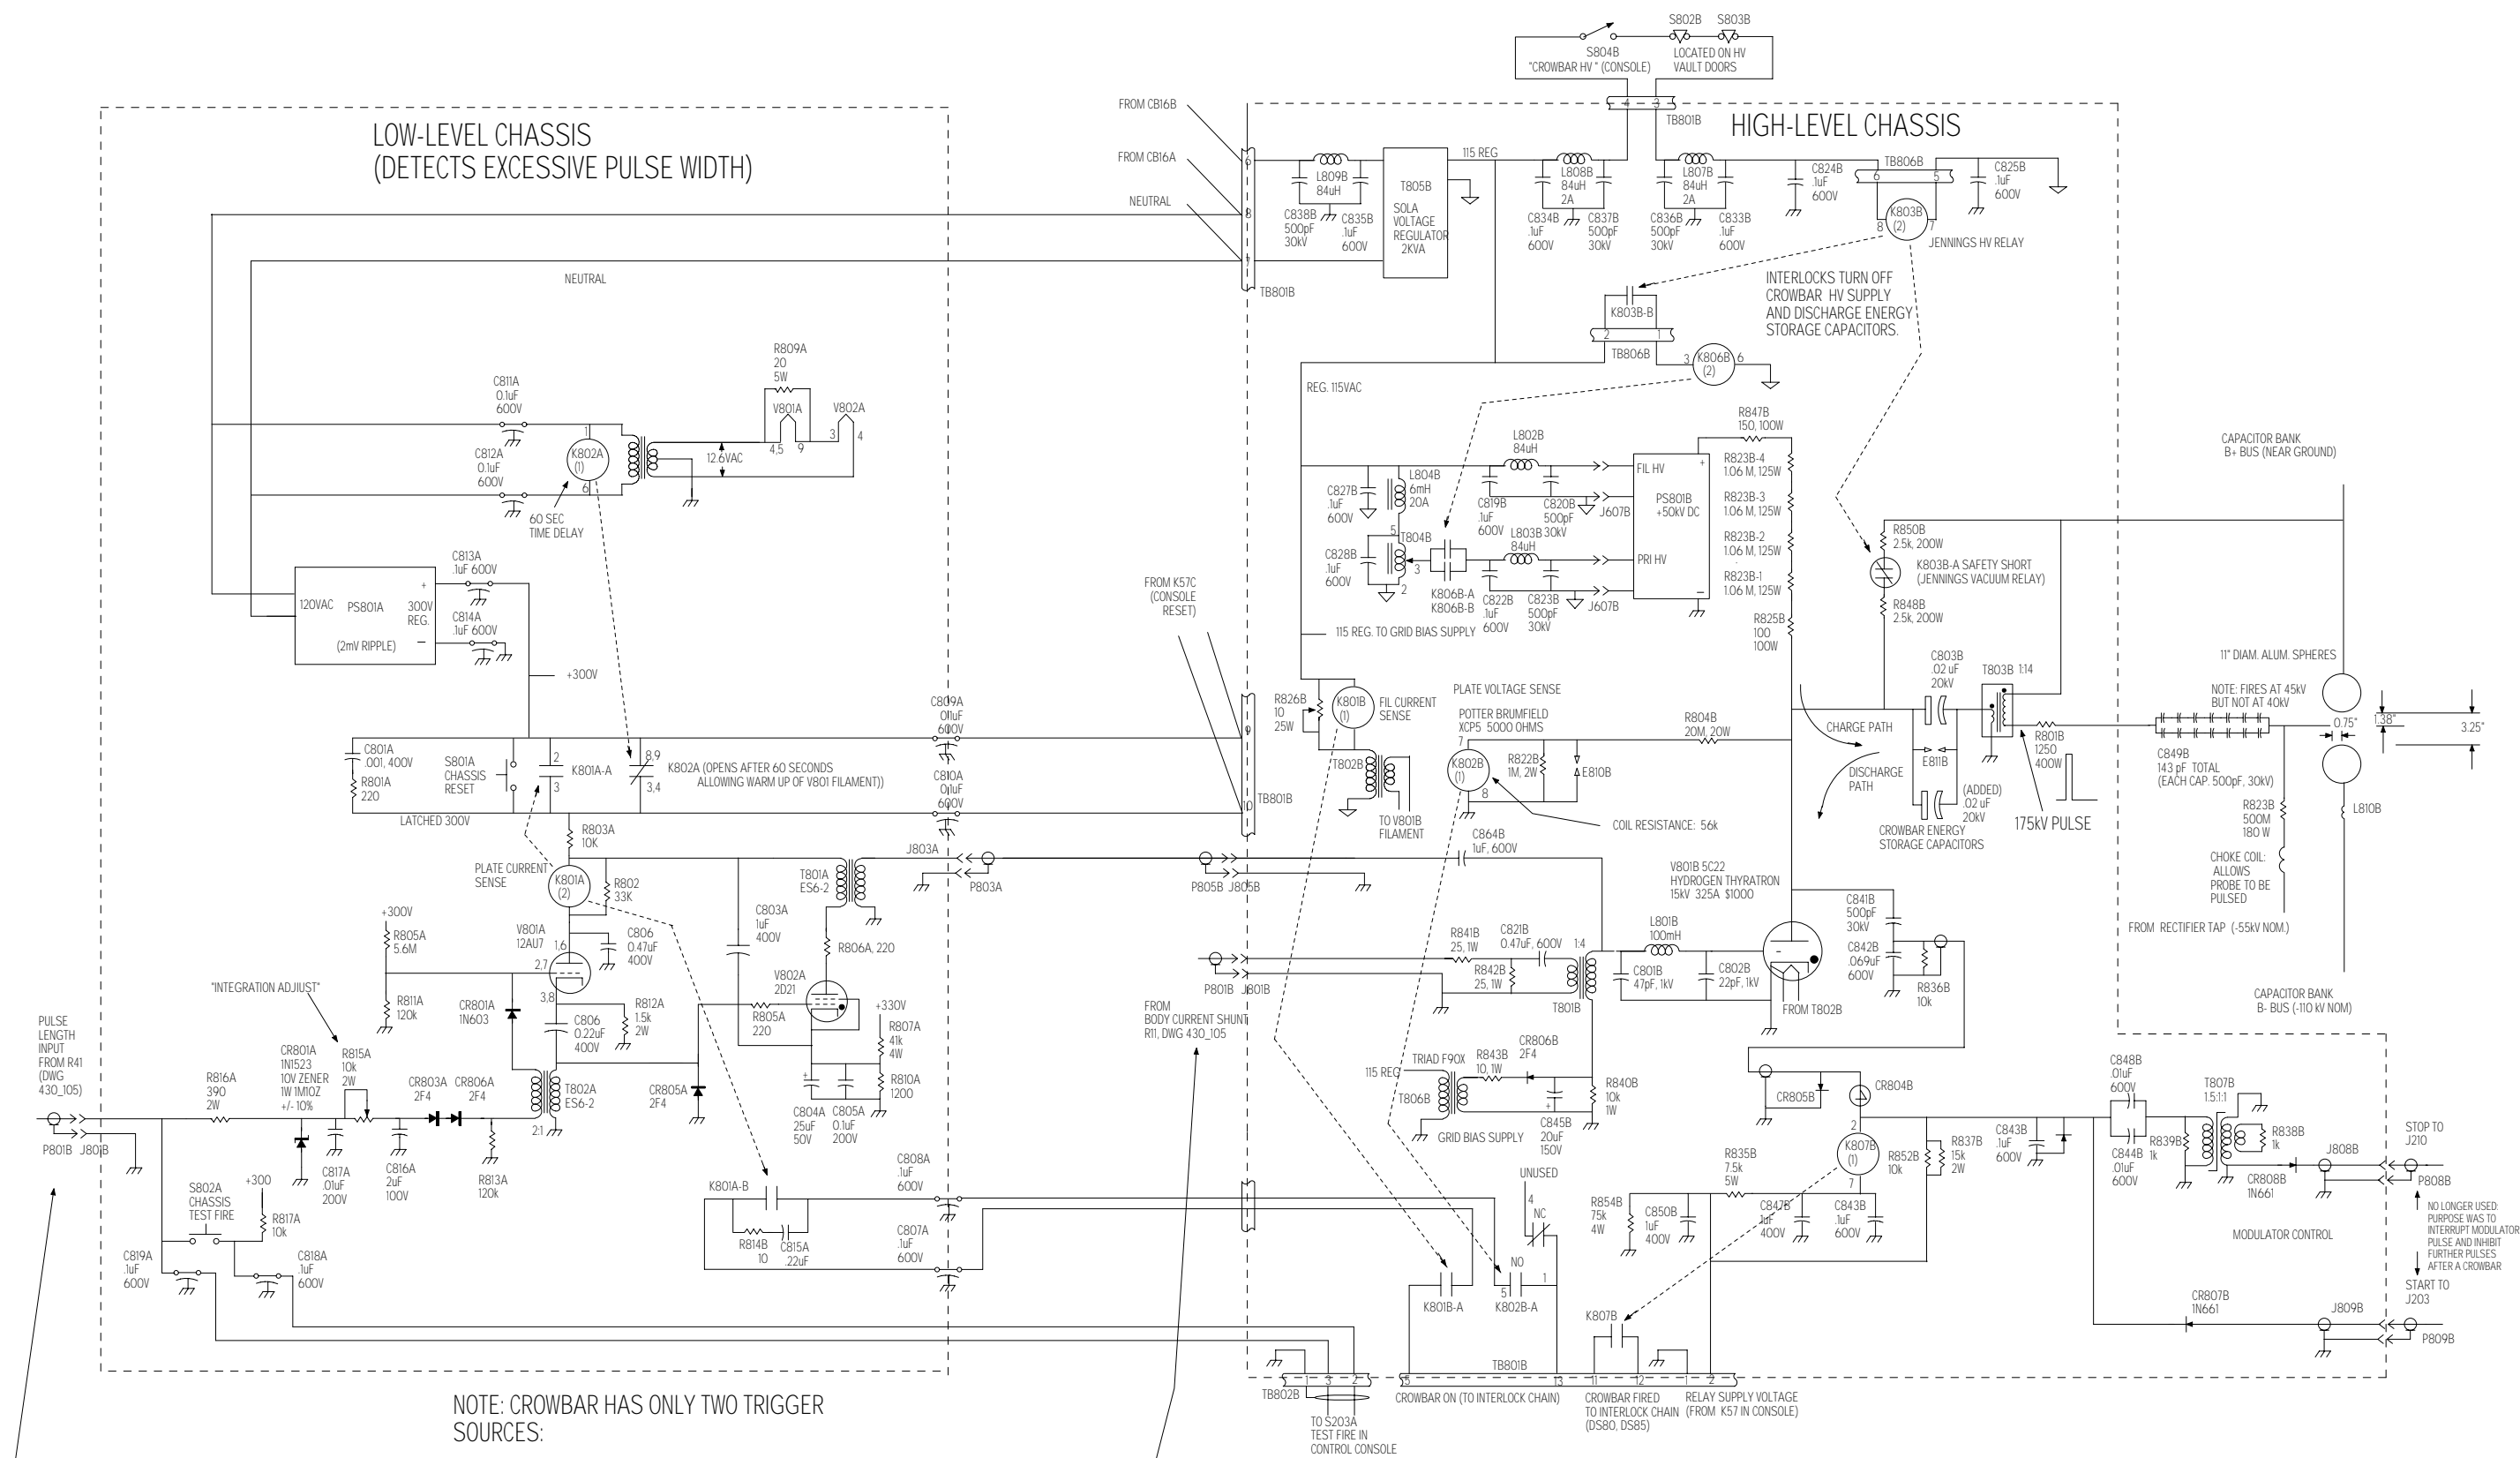
**LOW-LEVEL CHASSIS
(DETECTS EXCESSIVE PULSE WIDTH)**

HIGH-LEVEL CHASSIS

NOTE: CROWBAR HAS ONLY TWO TRIGGER SOURCES:

1. EXCESSIVE PULSE LENGTH (INTERNAL KLYSTRON ARC)
2. SUDDEN BODY CURRENT (INTERNAL KLYSTRON ARC)
