# KLYSTRON AGING SET-UP

430 TRANSMITTER  
DWG. 430\_AGE  
TITLE: CAPACITOR BANK KLYSTRON AGING SET-UP  
AND BEAM VOLTAGE CIRCUITRY  
DRAWN 12-98 TO REPLACE D349C105

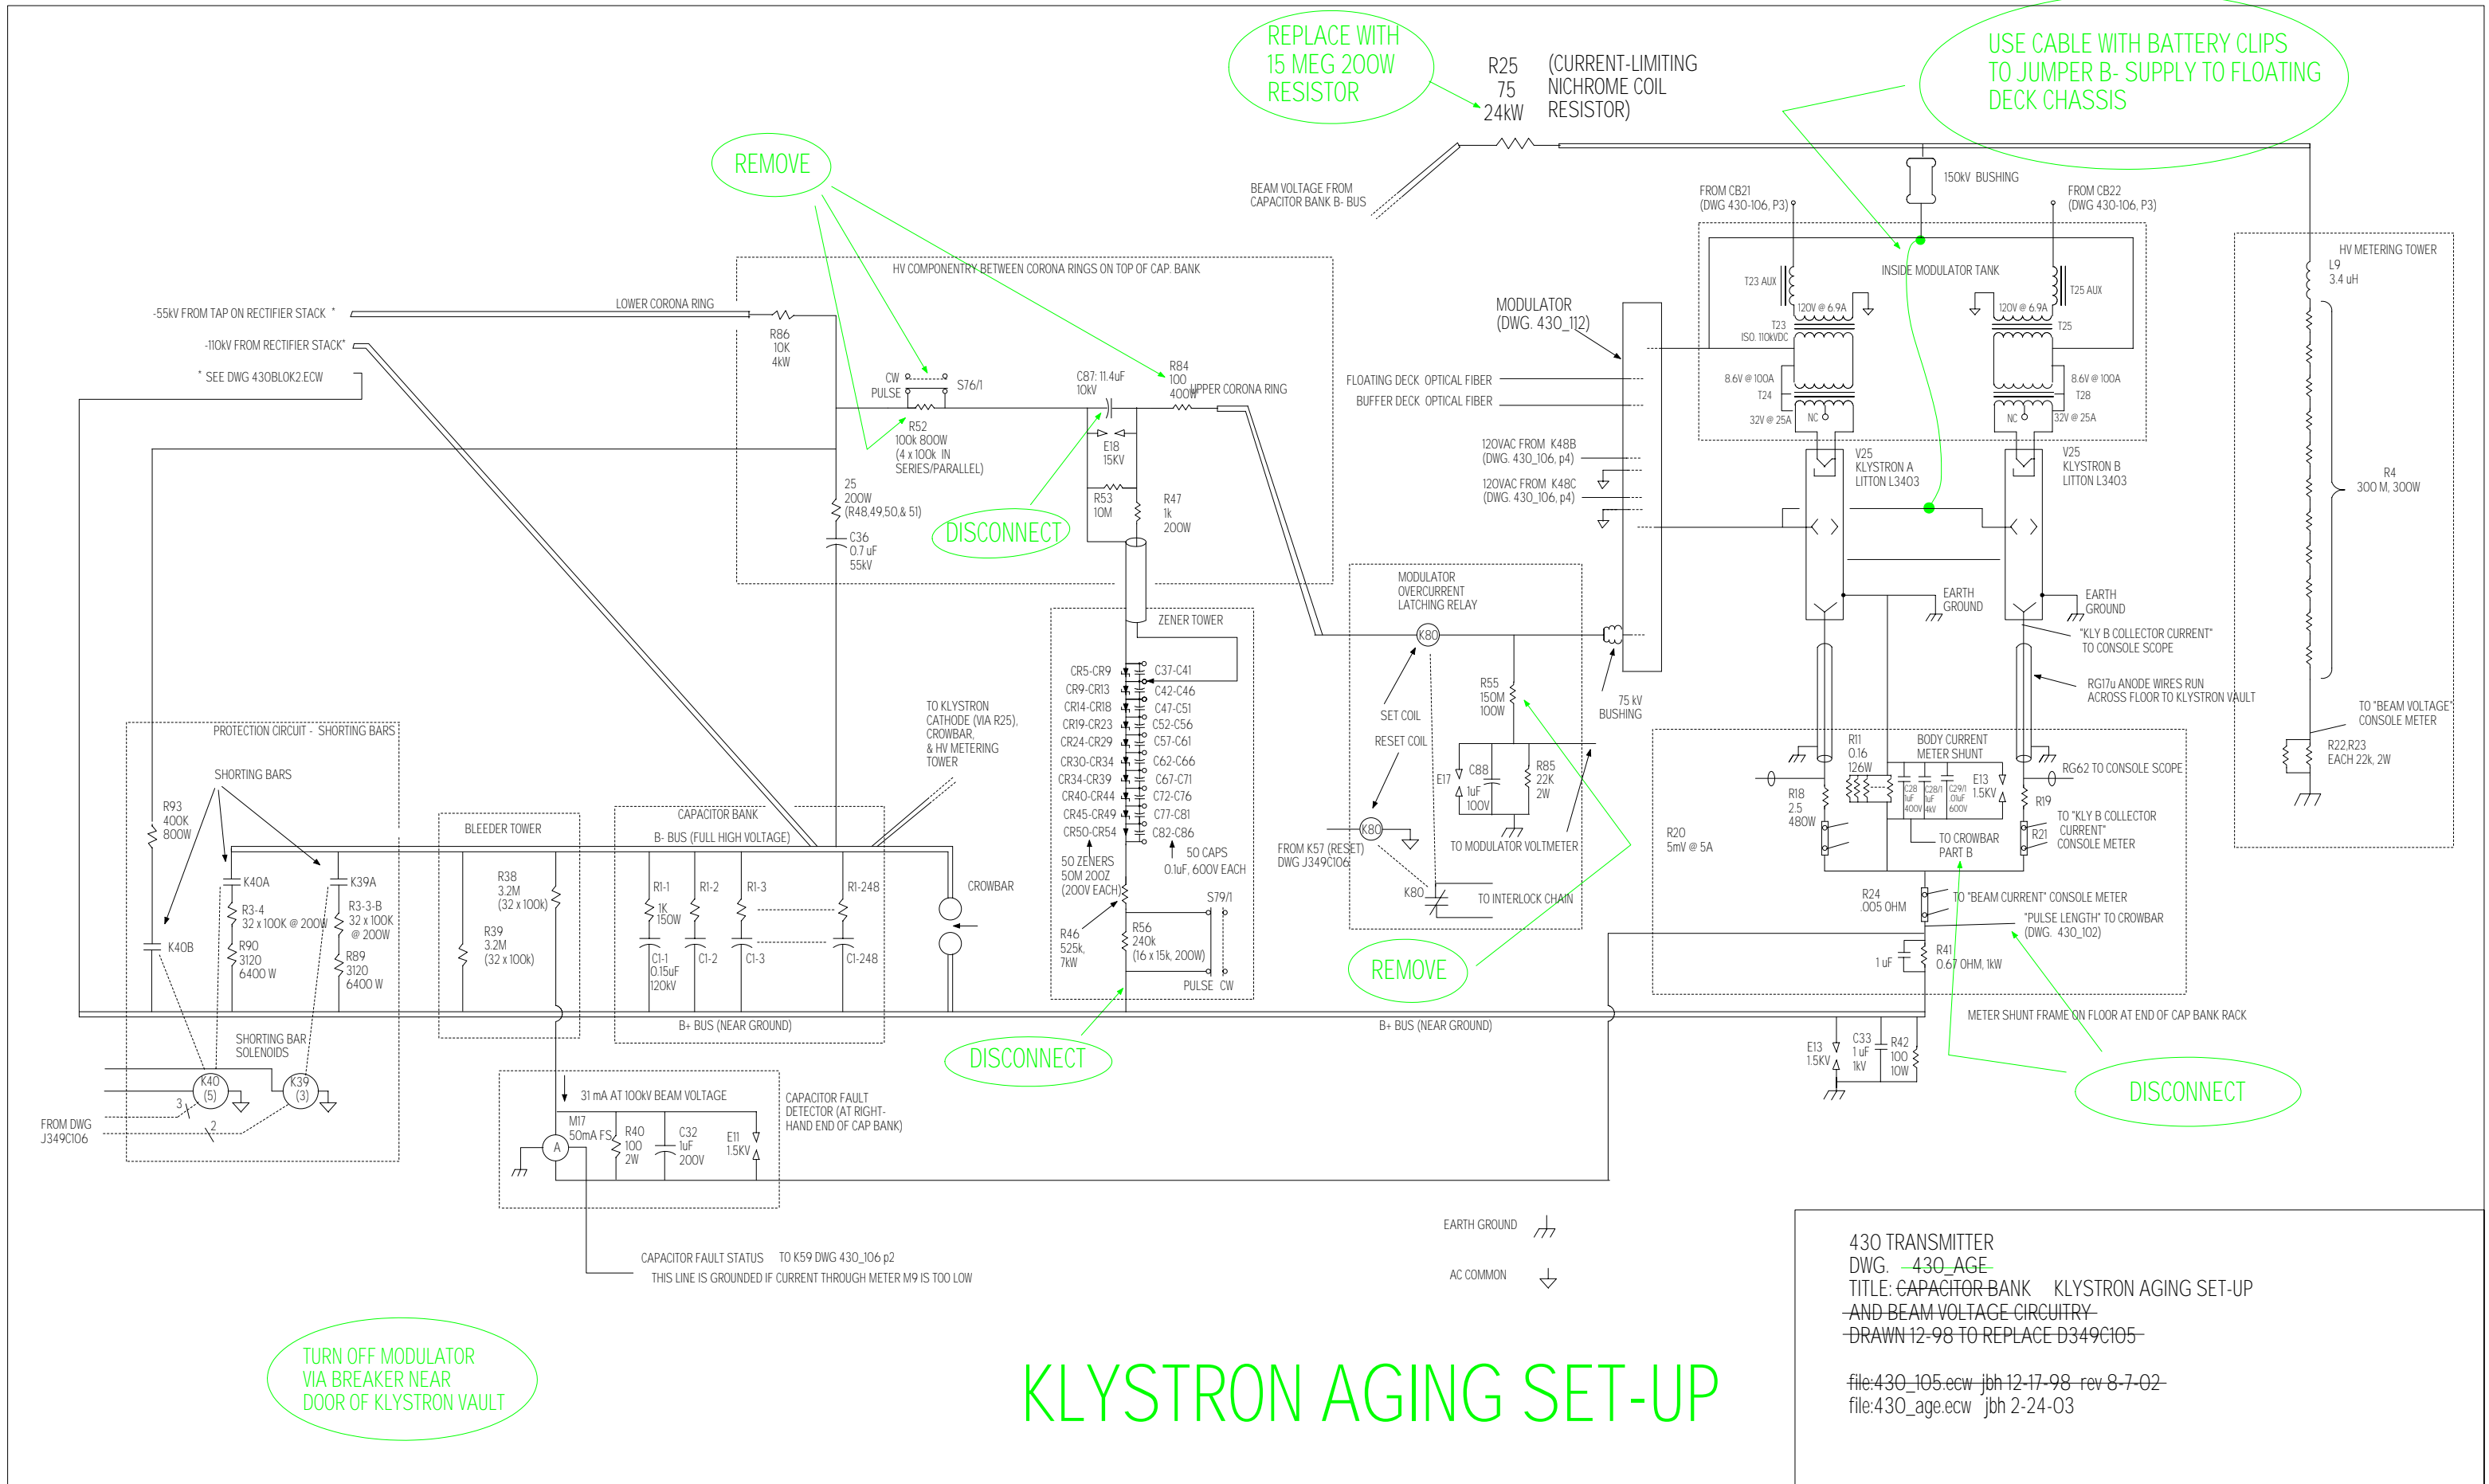
CAPACITOR FAULT STATUS TO K59 DWG 430\_106 p2  
THIS LINE IS GROUNDED IF CURRENT THROUGH M9 IS TOO LOW

TURN OFF MODULATOR  
VIA BREAKER NEAR  
DOOR OF KLYSTRON VAULT
